## **Environmental authority P-EA-100121435**

| Environmentally relevant activities | Locations |
|---|---|
| ERA 63 - Sewage Treatment 1(e) - Operating sewage treatment works, other than no-release works, with a total daily peak design capacity of more than 10,000 but not more than 50,000EP | Lots 2 and 3 Plan RP223470; Lot 1 Plan SL3427; Lot 254 Plan S31102; and Lots 83, 84, 86, 255, 256, 257 and 259 on Plan S312432. |

SOUTHERN REDLAND BAY WASTEWATER TREATMENT PLANT  
CONCEPT REHABILITATION PLAN - DETAIL SHEET 05

R01v05\_20020099\_Southern\_Redland\_Bay\_Stage\_3\_Assessments

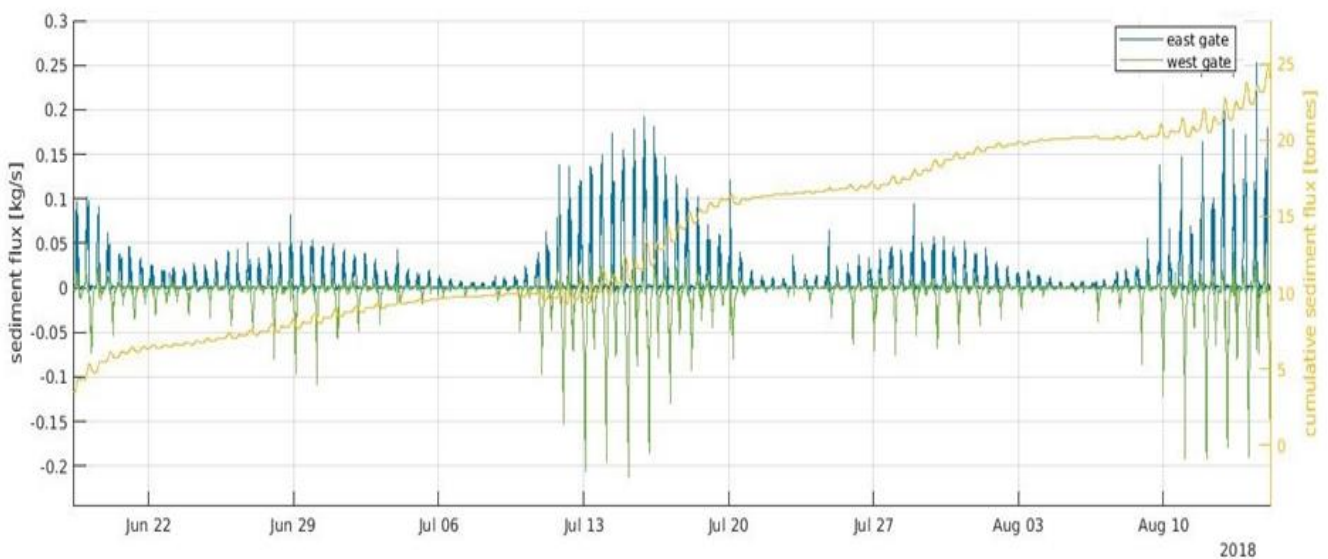
**FIGURE 9-19 SEDIMENT FLUX IN THE PROPOSED SOUTHERN REDLAND BAY MANGROVES (DEVELOPMENT CASE)**

Based on the sediment flux at the tidal inlet, the cumulative sediment flux (represented by the yellow line (Figure 9-19) into the mangroves was estimated.

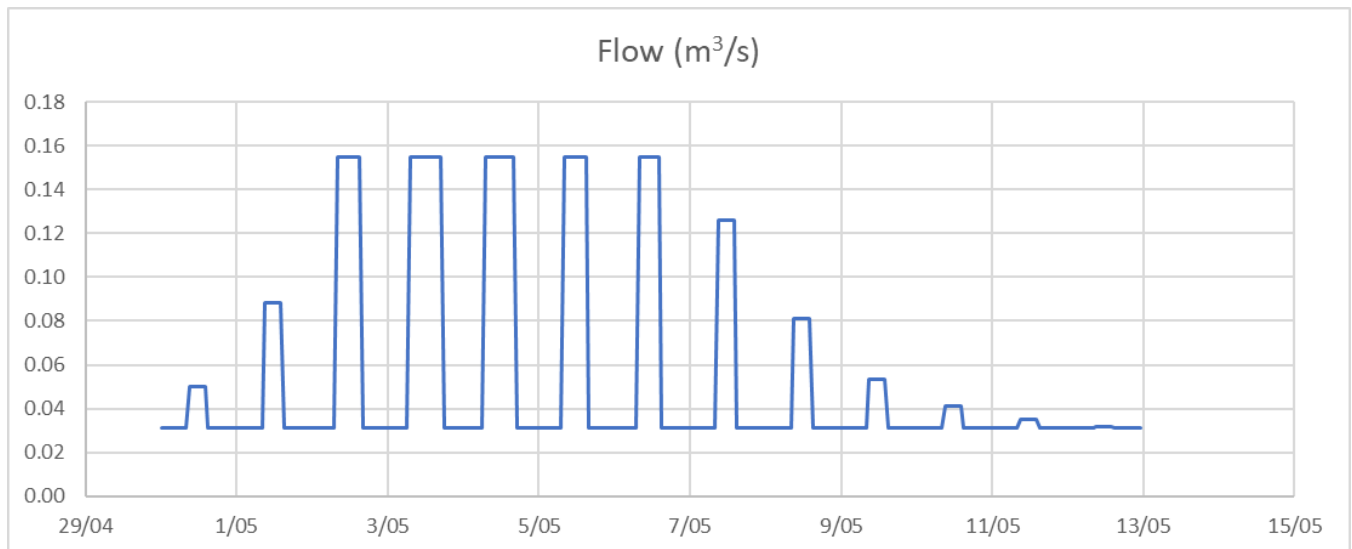
For a defined extreme wet weather case separately modelled by Stantec, recycled water flowrates illustrated in Figure 9-20 were adopted.

**FIGURE 9-20 TYPICAL WET WEATHER FLOW RATES**

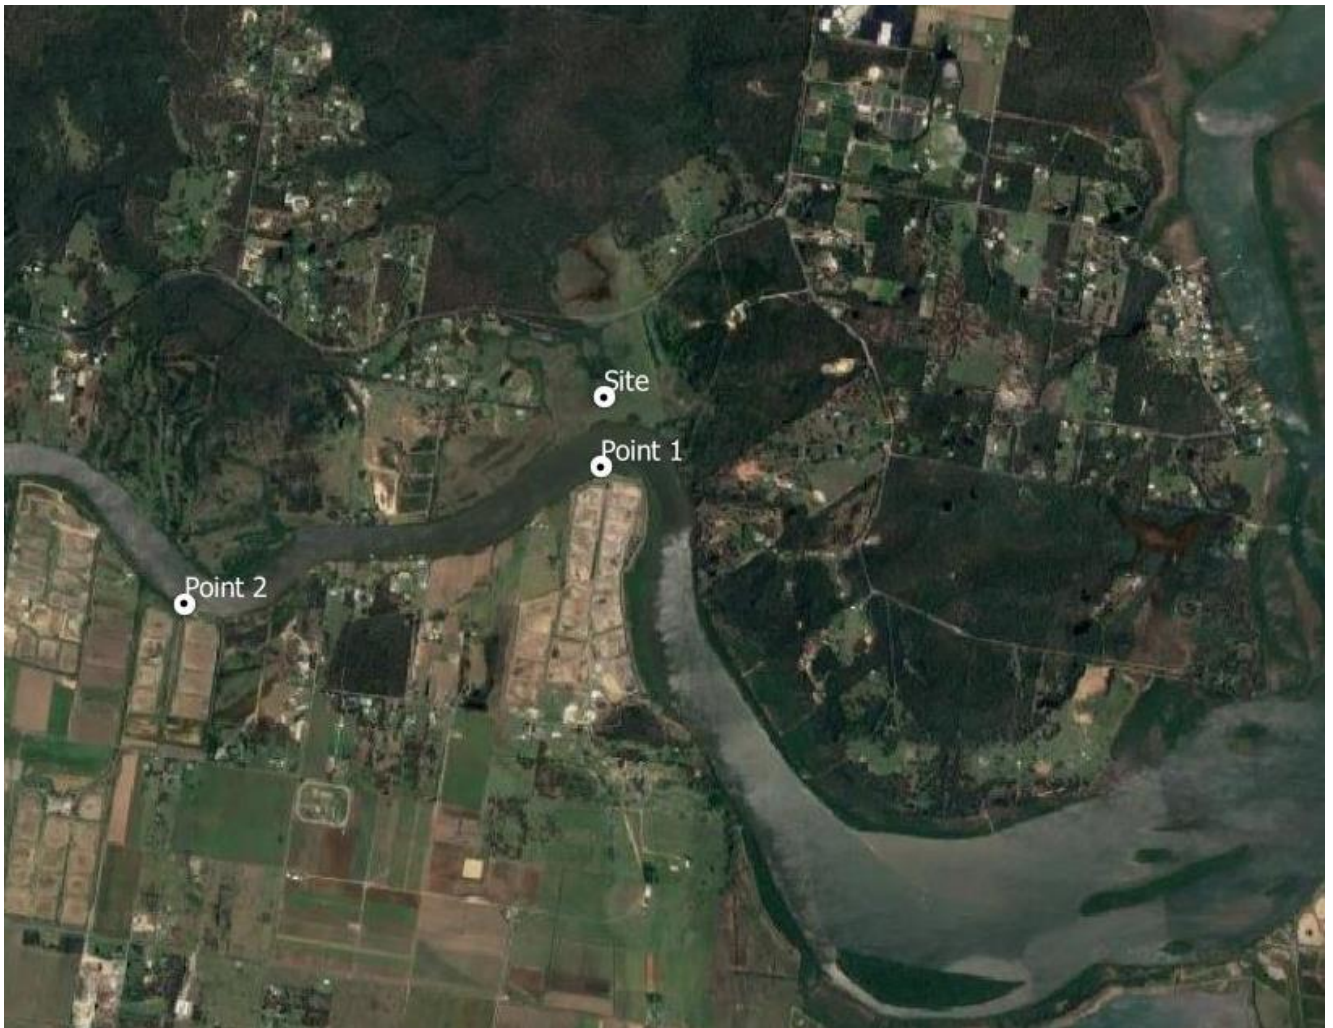
Given the above considerations, the model results were used to derive the predicted changes in bacteria, viruses and cryptosporidium concentrations above background concentrations at two potential prawn farm intake points (chosen as they are likely to be the most sensitive receptors in the immediate area) located adjacent to the southern bank of the estuary in the Logan River, in proximity to the Site (see Figure 9-21). The model outcomes are shown in Figure 9-22 to Figure 9-24.

**FIGURE 9-21 PRAWN FARM INTAKE POINTS**

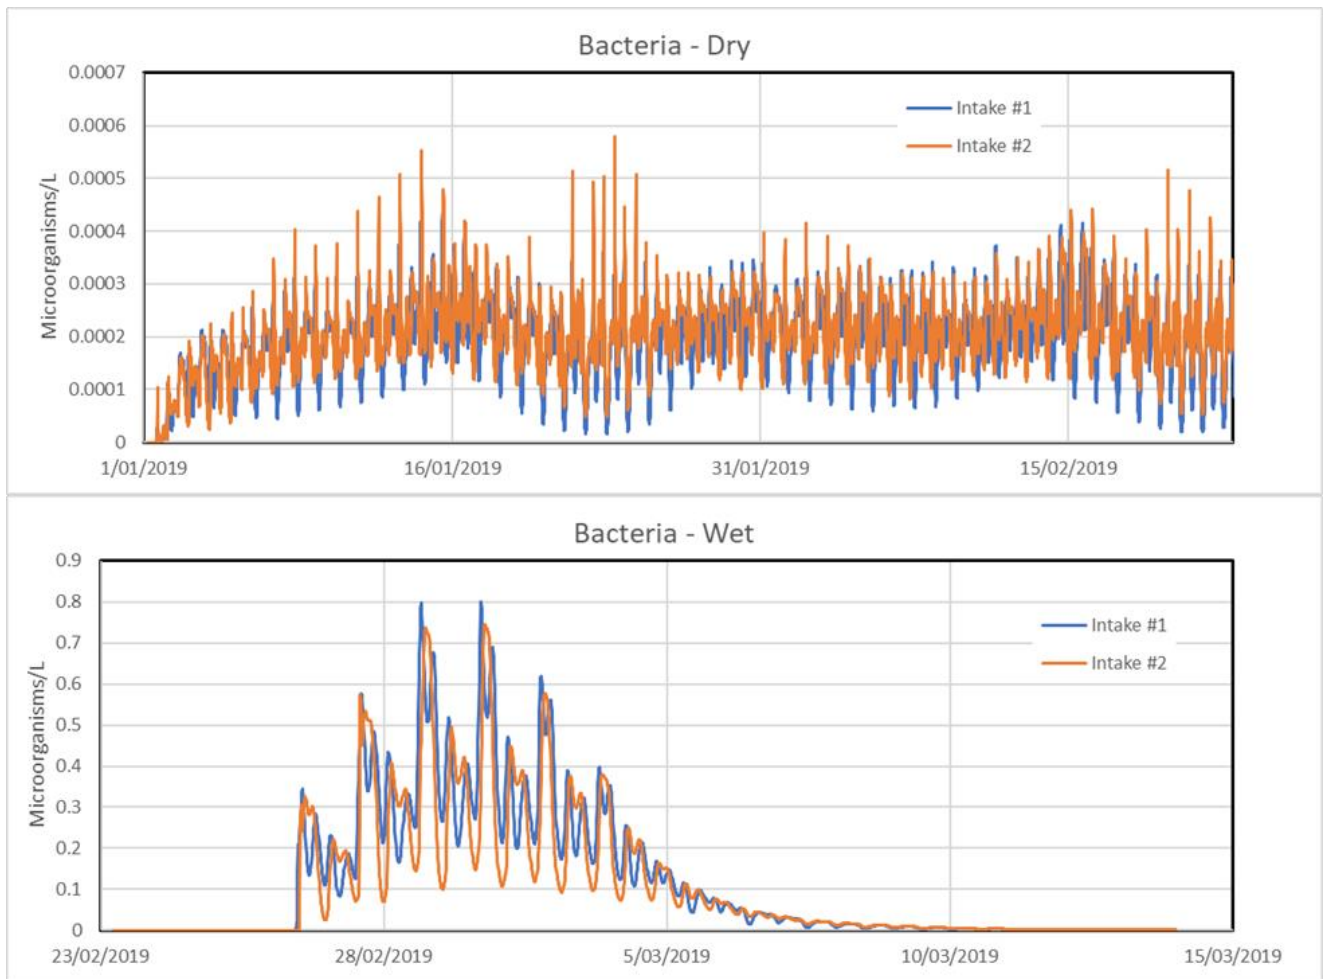
**FIGURE 9-22 BACTERIA CONCENTRATION RESULTS**

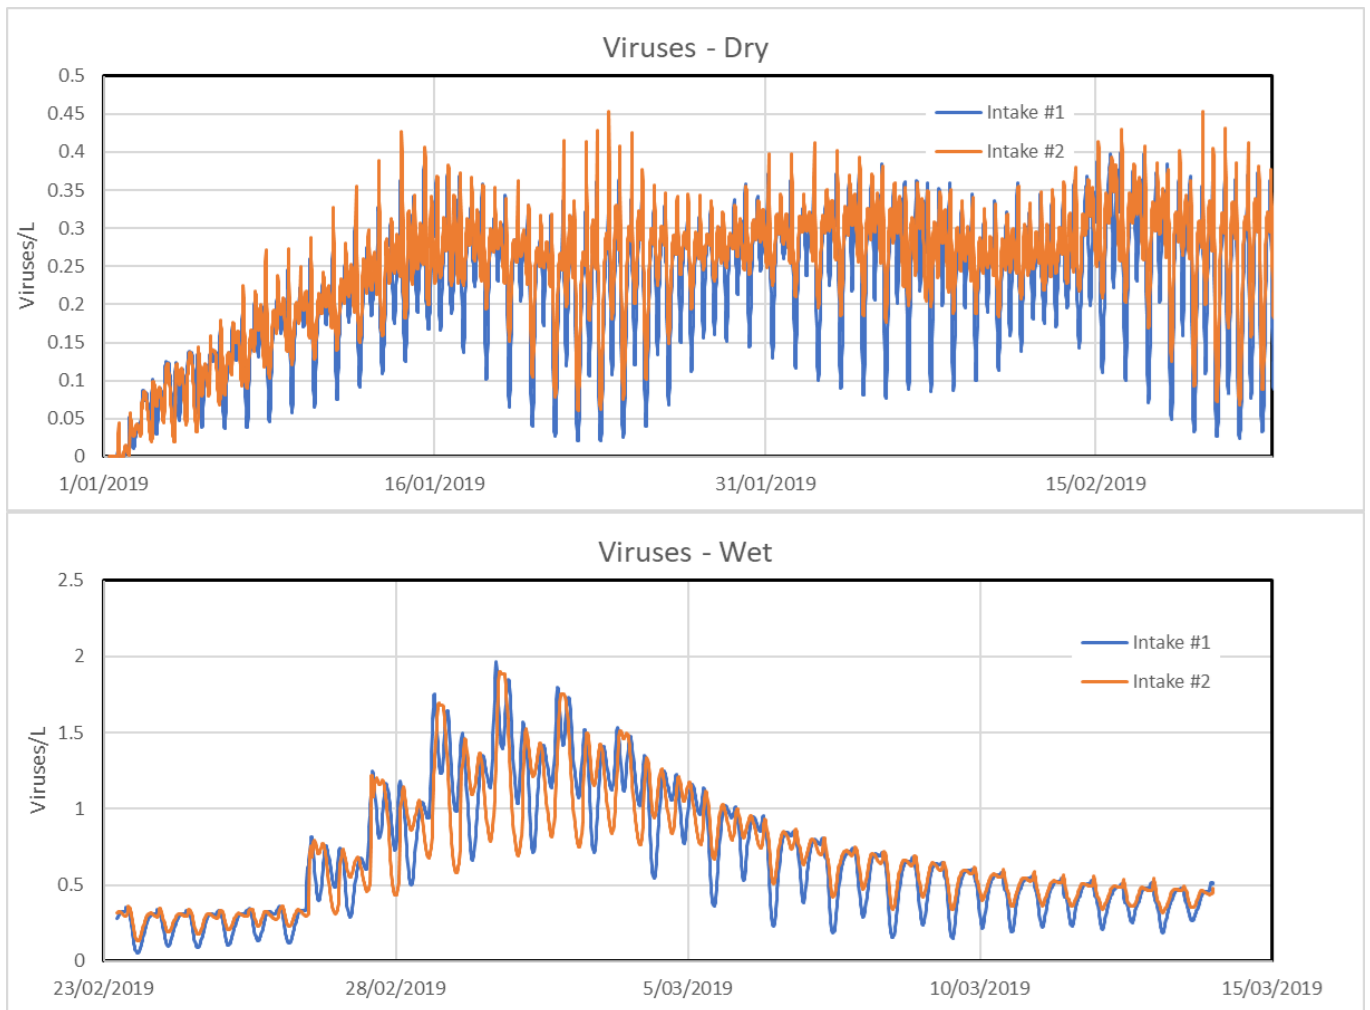
**FIGURE 9-23 VIRUS CONCENTRATION RESULTS**

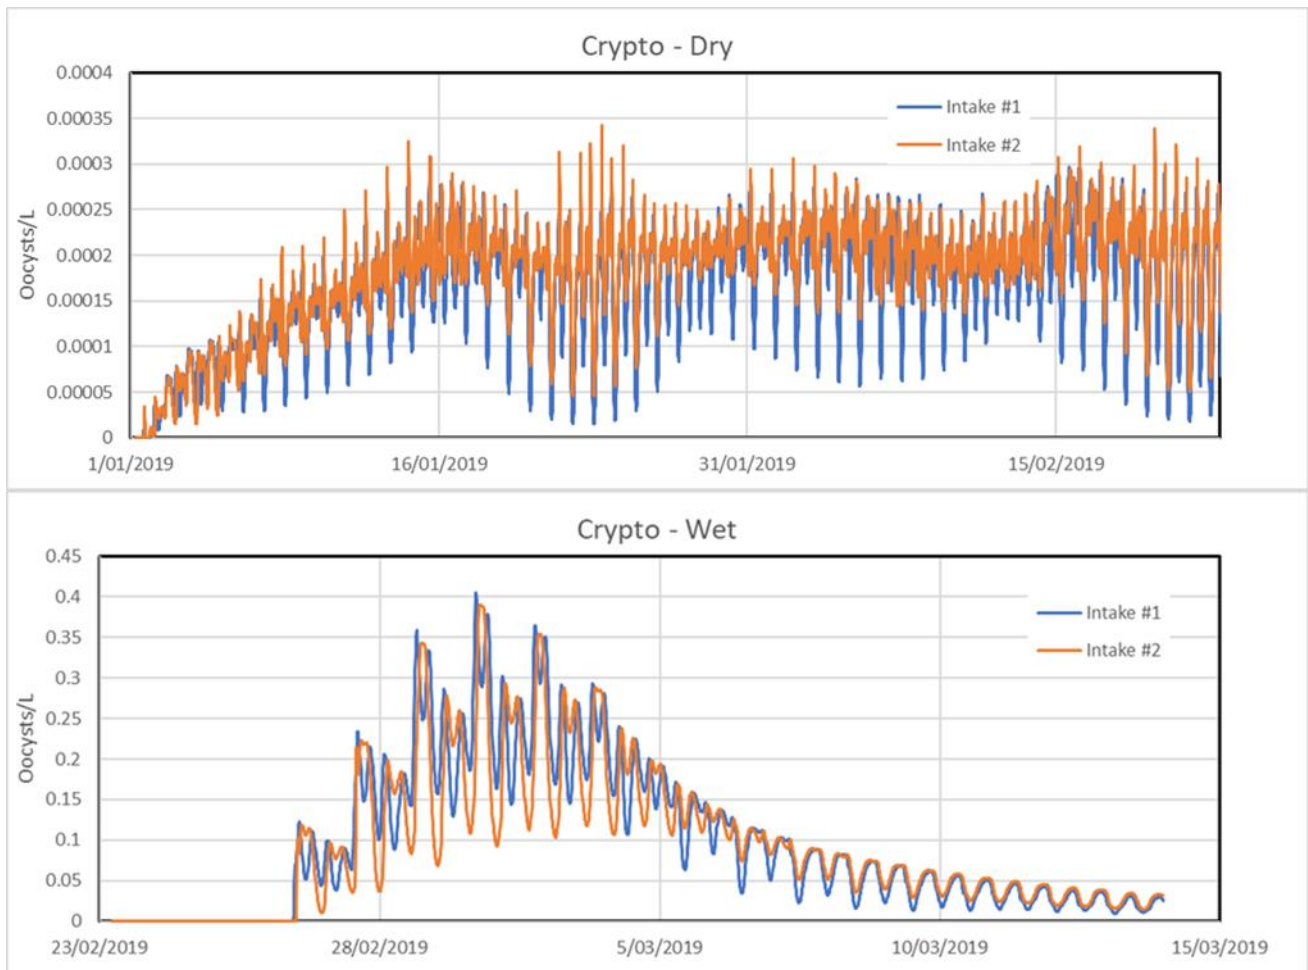
**FIGURE 9-24 CRYPTOSPORIDIUM CONCENTRATION RESULTS**

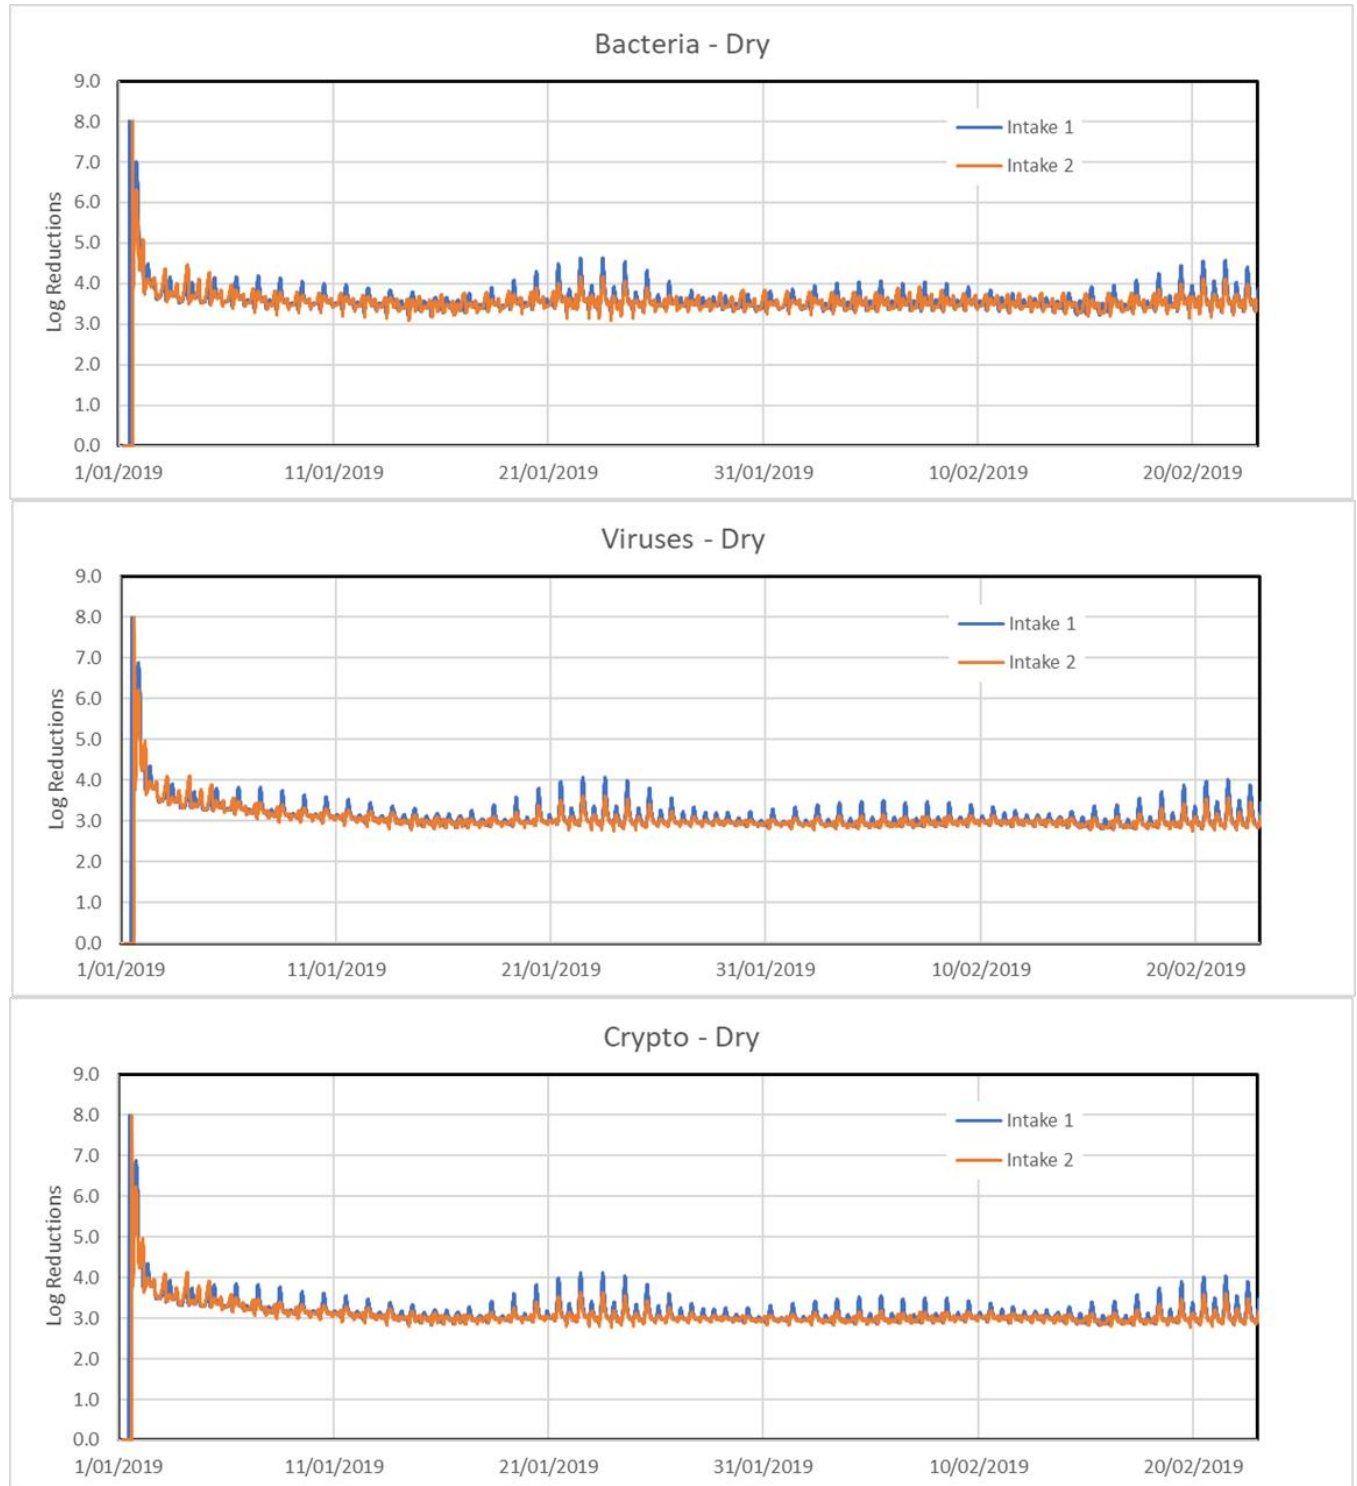
**FIGURE 9-25 DRY WEATHER LOG REDUCTIONS**

Comparisons of the predicted dry weather concentrations in the estuary against the treated ADWF concentrations (bacteria 0.7 microorganisms/L, viruses 252.98 viruses/L, crypto 2 oocysts/L) to estimate log reduction values are shown in Figure 9-25.

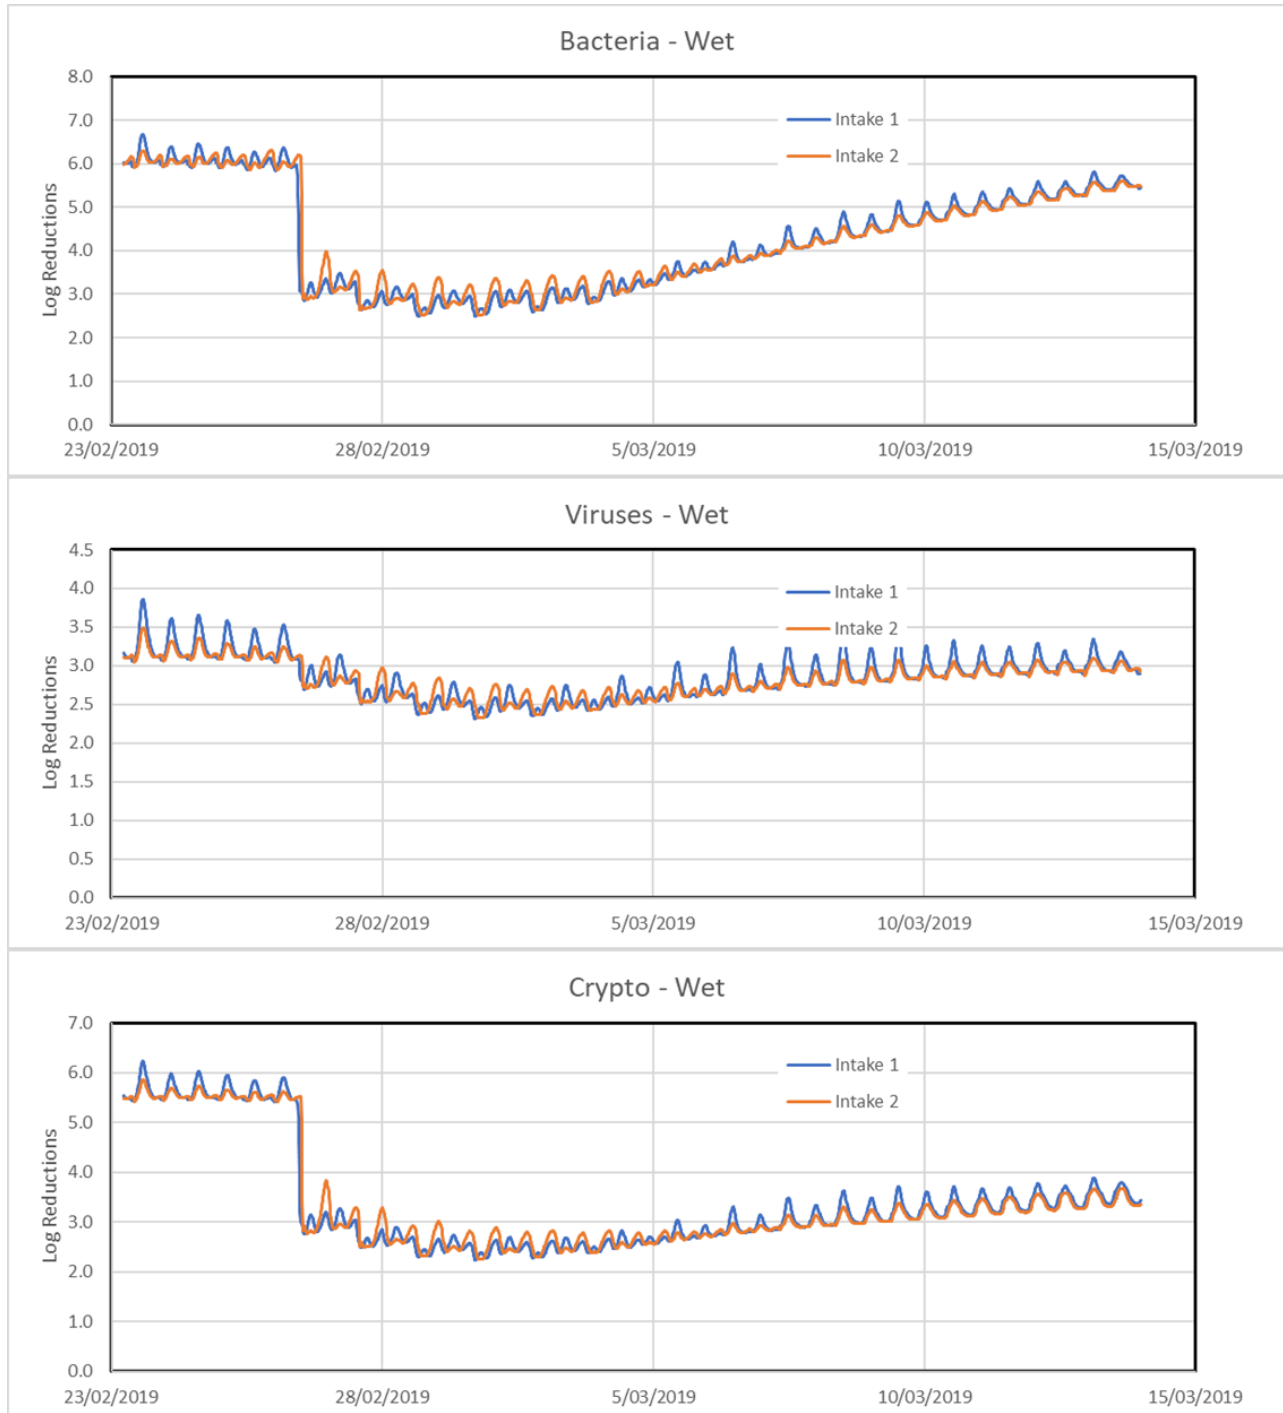
**FIGURE 9-26 WET WEATHER LOG REDUCTIONS**

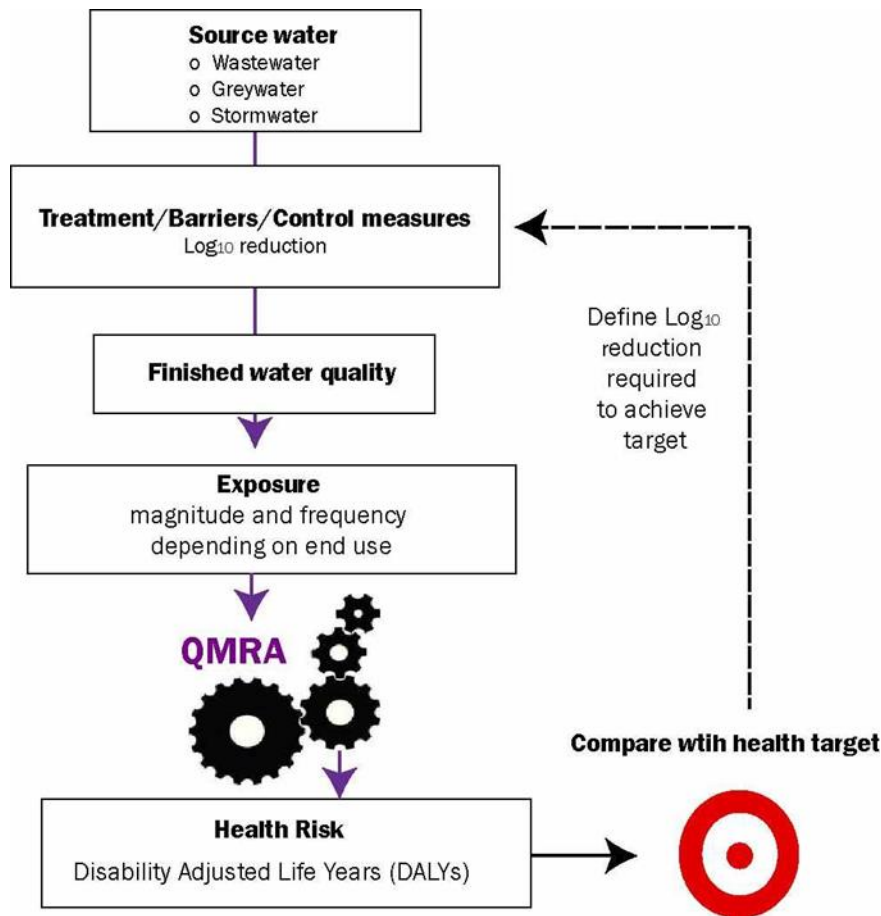
**FIGURE 9-27 APPROACH FOR DEFINING TREATMENT REQUIREMENTS IN THE AUSTRALIAN GUIDELINES FOR WATER RECYCLING (CUNLIFFE AND PETERSON 2019)**

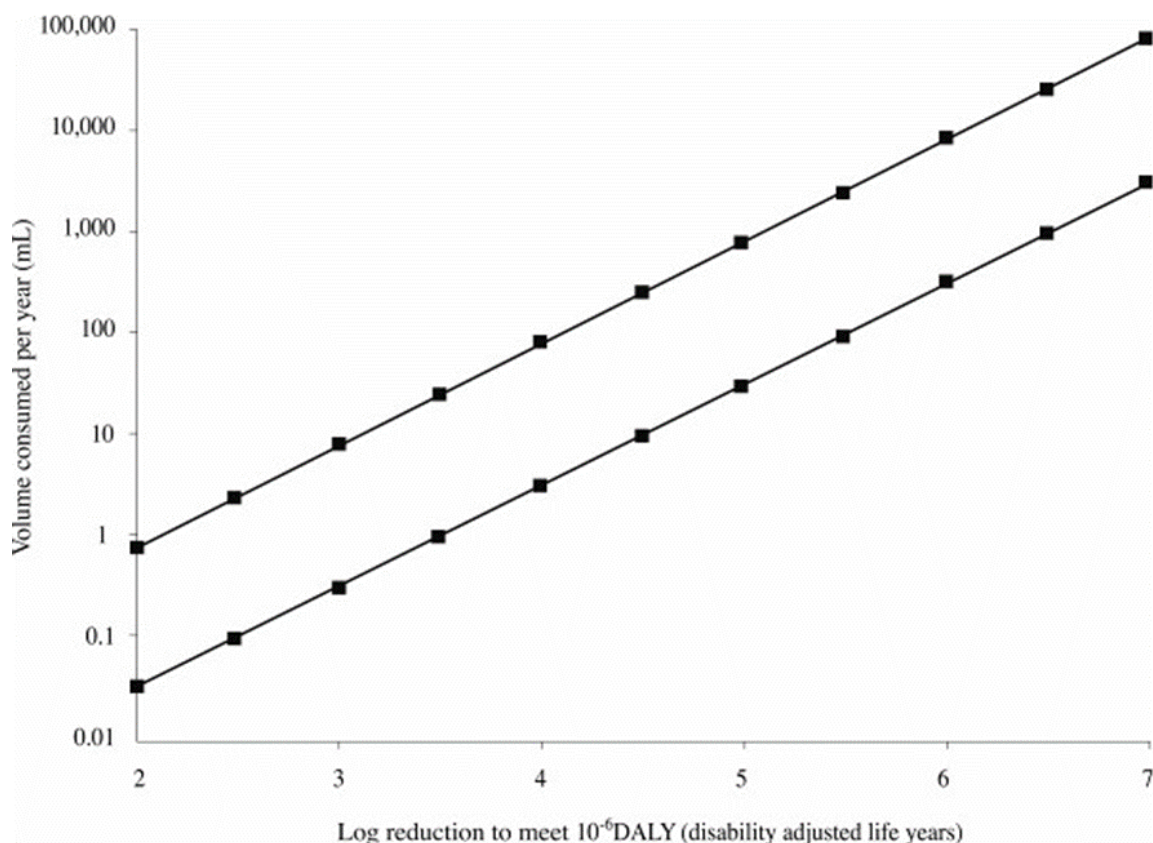
In order to assess the adequacy of treatment, end-use activities need to be defined. In the case of the Logan River, a wide variety of uses may occur including recreational and occupational (e.g. aquaculture) activities. Rather than attempt to define these, the AGWR approach was applied to quantify the maximum allowable safe volume that could be consumed (given the level of protection in Table 9-3) for each reference pathogen. Figure 9-28 illustrates the relationship between volume consumed and required Log reduction for each reference pathogen. The more specific calculations are included in Table 9-4.

**FIGURE 9-28 LOG10 REDUCTIONS REQUIRED AS A FUNCTION OF VOLUMES EXPOSED (REPRODUCED FROM AGWR FIGURE A2.1). UPPER LINE REPRESENTS BACTERIA AND PROTOZOA, LOWER LINE IS FOR VIRUSES**

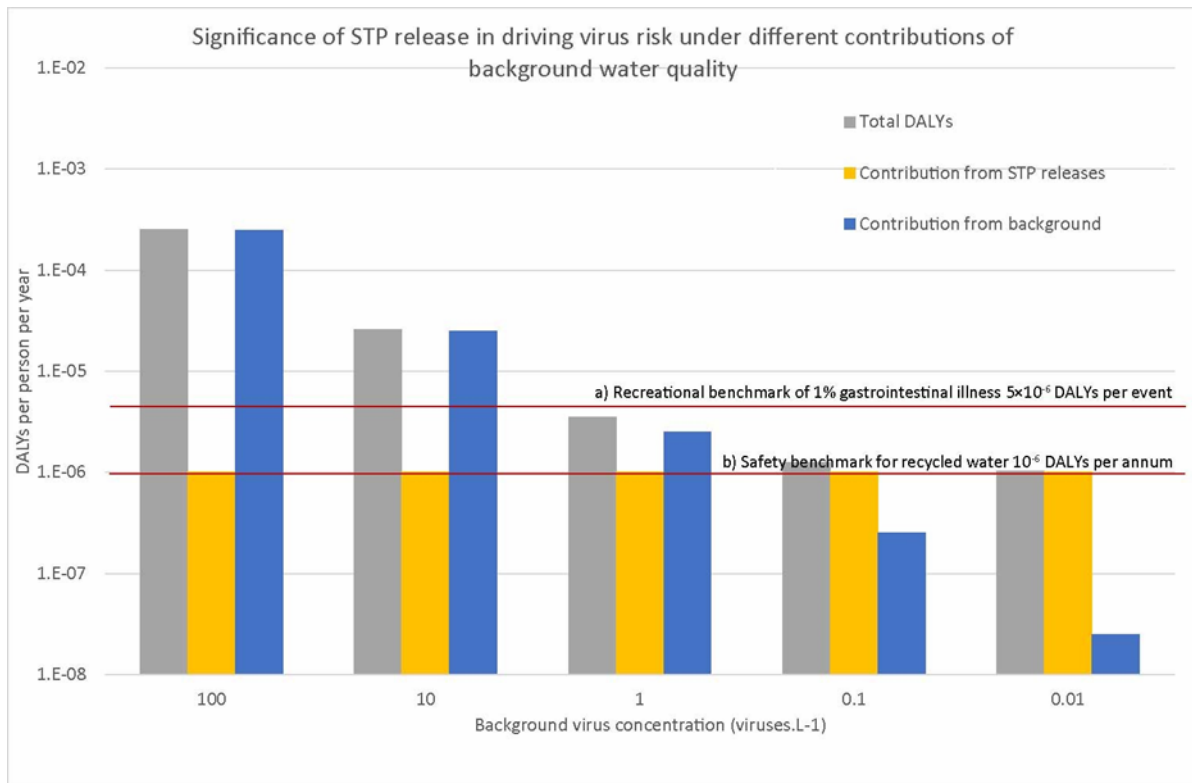
With a high background concentration of viruses in the Logan River, the total DALYs exceed the safety target (100, 10 and 1 viruses per L), however in each of these cases the contribution from background contamination was driving the risk. That is, in Figure 9-29, the background contribution in these cases is equivalent to the total DALYs. Once the background contribution drops below the SRBWWTWP contribution (0.1 and 0.01 virus unit/L), then the SRBWWTWP contribution drives the total. Therefore, as long as the SRBWWTWP contribution is ensured to achieve the safety target, then it will not significantly increase the risk to water users of the Logan River.

FIGURE 9-29 SIGNIFICANCE OF WWTP RELEASE DRIVING VIRUS RISK UNDER DIFFERENT CONTRIBUTIONS OF BACKGROUND WATER QUALITY

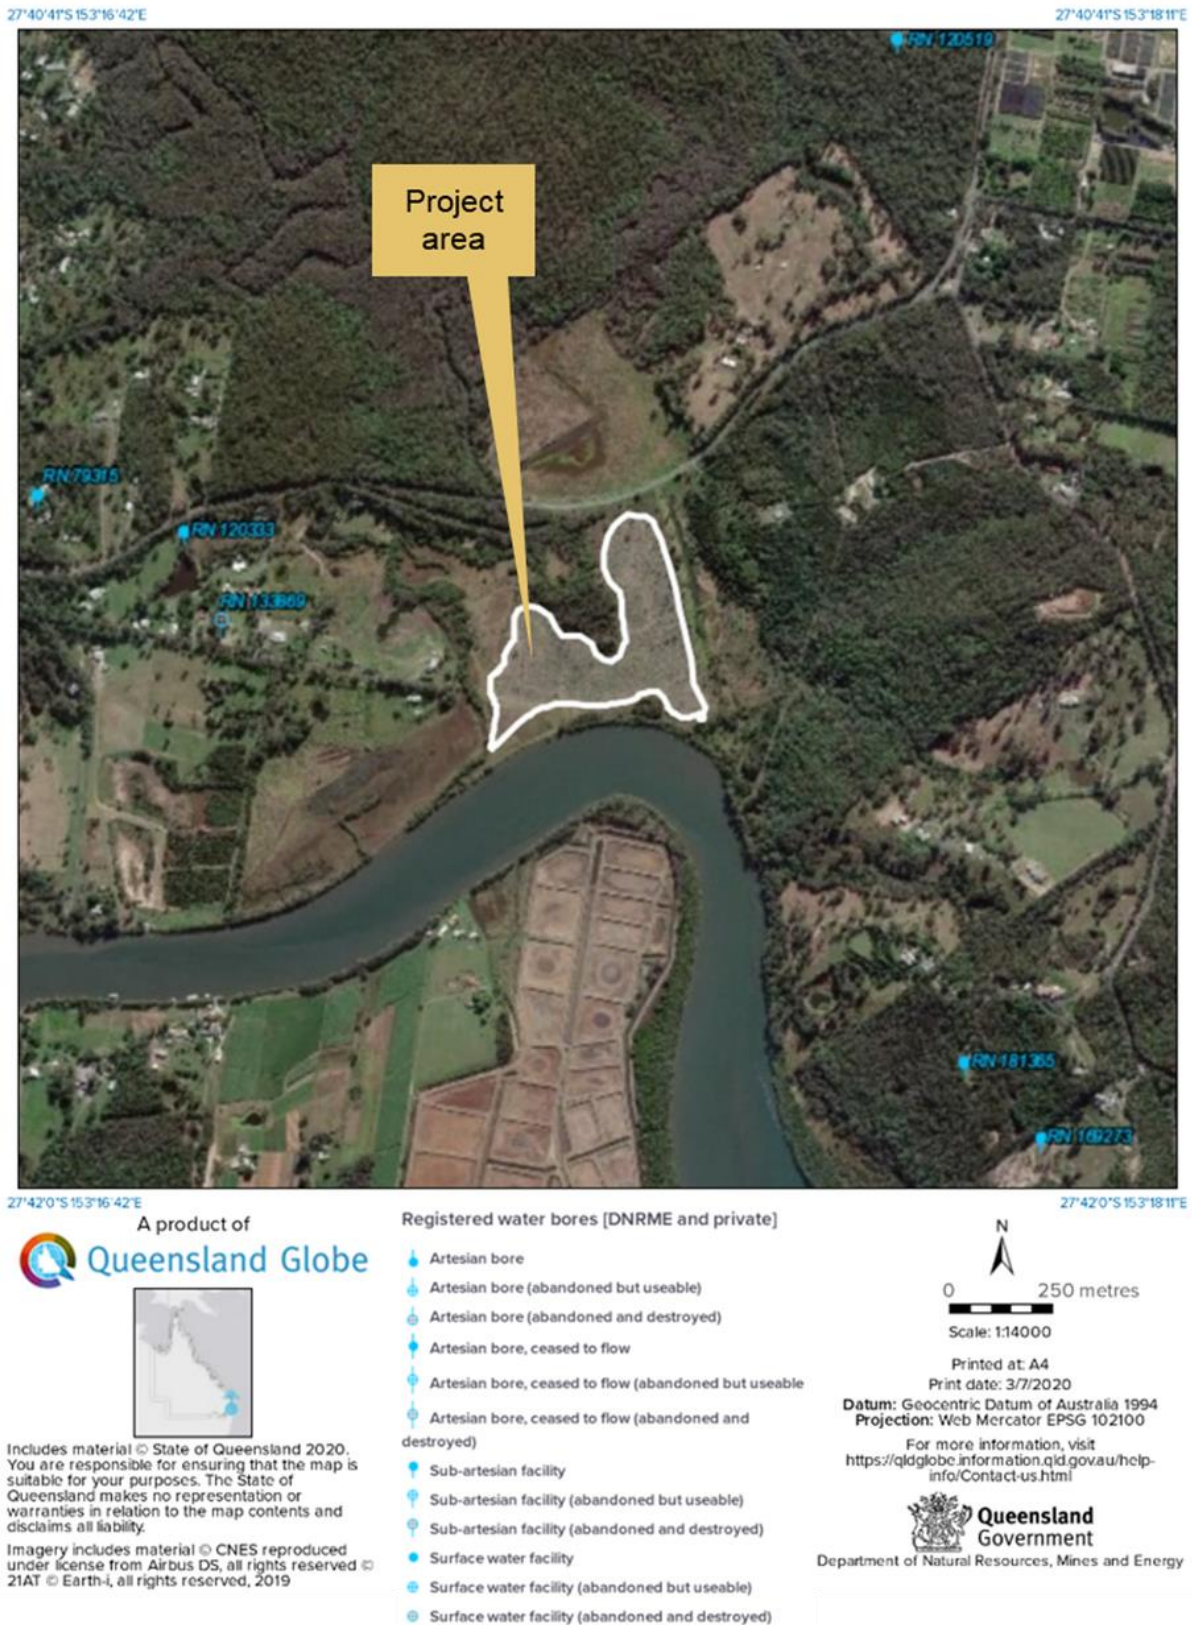
The MOA is located within the Logan-Albert Basin. There is no known groundwater management area listed for this area. The nearest recorded groundwater wells are more than 1 km away (Figure 10-1) and are reported to intersect the Bunya Phyllite/Neranleigh-Fernvale beds, described as Early Carboniferous to Late Devonian age sedimentary siliclastic and igneous mafic volcanic rocks. There are no recorded groundwater level or salinity data available for these wells.

**FIGURE 10-1 LOCATIONS OF REGISTERED GROUNDWATER WELLS SHOWN AS BLUE DOTS (SOURCE: QUEENSLAND GLOBE)**

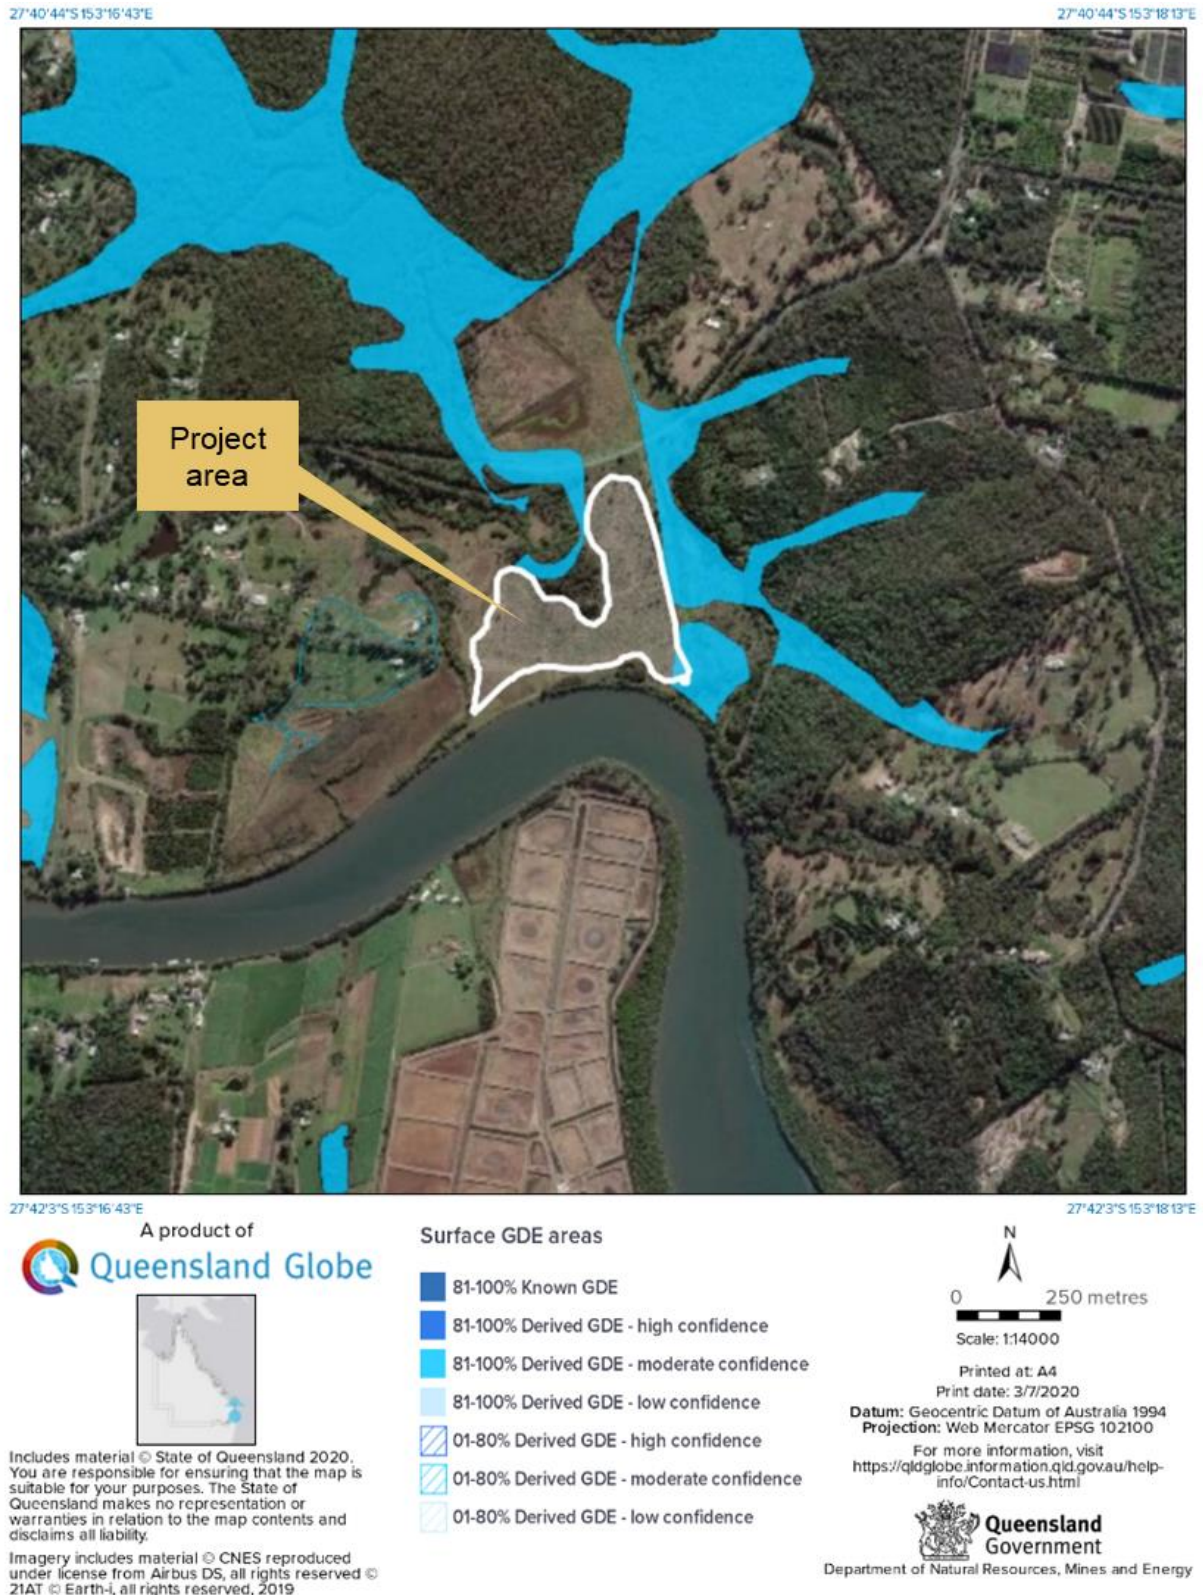
**FIGURE 10-2 LOCATION OF POTENTIAL AQUATIC GDES, SHOWING AREA OF MODERATE POTENTIAL FOR AQUATIC GDES IN ALLUVIAL AQUIFERS IN PURPLE (SOURCE: QUEENSLAND GLOBE)**

Aquatic and terrestrial Groundwater Dependent Ecosystems (GDEs) are identified (with moderate confidence) near the MOA based on data from Queensland Globe (Figure 10-2 and Figure 10-3). Works to be undertaken for this project are in areas which have been previously cleared or have historically contained no vegetation. It is understood that most vegetation around the MOA will be retained, although some clearing of vegetation is required as part of this project. The Vegetation Clearing and Fauna Management Plan prepared by Saunders Havill Group should be referred to for further details.

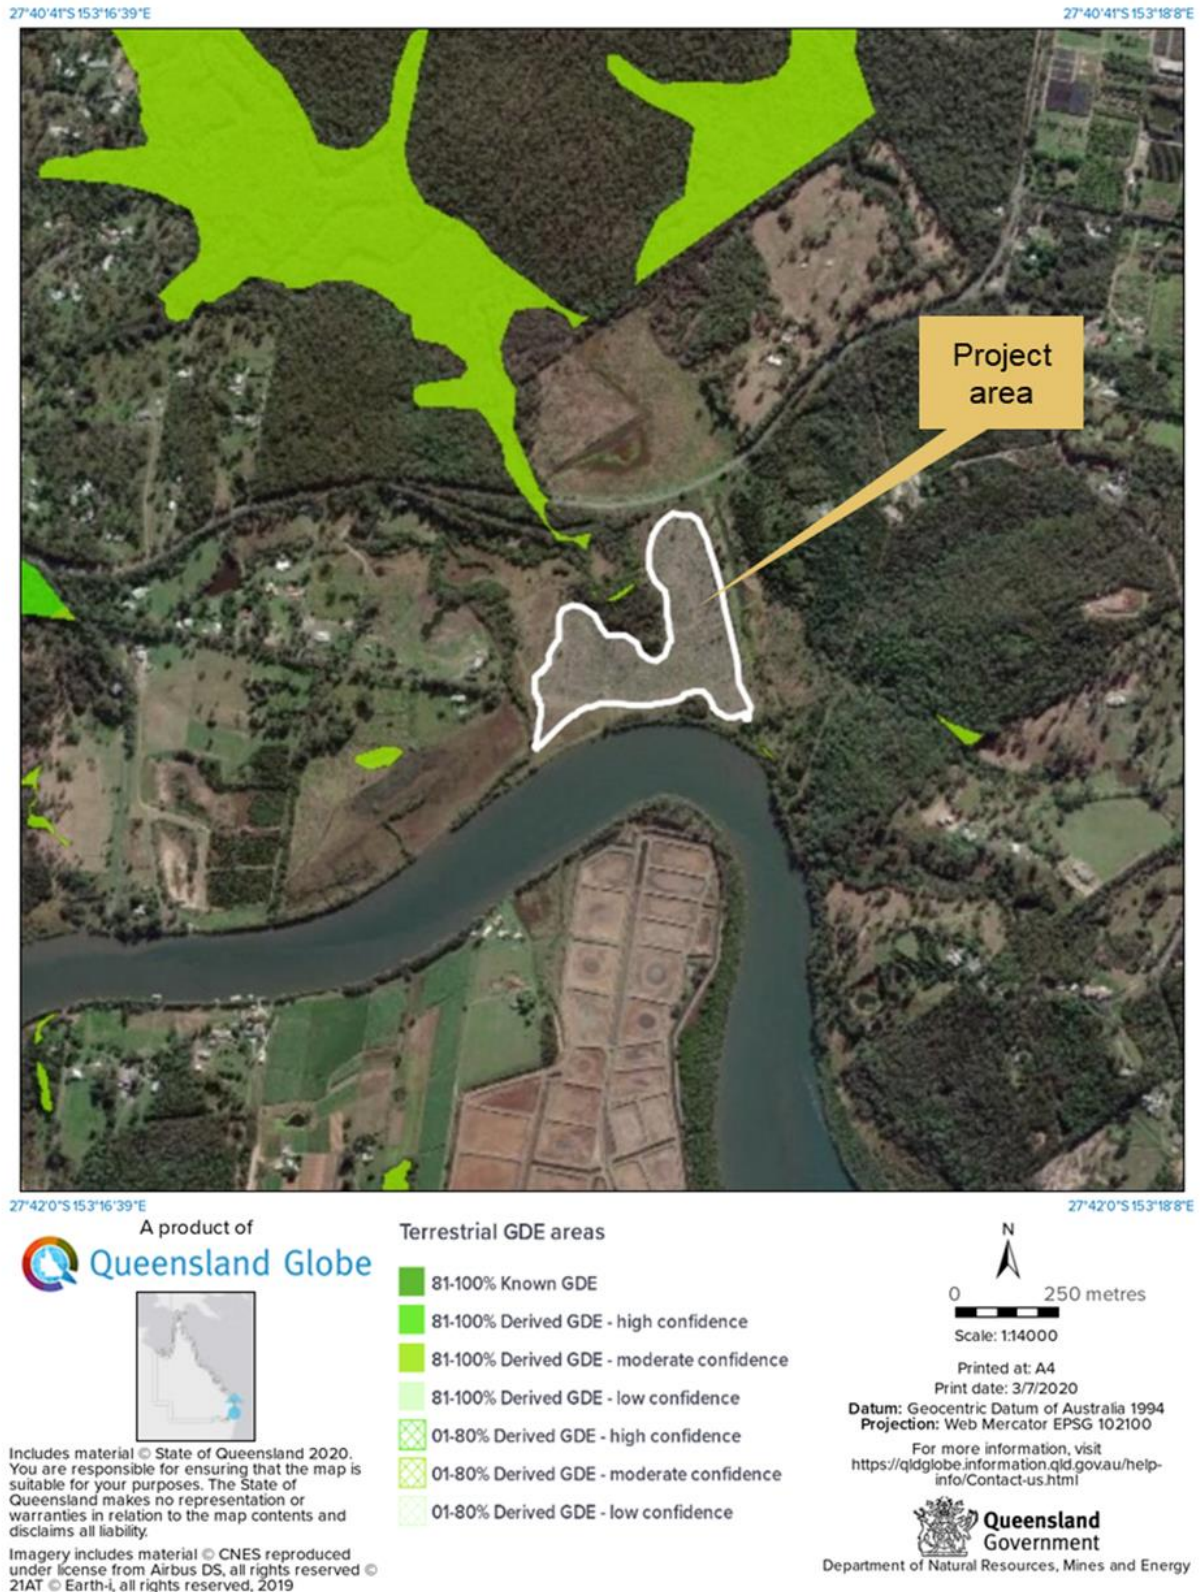
**FIGURE 10-3 LOCATION OF POTENTIAL TERRESTRIAL GDES LISTED AS MODERATE POTENTIAL GDES IN ALLUVIAL AQUIFERS IN GREEN (SOURCE: QUEENSLAND GLOBE)**

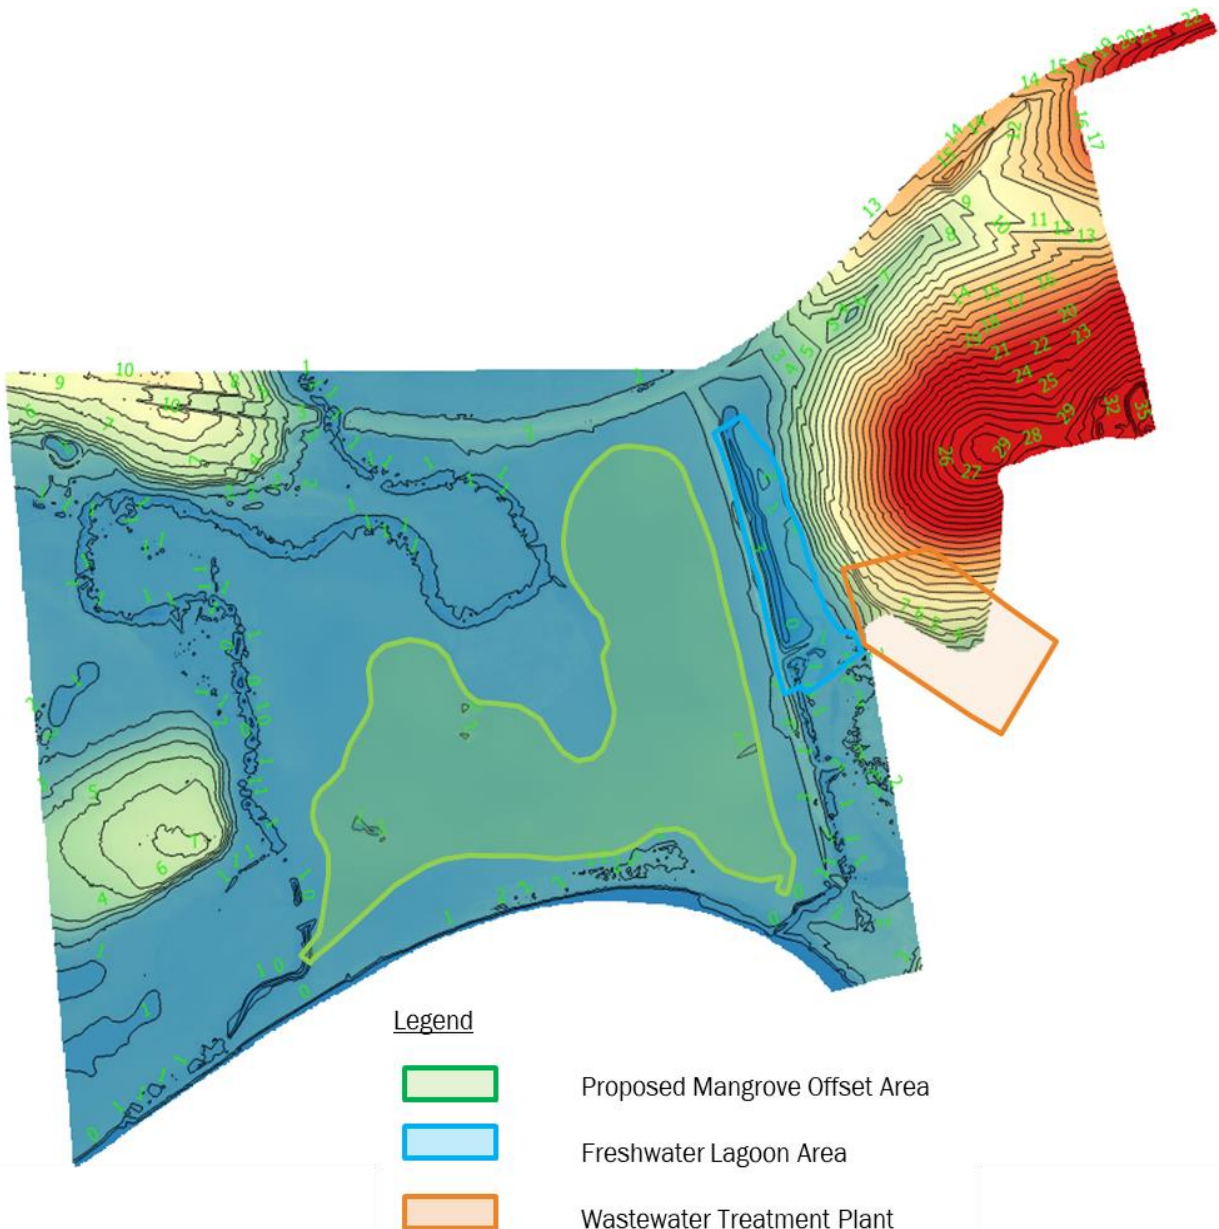
FIGURE 11-1 EXISTING SITE ELEVATIONS
