## **Environmental authority P-EA-100121435**

| Environmentally relevant activities | Locations |
|---|---|
| ERA 63 - Sewage Treatment 1(e) - Operating sewage treatment works, other than no-release works, with a total daily peak design capacity of more than 10,000 but not more than 50,000EP | Lots 2 and 3 Plan RP223470; Lot 1 Plan SL3427; Lot 254 Plan S31102; and Lots 83, 84, 86, 255, 256, 257 and 259 on Plan S312432. |

SOUTHERN REDLAND BAY WASTEWATER TREATMENT PLANT  
CONCEPT REHABILITATION PLAN - DETAIL SHEET 05

R01v05\_20020099\_Southern\_Redland\_Bay\_Stage\_3\_Assessments

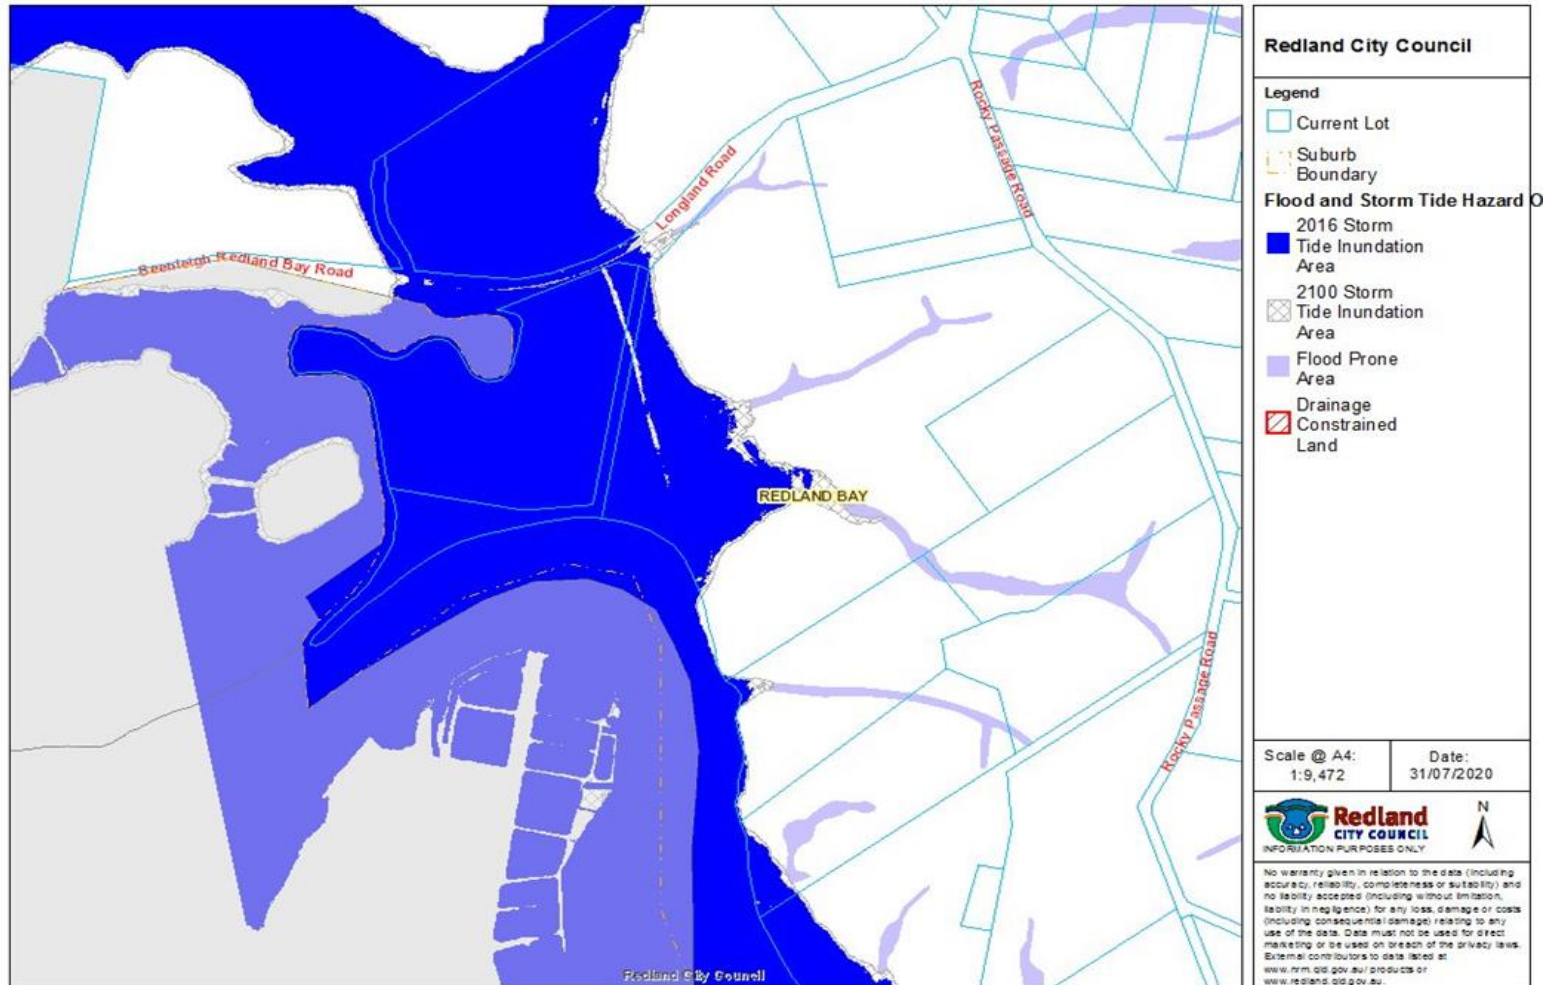
The proposed Mangrove Offset Area (MOA) and Freshwater Storage Lagoon (FSL) are located within the flood and storm tide hazard areas, whereas the Waste Water Treatment Plant (WWTP) itself is located outside / above these areas. See Figure 11-2 for the Redland City Flood and Stormtide Overlay.

FIGURE 11-2 REDLAND CITY FLOOD AND STORMTIDE OVERLAY

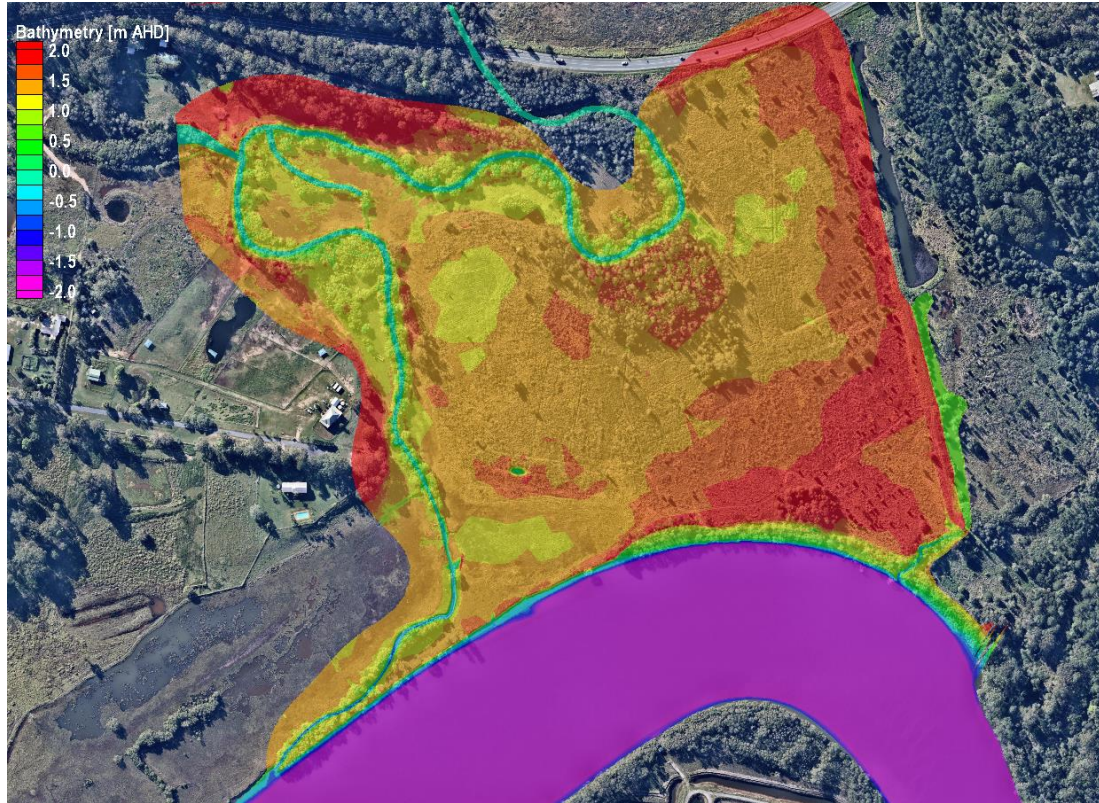
**FIGURE 11-3 EXISTING SITE ELEVATIONS**

Land elevations for the existing and developed cases are depicted in Figure 11-3 and Figure 11-4. Figure 11-4 depicts how the excavated subtidal area (light blue) extends from -0.5 to 0.3 m AHD and the excavated intertidal area (light green and greenish yellow) from 0.3 to 1.0 m AHD. With the appropriately sized culverts, the modelling indicated that the MWL and MHWSL within the site would be approximately 0.3 m and 1.0 m respectively. Thus, it can be expected that mangroves will stabilize the transition between the subtidal channel and intertidal area and extend to the upper limit of the excavated intertidal area.

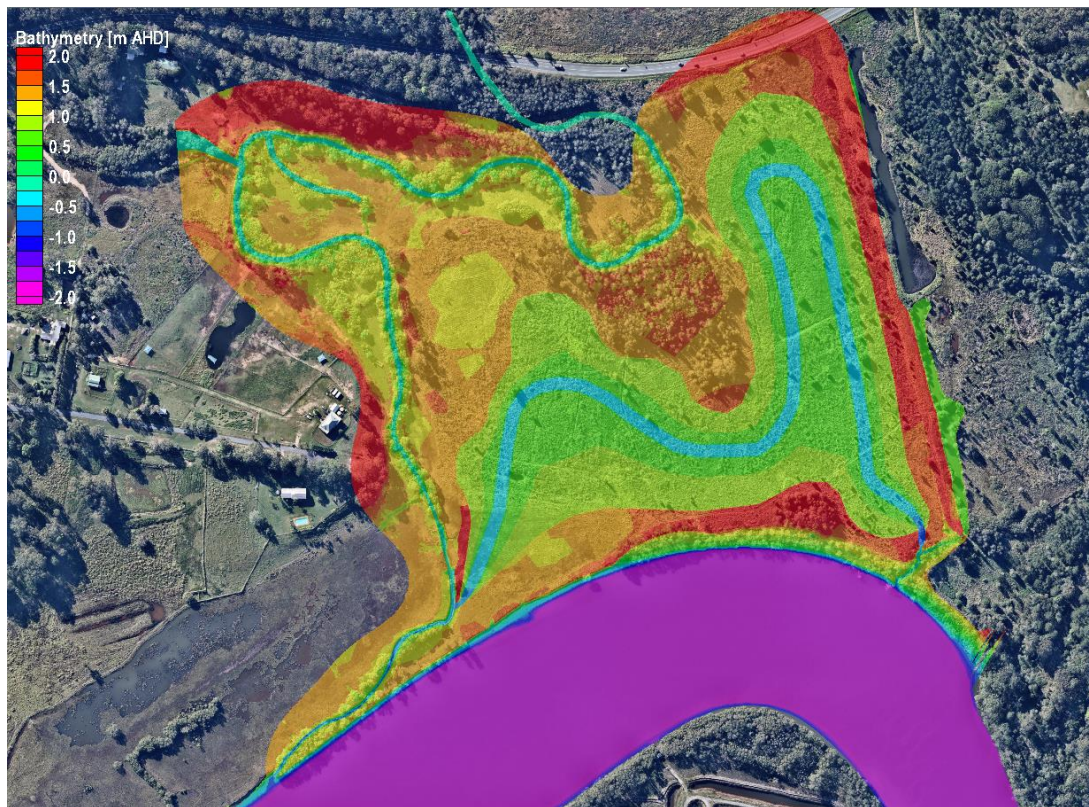
FIGURE 11-4 PROPOSED ELEVATIONS

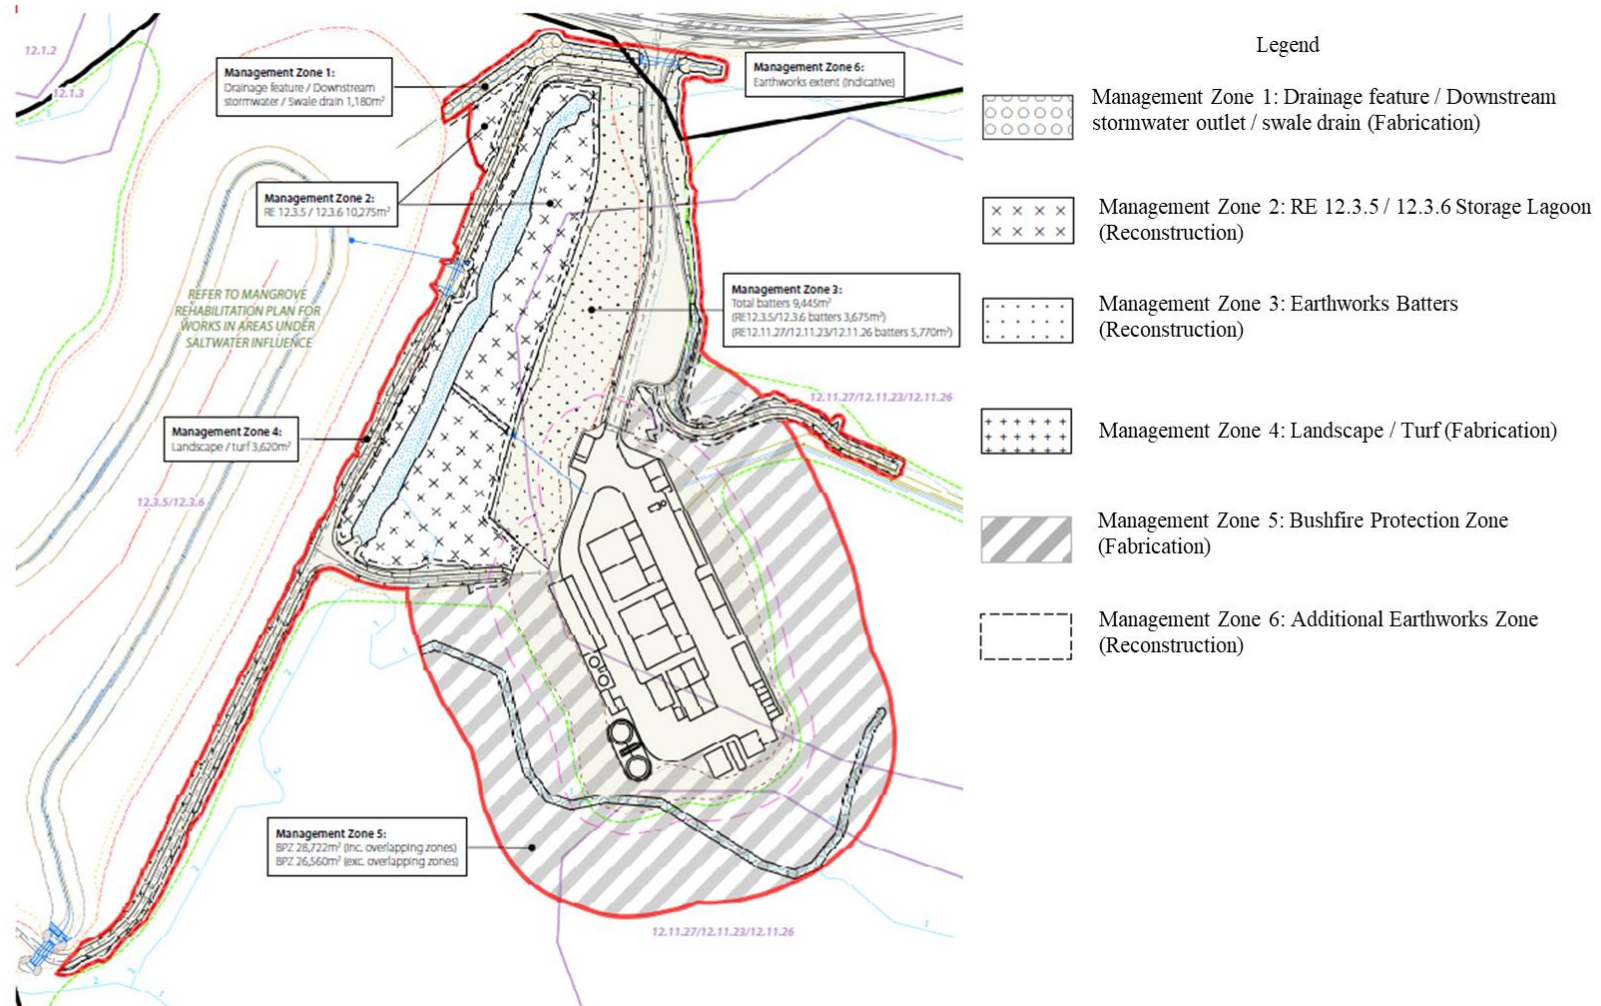
**FIGURE 11-5 SOUTHERN REDLAND BAY WWTP – CONCEPT REHABILITATION PLAN MANAGEMENT ZONE**

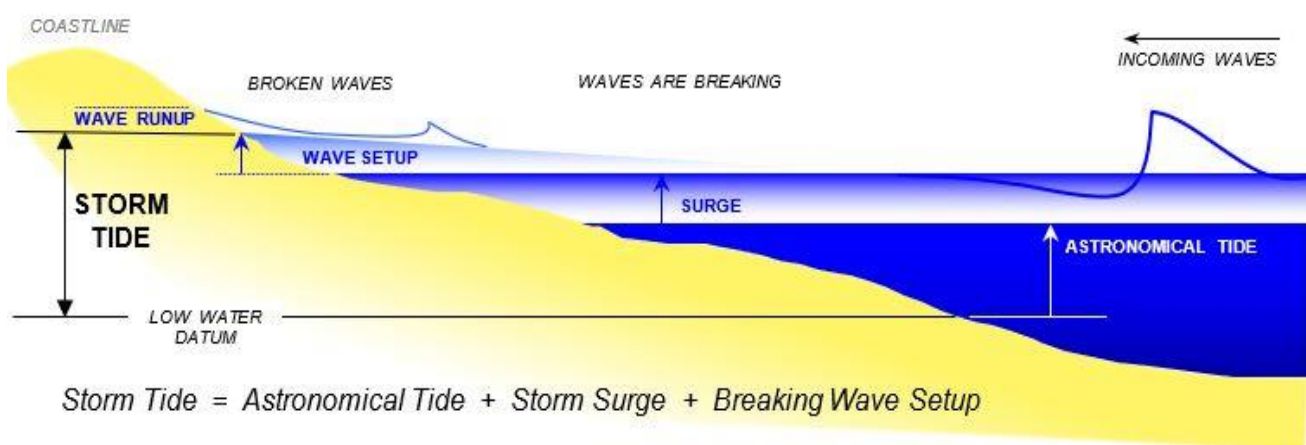
**Figure 3-1 Components of a storm tide event**

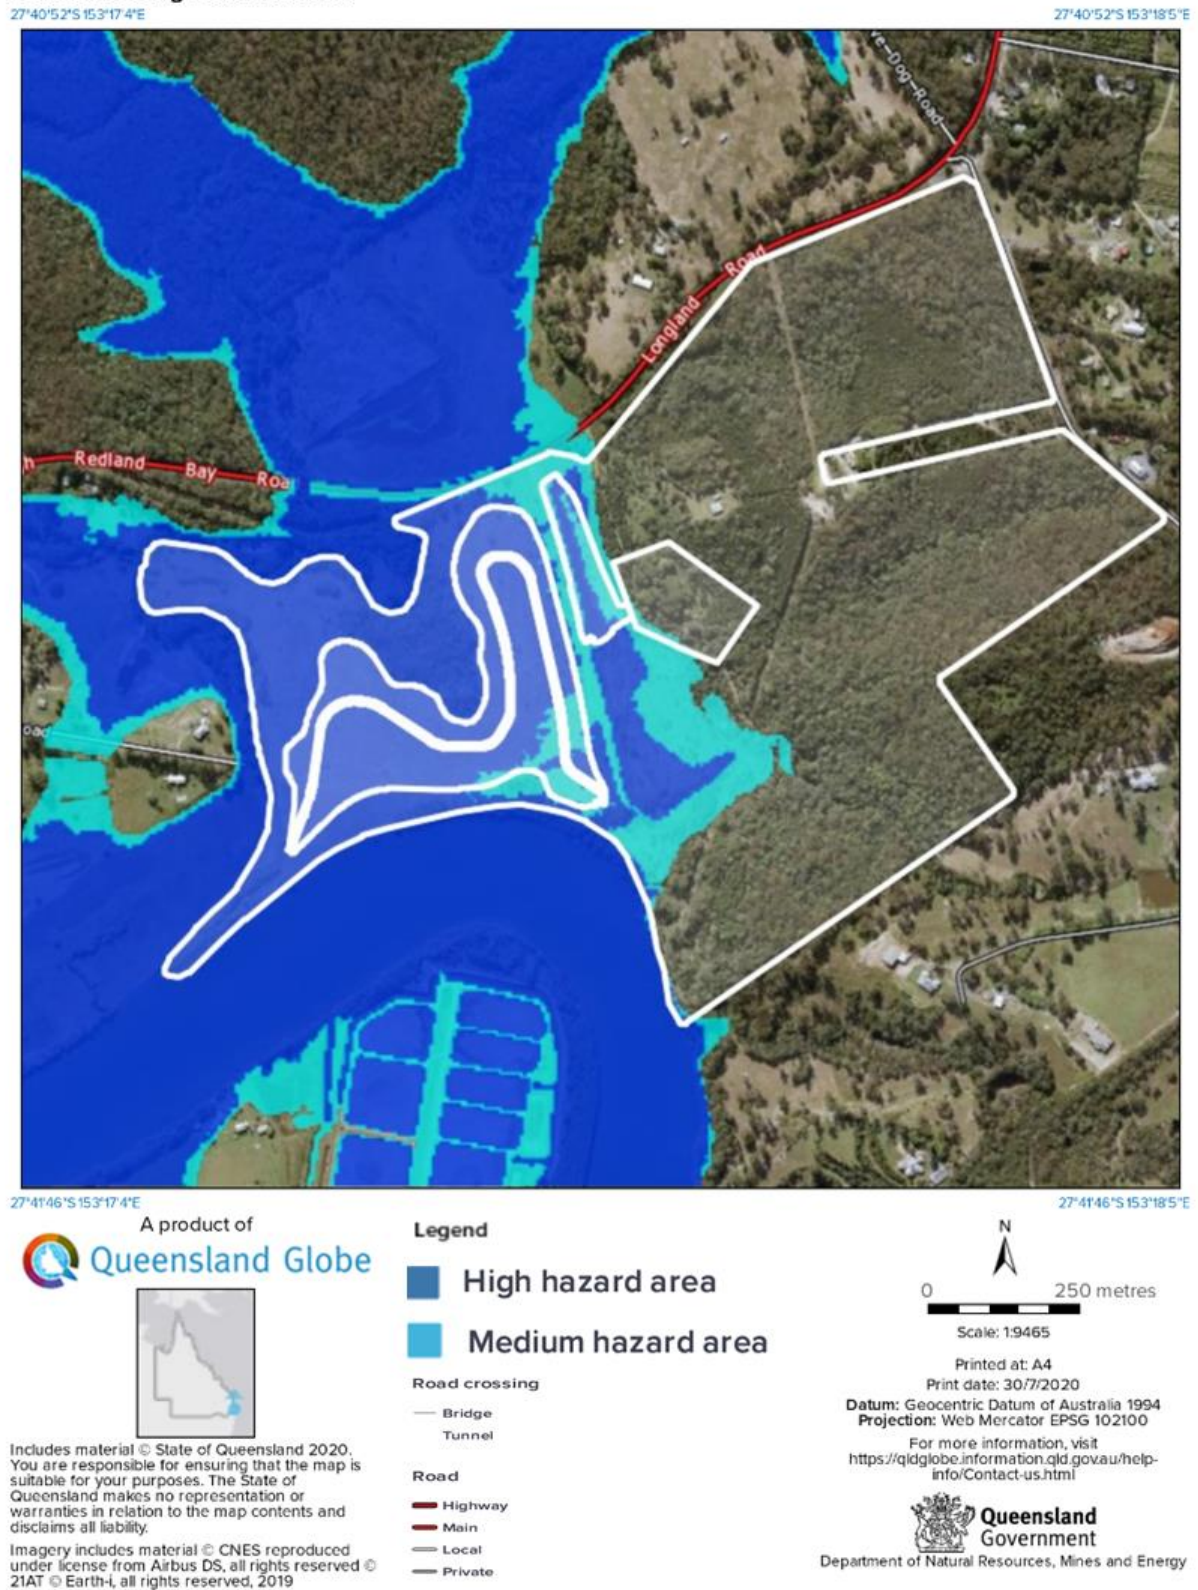
Figure 4-1 Medium to High Inundation Hazard Area (Source: Queensland Globe)

Investigations of the storm tide inundation hazard overlay indicate that the whole site is already within the high to medium hazard area, see Figure 2-3. The DSTE for the Site is 2.63mAHD (Table 3-3, excluding sea level rise), so about 1.64m above the usual level of MHWS, and 1.1m above the level of HAT. With sea level rise of 0.8m by 2100, water levels can be expected to be even higher.

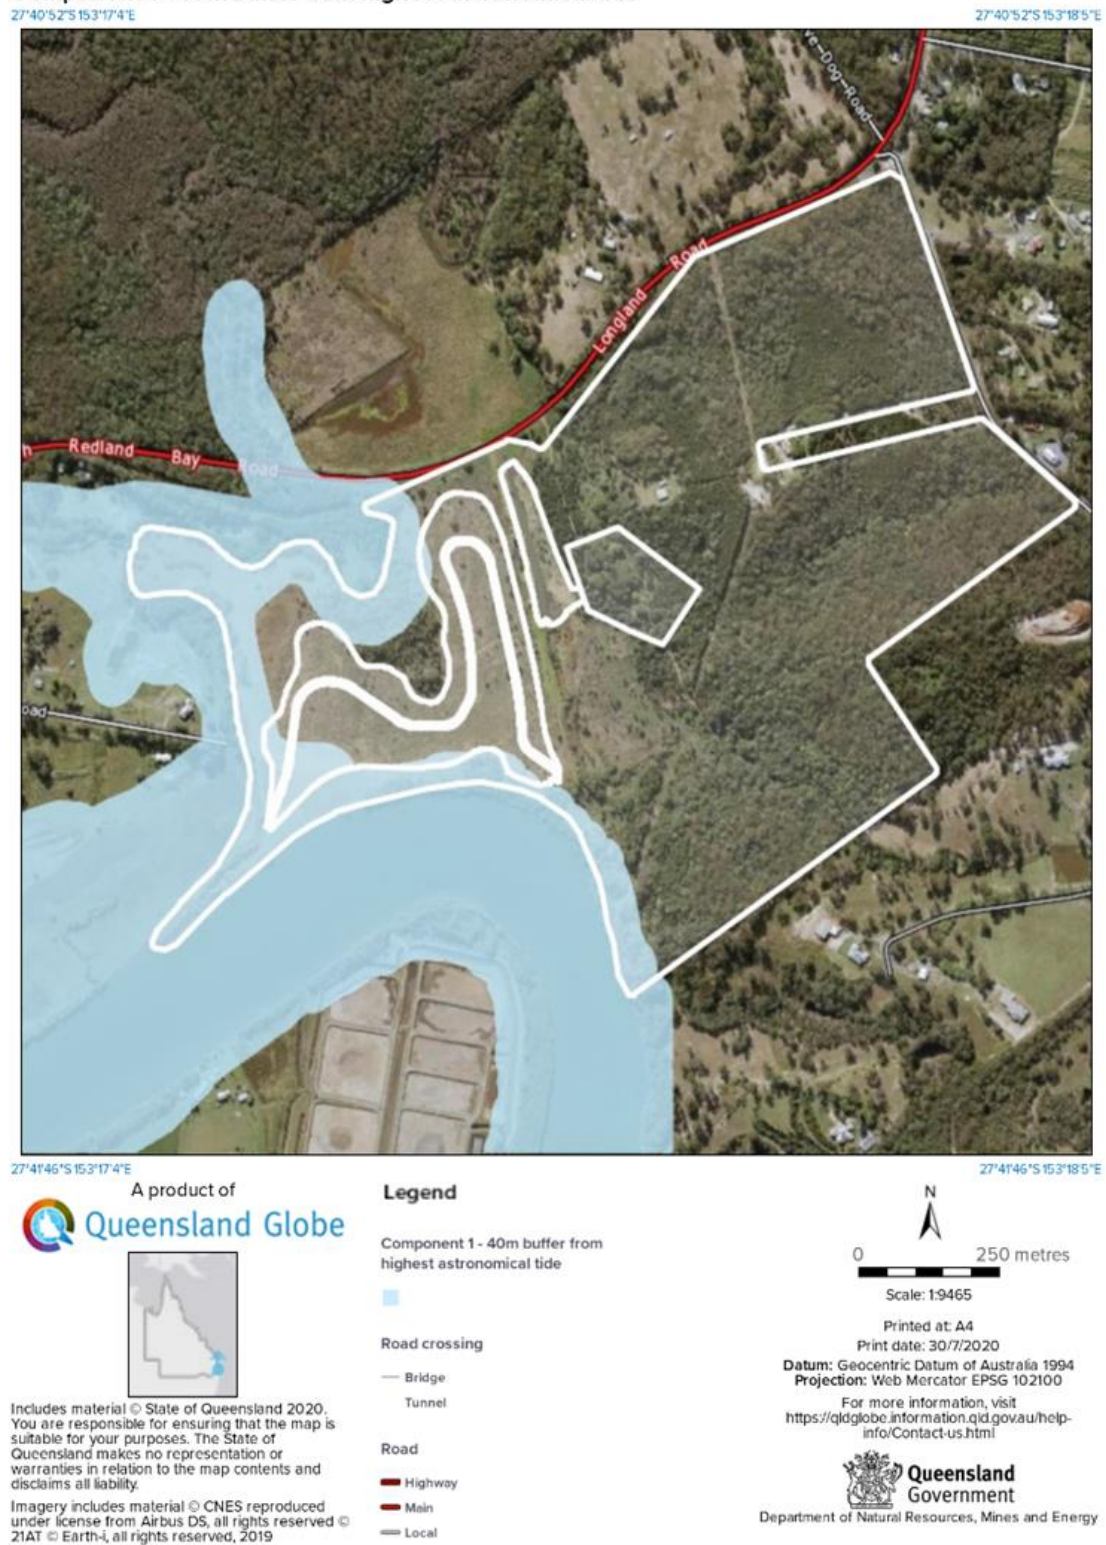
Component 1 - 40m buffer from highest astronomical tide

Figure 4-2 State Erosion Prone Area (Source: Queensland Globe)

The Site is partially located within the EPA (See Figure 4-2 and Figure 4-3). Generally, development in the EPA is recommended to be avoided - unless it is a coastal dependent development.

The mangrove offset area and freshwater lagoon area within the Site are located within the EPA (see Figure 4-2 and Figure 4-3). The HAT + 0.8 m sea level rise component is the governing component in these areas. Due to the MOA and salt couch in these areas being tidally dependant (mangroves and salt couch habitats in the region are tidally influenced), the Site's location in an EPA is a matter of least concern (See Section 4.6.3 for further details).

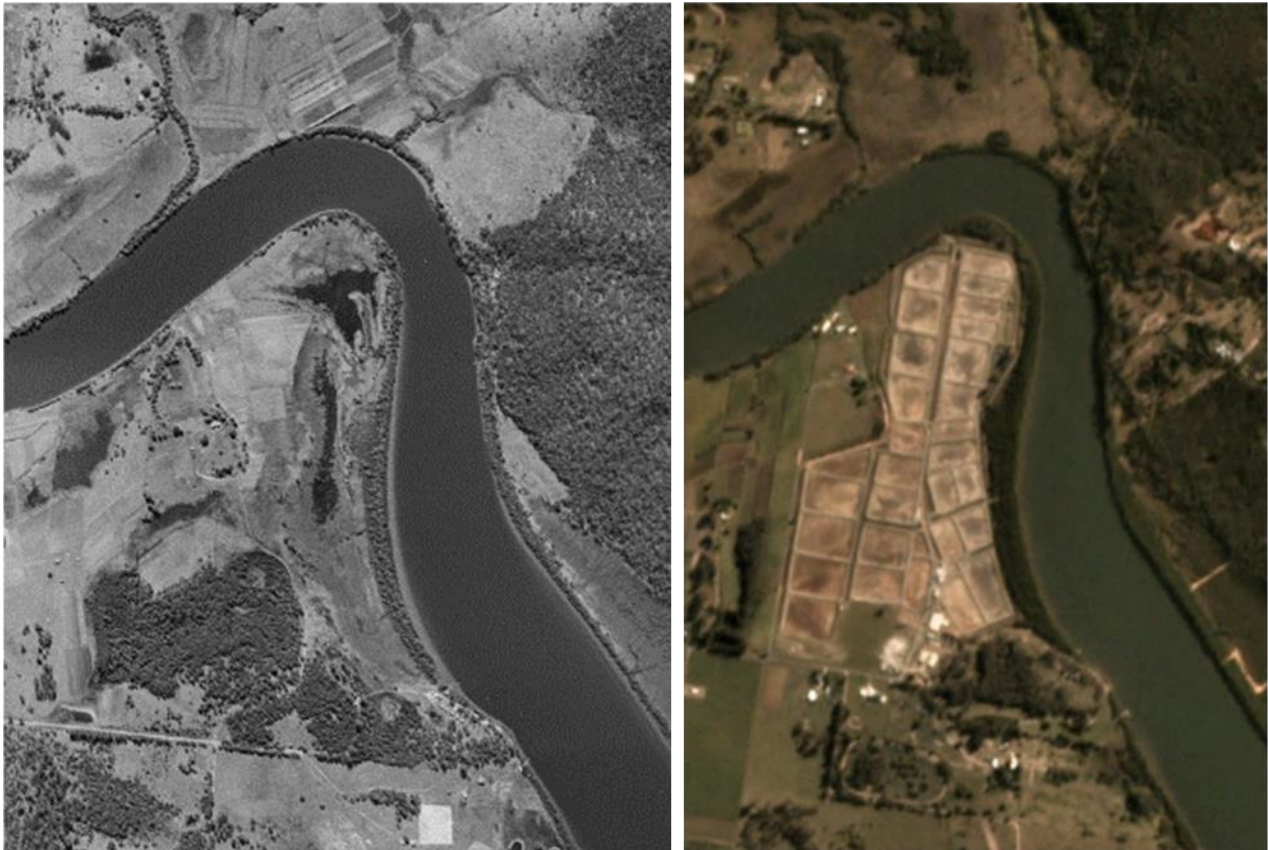
As the Site is located at the outside bend of the Logan River, it is more prone to erosion than other areas of a river such as straight sections or within inside bends. Rivers tend to migrate in the direction of the outer river bend until a cut-off occurs. An investigation of historical imagery indicates that the river bank has not moved appreciably in some 62 years, as illustrated in Figure 4-4. As such, it is apparent that the banks of the river are well established and not subject to long term erosion.

Figure 4-5 Left Aerial Image from 1955 and Right Aerial Image from 2017 (Source : Qimagery, Queensland Government)

Based on the above assessment, and observations made on several site inspections, it is apparent that the riverbank is stable and shows no signs of long-term erosion. To reinforce this, it will be important to continue to maintain a well vegetated riverbank and keep any development works (e.g. maintenance access paths) sufficiently landwards of the banks such that there are no impacts.
