Teys Australia Beenleigh Pty Ltd

*Transitional Environmental Program
(TEP) MAN17840*

Stormwater Management

MILESTONE 9 REPORT

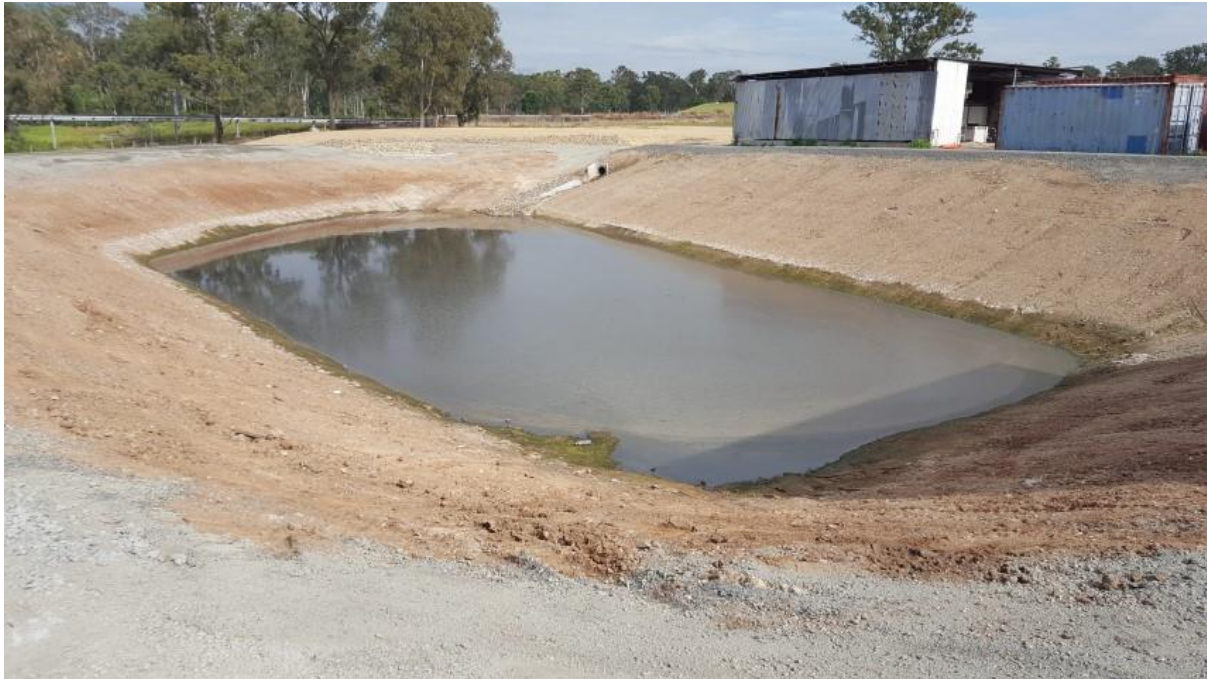
When redesigning the eastern pond, the topography, current infrastructure and land use limitations were taken into consideration. This includes the stream order to the south of the pond and the buildings to the east and north. Due to these limitations, the completed Eastern contaminated stormwater catchment pond was constructed to capture 2.1ML of rainfall run-off. A volume of 2.53ML is required to be captured by the pond to meet a 1:20 year, 24 hour storm intensity frequency duration. To ensure the facility can contain a 1:20 year, 24 hour equivalent storm event, a proprietary Flygt precast pump station has been installed at the Eastern Pond containing two 22kW pumps. Each of the installed pumps are designed to be capable of dewatering the eastern stormwater pond at a volume of 3.46ML over a 24 hour period, exceeding the ARI frequency duration volume by 900,000L. Water that enters the eastern pond will be pumped to the decommissioned waste water ponds which have a calculated storage volume in excess of 20ML.

Figure 1: The completed Eastern Contaminated Stormwater Pond

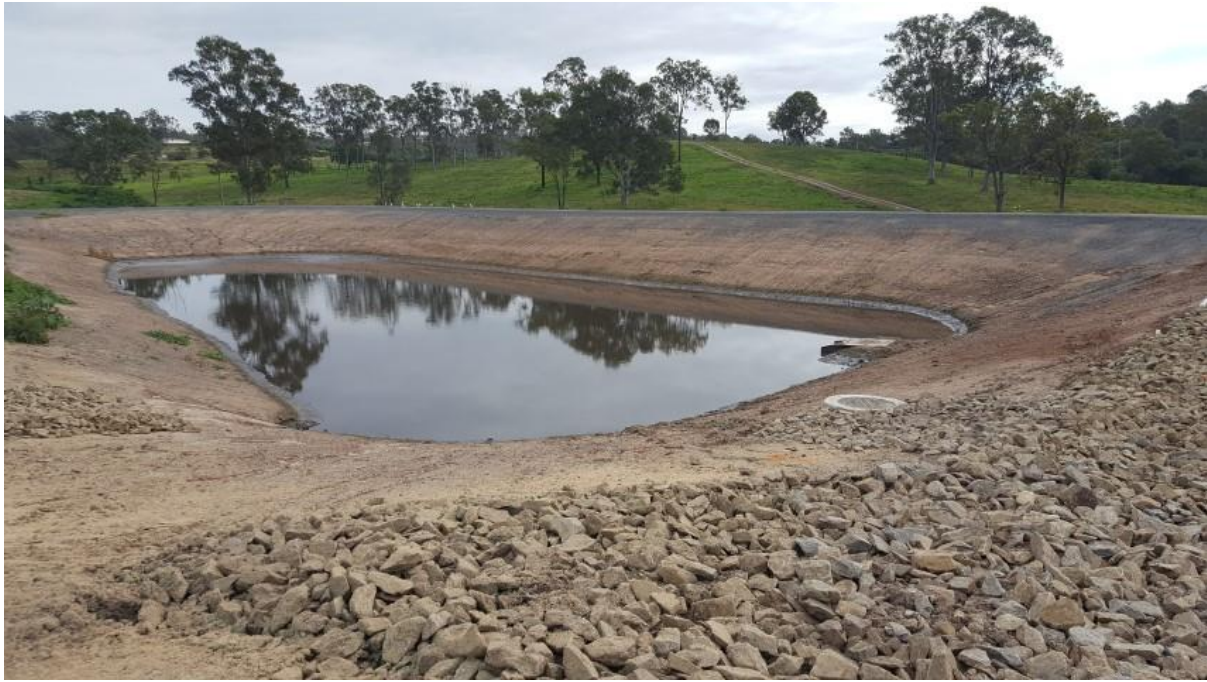
The completed Western Stormwater pond has been constructed to capture and hold a volume of 6.1ML. A volume storage capacity of 4.9ML is required to capture a 1:20 year, 24 hour rainfall event falling on the west section of the cattle holding pens (Refer to Figure 2). Run-off in the western catchment is collected by open surface drainage on the downhill side of the pens and directed to the Western pond. Clean stormwater run-off on the uphill side of the pens is intercepted by surface bunding and swales directed into new 'black brute' HDPE stormwater drains installed under the cattle pens. This clean water is discharged to the local watercourse. A proprietary Flygt precast pump station has been installed at the Western Pond containing two 22kW pumps.

Water that enters the Western pond will be pumped to the Covered Anaerobic Lagoon (CAL) for treatment. Dewatering of the Western pond will generally be during days following a storm event, and will be limited to a maximum discharge flow rate of 30L/S as to not negatively affect the anaerobic treatment performance of the CAL.

Figure 2: The completed Western Contaminated Stormwater Pond.

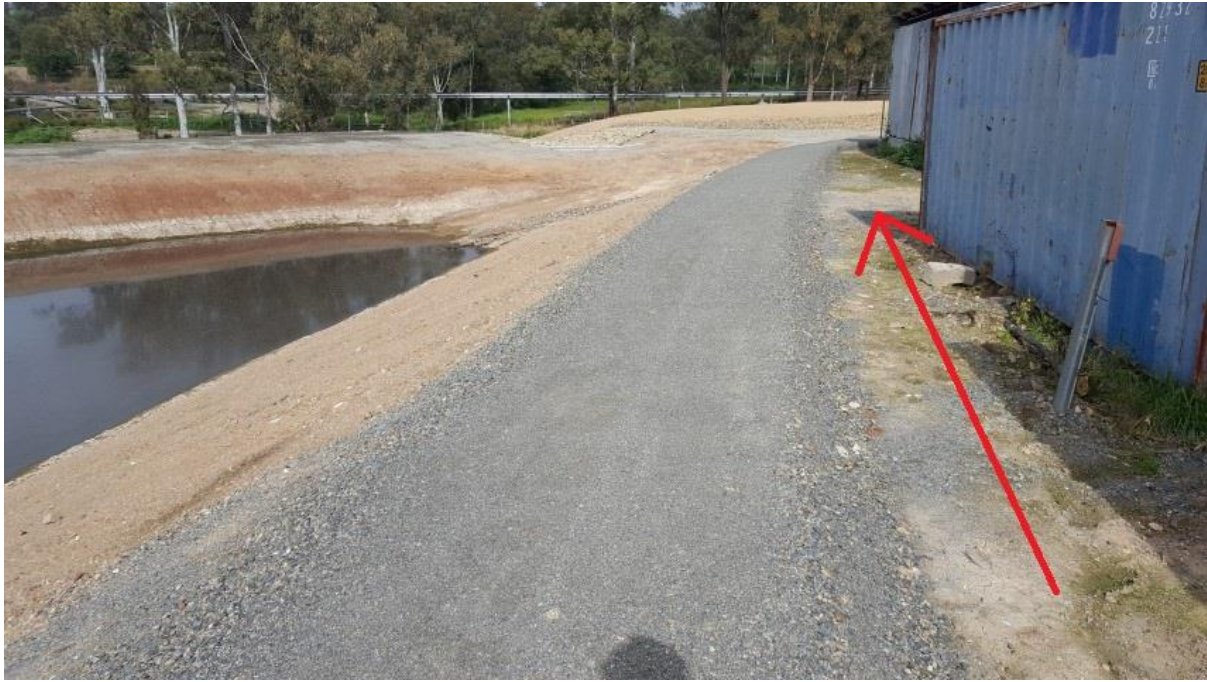
Clean stormwater run-off in the eastern catchment is intercepted by drains and bunds to divert this run-off around the outside of the new East Pond, The crest height of the constructed East pond has been raised to exclude clean water surface run-off from the plant and maintenance yard area from entering into the pond (Refer to Figure 3). This run-off is collected and directed around the back and sides of the pond via open drainage channels to discharge directly into the local water course.

Figure 3: Clean stormwater is directed along the topside of the eastern contaminated pond to the creek.

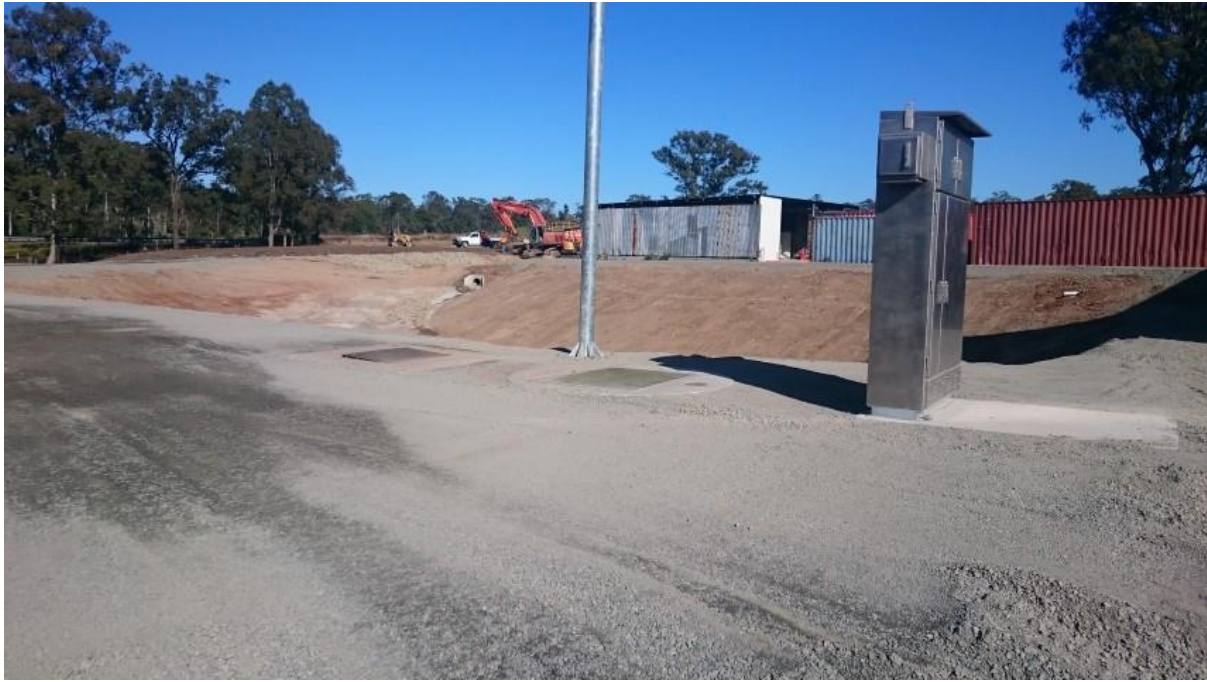
The eastern and western contaminated pump stations have been installed with dual 22kw Variable Speed Drive (VSD) pumps. These pumps operate by automatic activation of a float switch system inside the pump station. Pump speed can be selected by operating a potentiometer control on the local pump station switchboard (Refer to Figure 4).

The pumps at the western contaminated pond will cycle between duty and standby with only one pump operating at any given time during the dam pump out operation as per the functional requirements of the as built design.

The pumps at the eastern contaminated pond shall also cycle between duty and standby but the pump on standby will remain on call if required to handle an excessive rate of inflow to the pond during significant rainfall events exceeding the 1:20 year, 24 hour, design rain event.

Figure 4: Installed control panel at the Eastern Stormwater Pond.

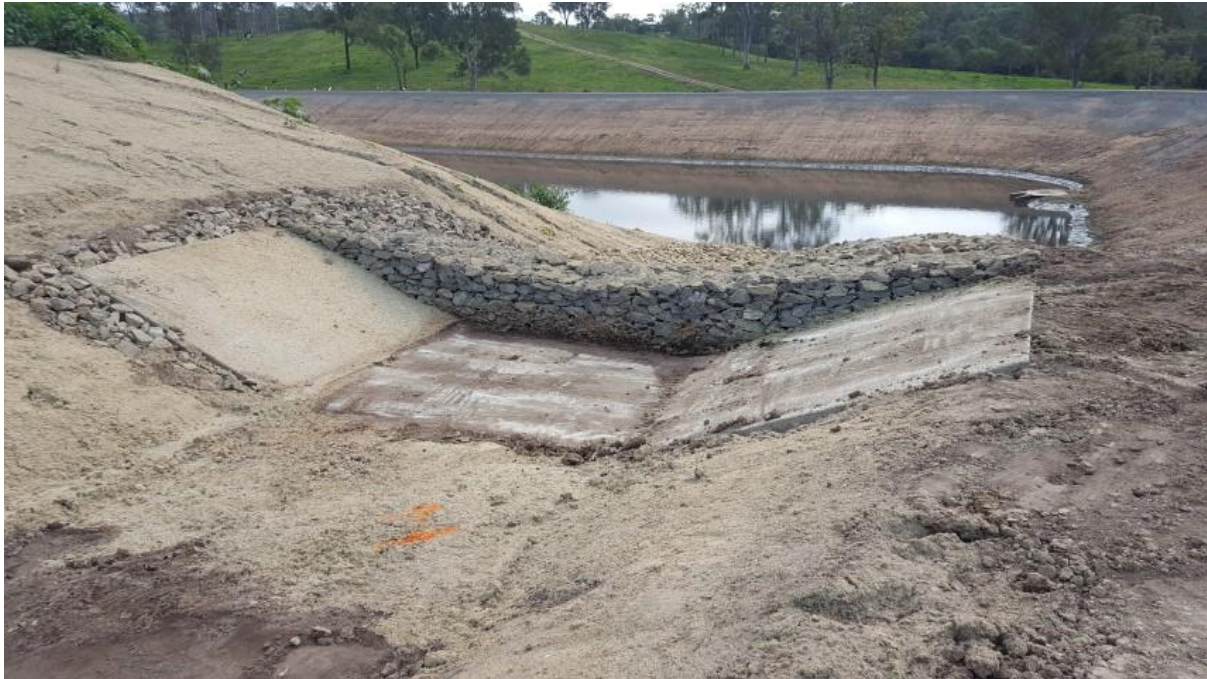
The Western contaminated pond inlet has been installed with a rock gabion weir to assist with capture of suspended sediment directed from the cattle yards into the western stormwater pond via the constructed swale drains (Refer to Figure 5).

Figure 5: Rock gabion installed at the Western Contaminated Pond inlet.

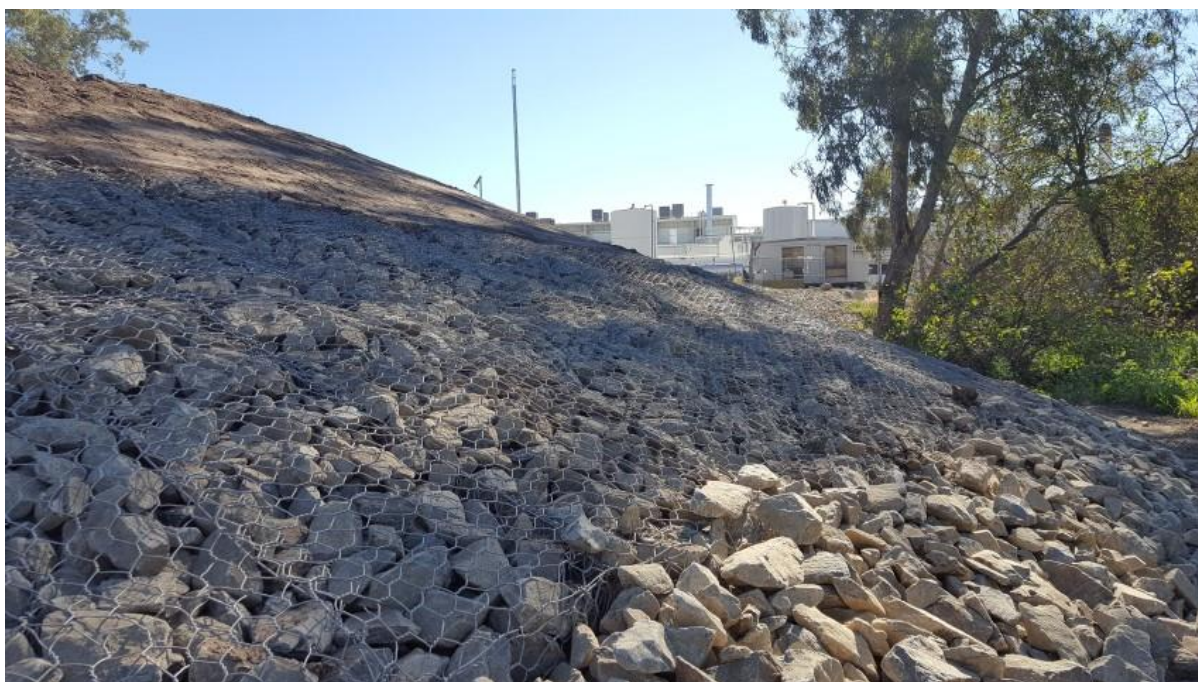
Batter protection has been installed on the south-eastern side of the Eastern contaminated pond adjacent to the creek. The batter protection is designed to protect the embankment from potential scour and erosion during major flood events. The velocity of water during major events was identified as having the potential to impact the integrity of the pond embankment. To mitigate this risk, Teys Australia Beenleigh has installed scour protection which consists of rock wire baskets and dump rock 70-300mm in size (Refer to Figure 6).

Figure 6: Installed scour protection on the eastern contaminated pond to maintain wall integrity during significant rainfall events.
