# PRCP schedule

## PRCP schedule P-PRCP-100762188

| Location(s) |
|---|
| Mining lease (ML) 20676, ML20688, ML20689 and ML100130 |

## Section B - Final site design and reference maps

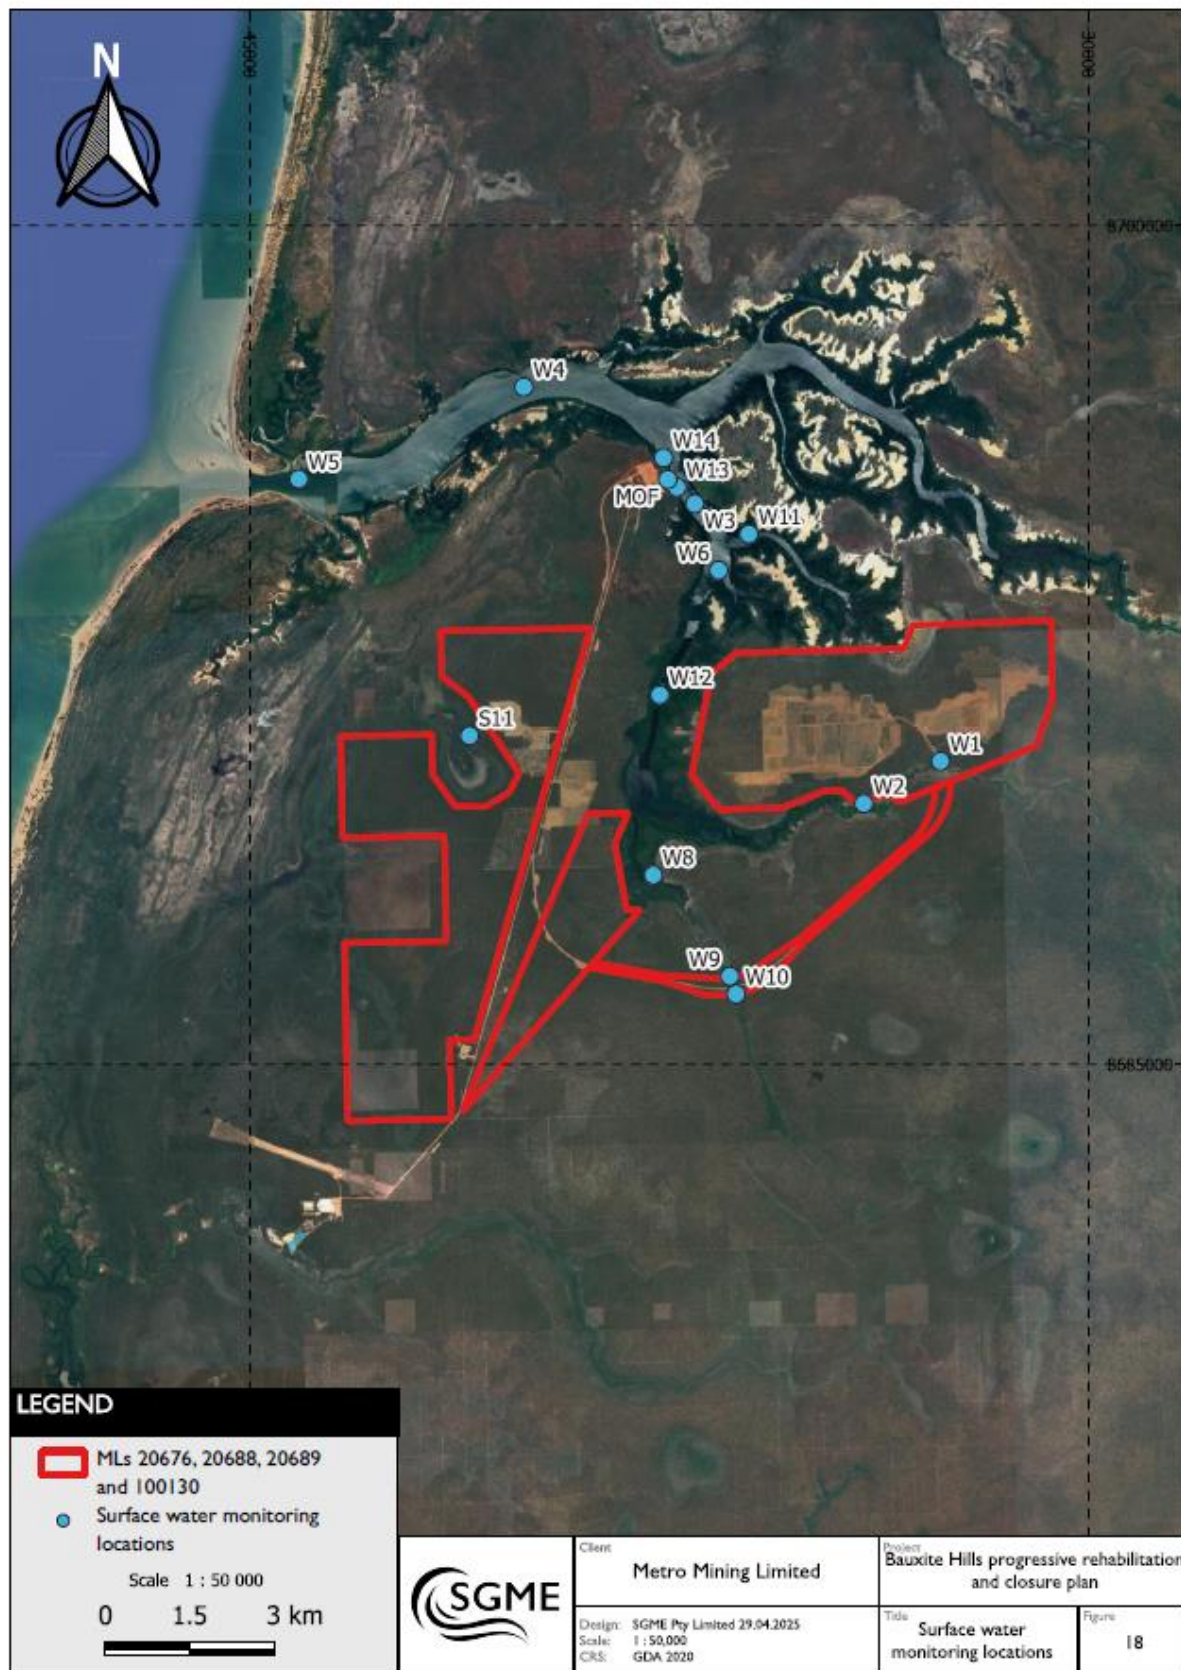
Figure 3- Receiving waters monitoring locations

| Skardon River upper estuary | | | |
|---|---|---|---|
| S11 | 613192 | 8695468 | Big Footprint Swamp |

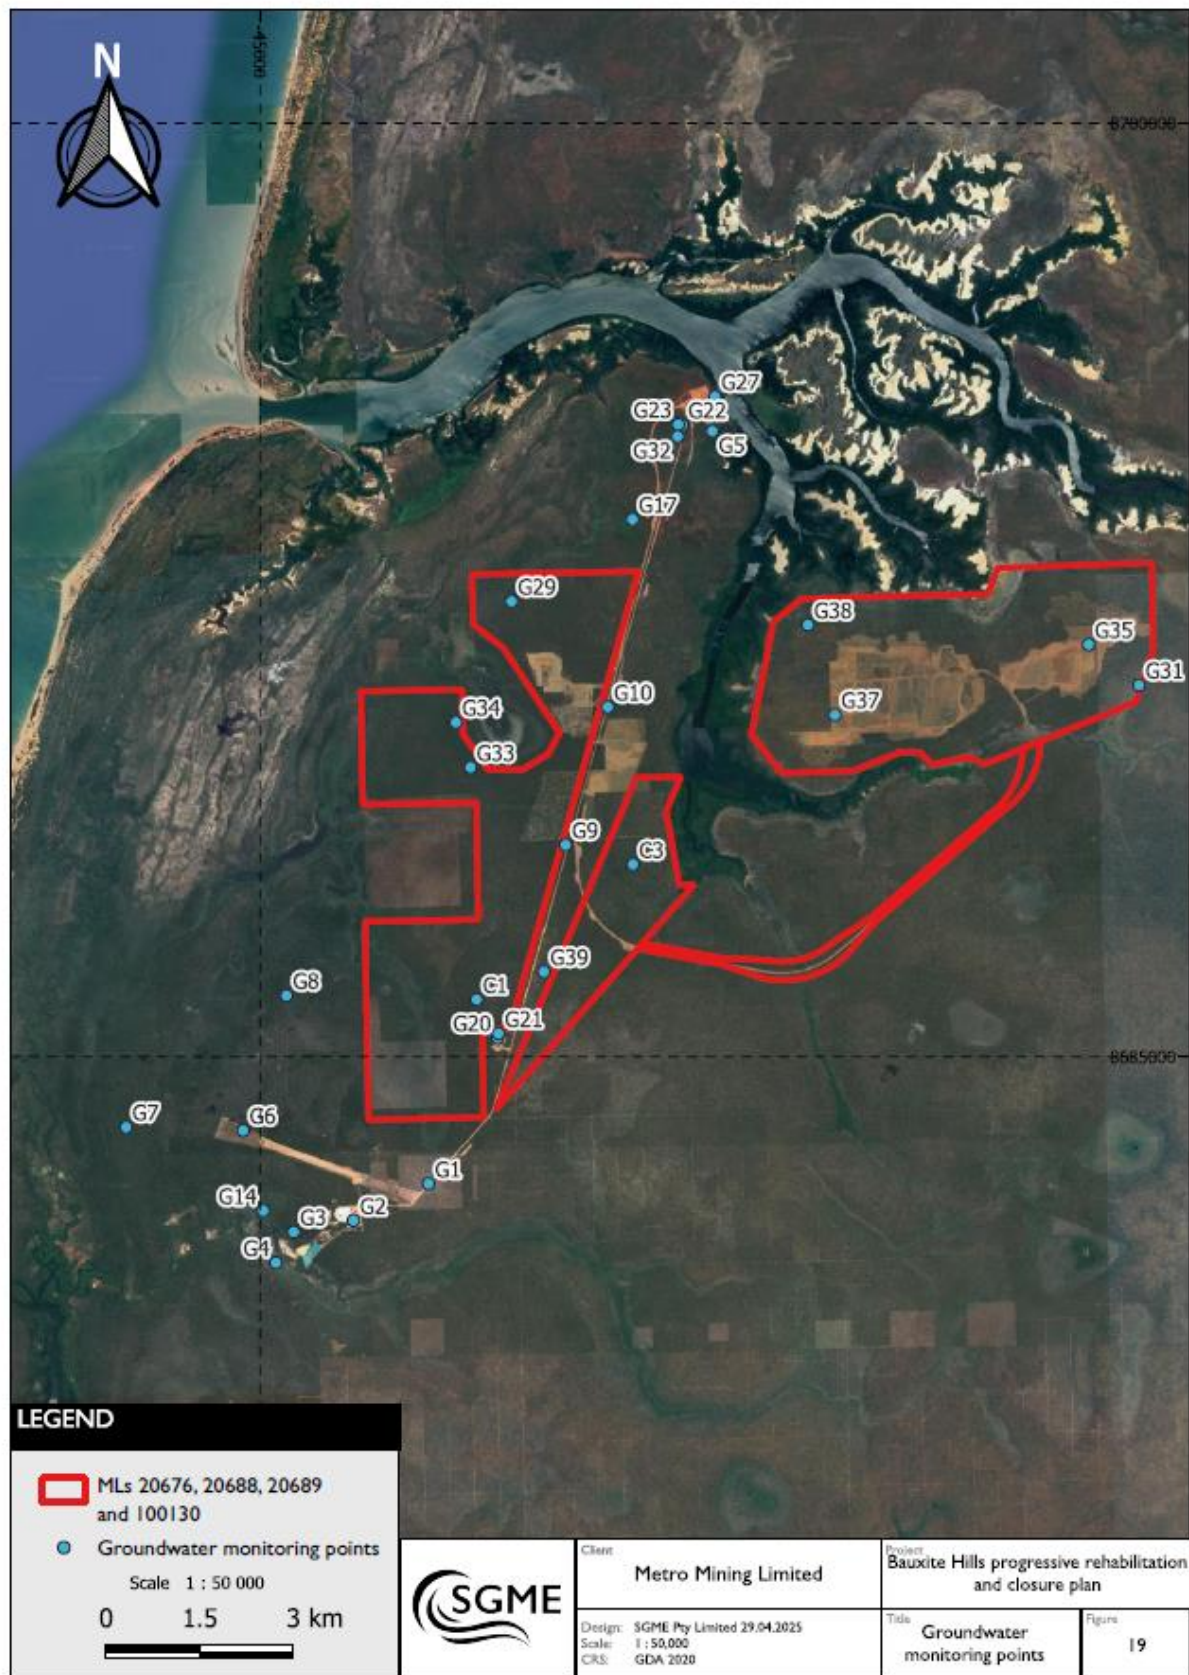
Figure 4. Groundwater monitoring locations

*a. RL must be measured at the top of the bore casing to the nearest 5 cm.*
