# PRCP schedule

## PRCP Schedule P-PRCP-100785995\_V1 Cloncurry Mining Project

P-PRCP-100785995\_V1 Cloncurry Mining Project

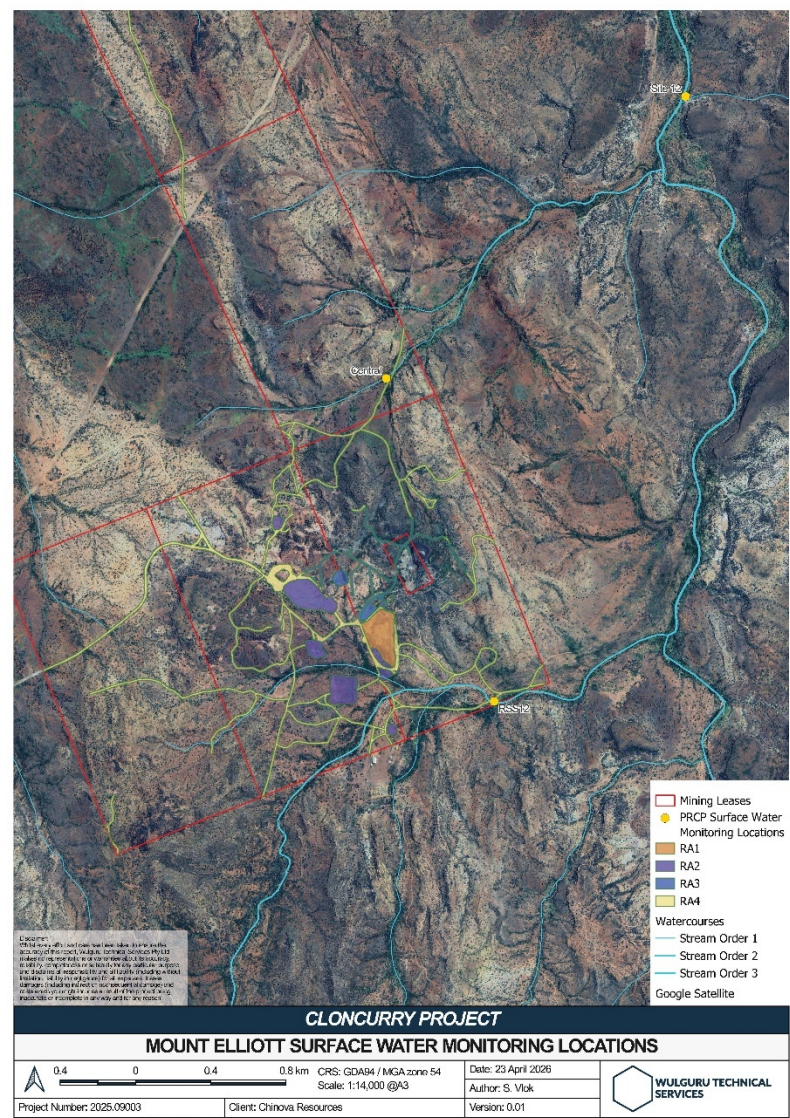
Figure 3. Mount Elliott surface water monitoring locations

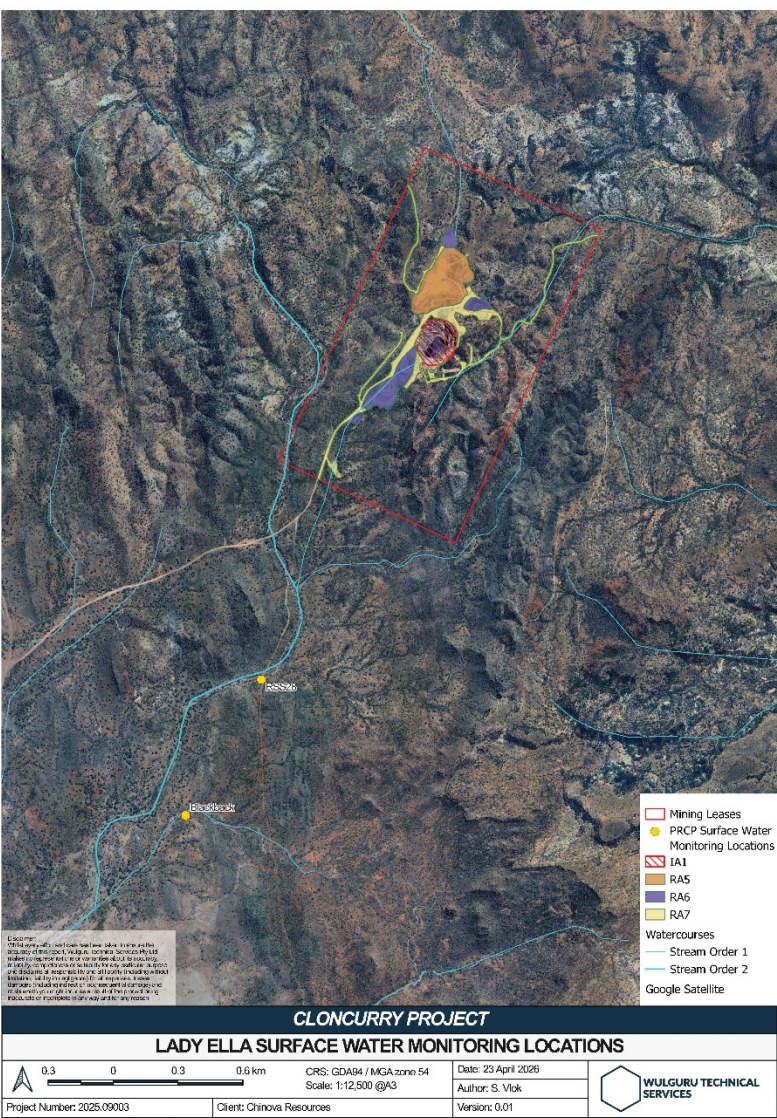
Figure 4. Lady Ella surface water monitoring locations

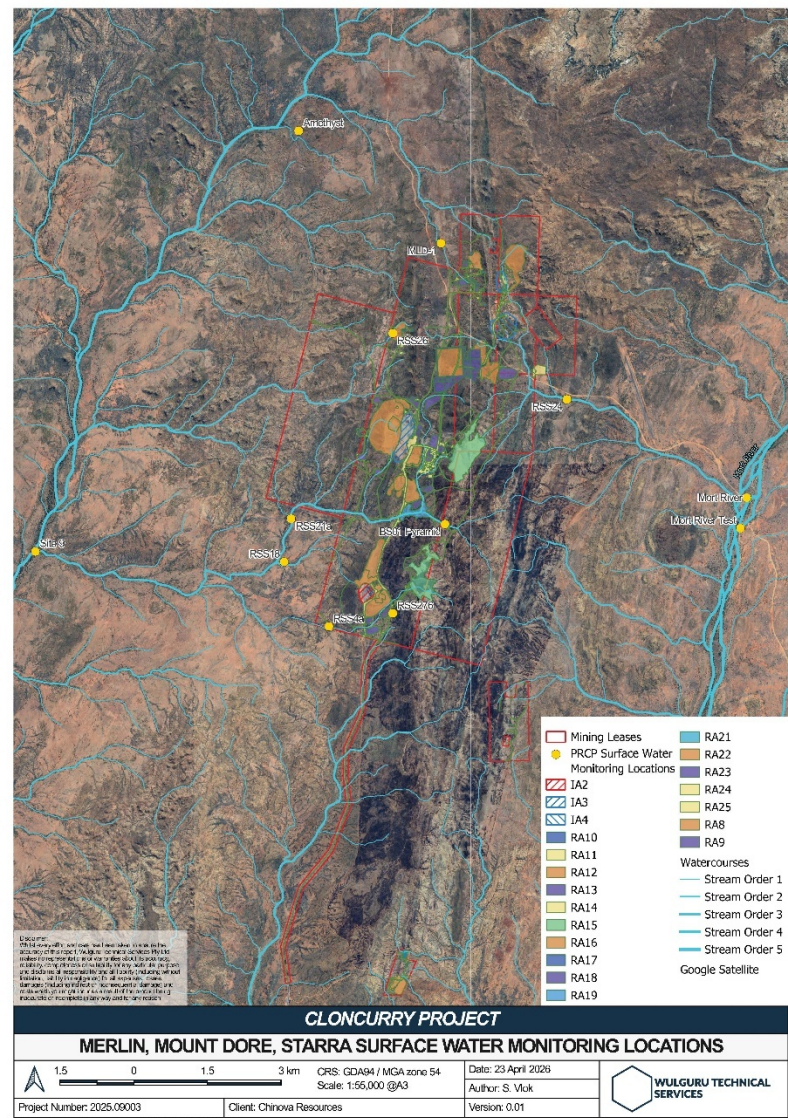
Figure 5. Merlin, Mount Dore, and Starra surface water monitoring locations

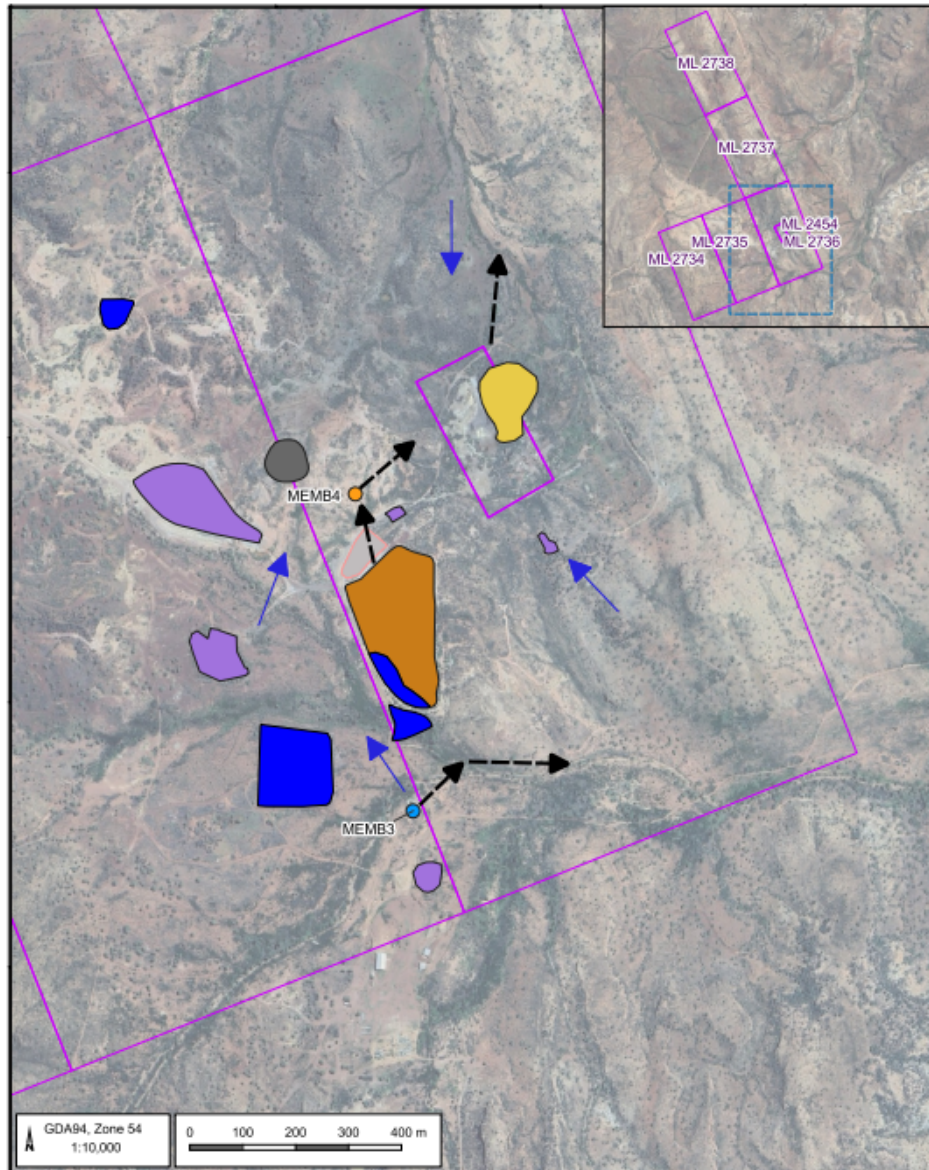
Figure 6. Mount Elliott Groundwater monitoring locations

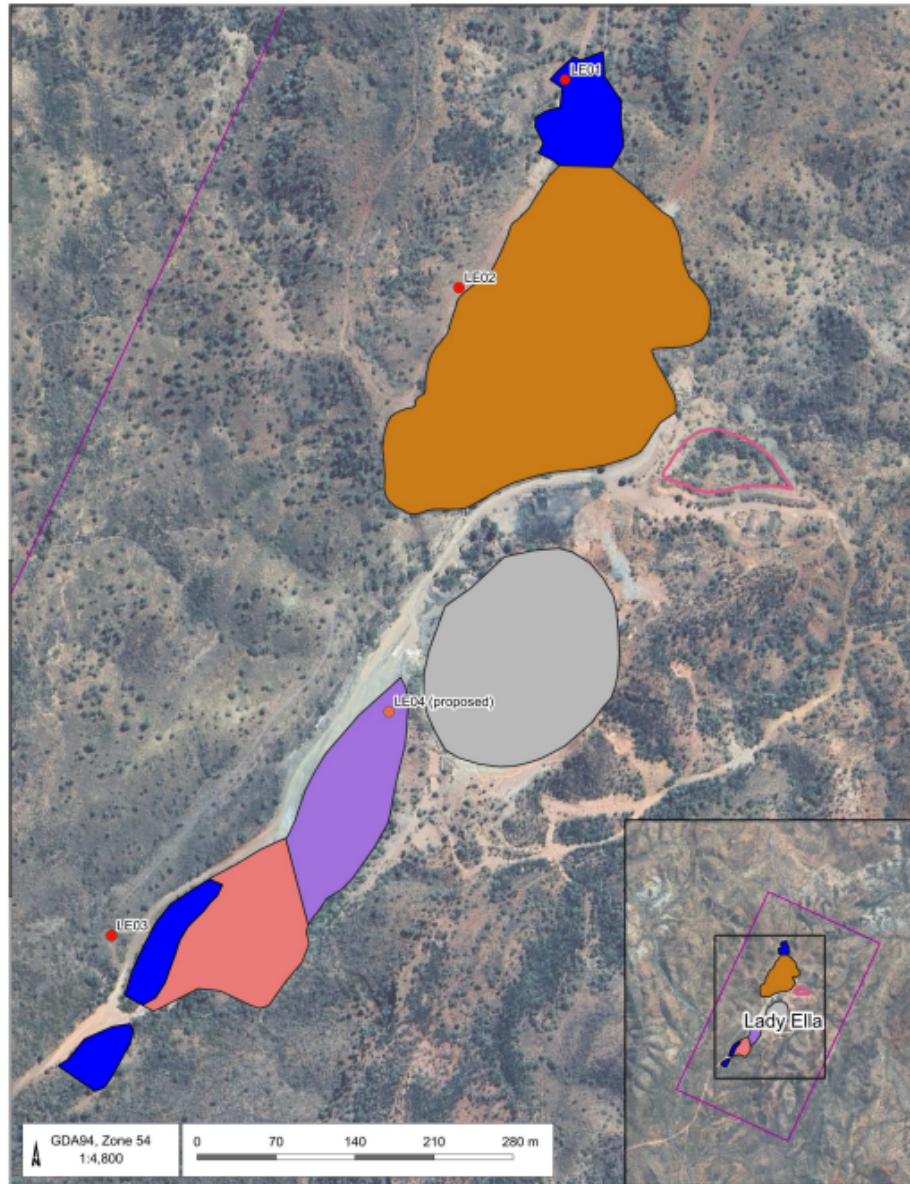
Figure 7. Lady Ella Groundwater monitoring locations

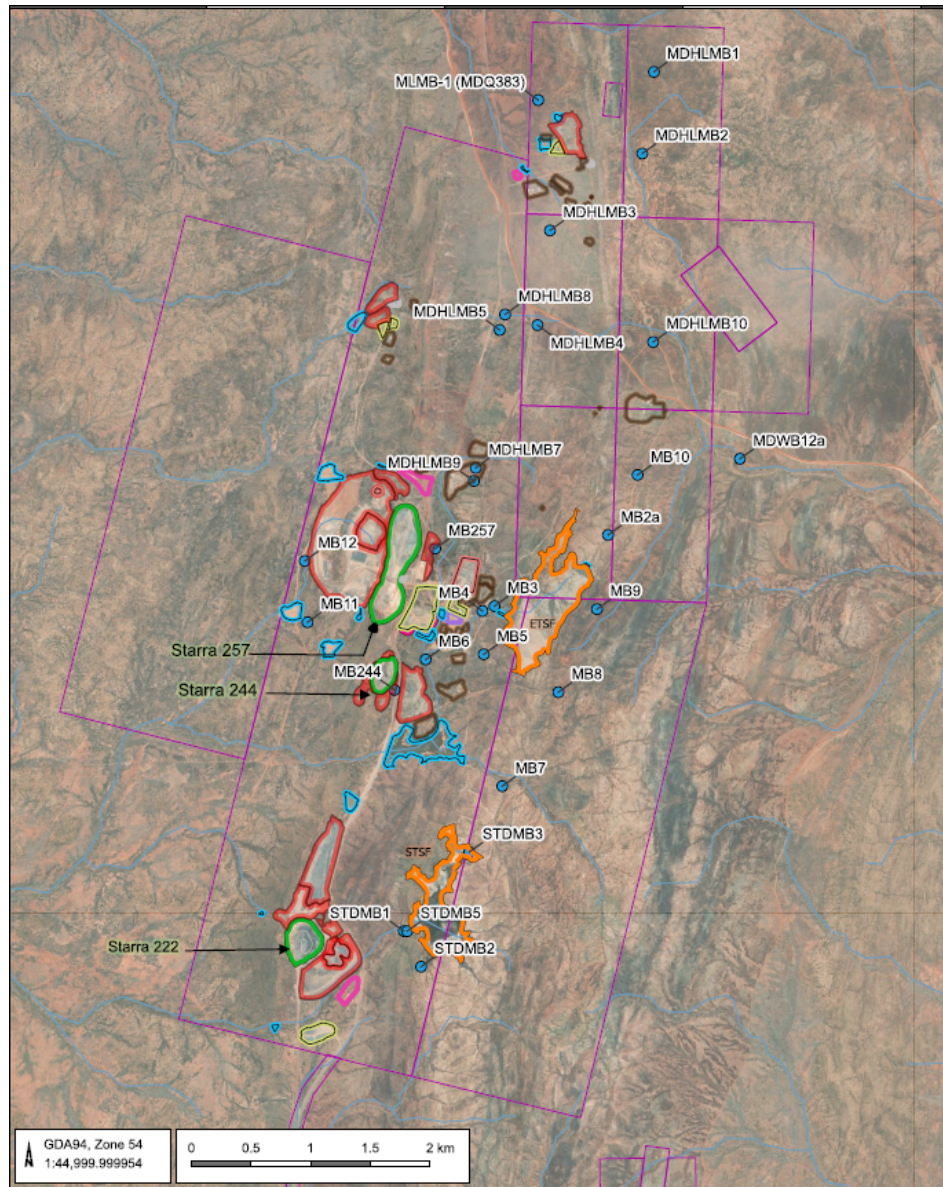
Figure 8. Merlin, Mount Dore and Starra Groundwater monitoring locations
