# Progressive Rehabilitation and Closure Plan

## Stuart Kerogen Shale Project

Queensland Energy Resources

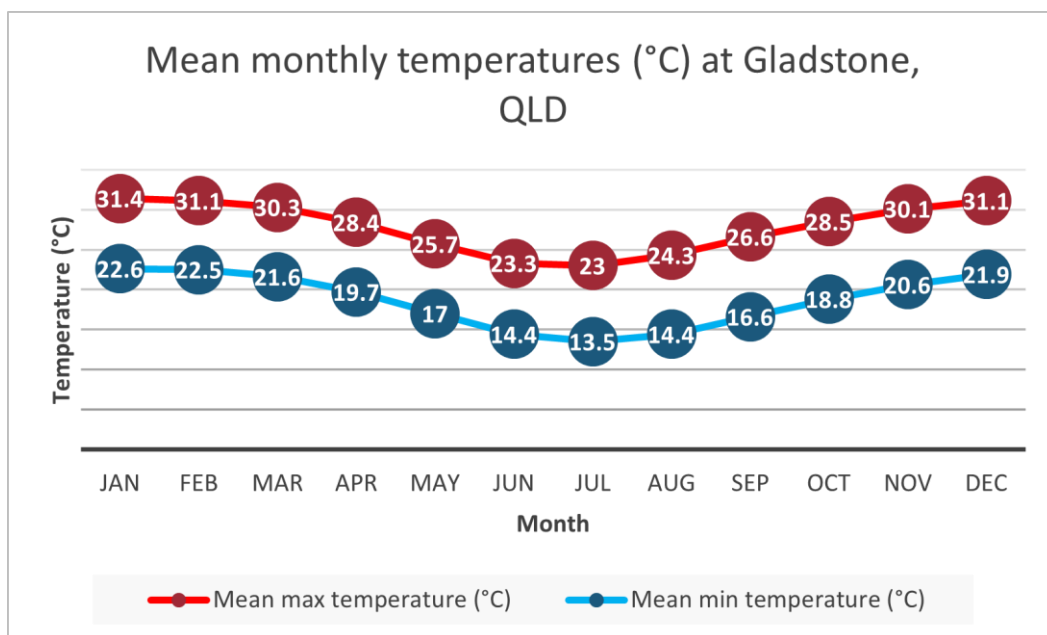
Figure 2.3 Long-term maximum & minimum monthly temperatures at Gladstone Radar Station

The region experiences an average maximum temperature of 27.8°C and an average minimum temperature of 18.6°C. January is the hottest month with an average maximum temperature of 31.4°C, while July is the coldest month with an average minimum temperature of 13.5°C. The long-term monthly mean maximum and minimum temperature for the Gladstone Radar Station is presented in Figure 2.3. The annual average relative humidity reading collected at 9:00 am from the Gladstone Radar Station is 67%, while at 3:00 pm the annual average is 53%.

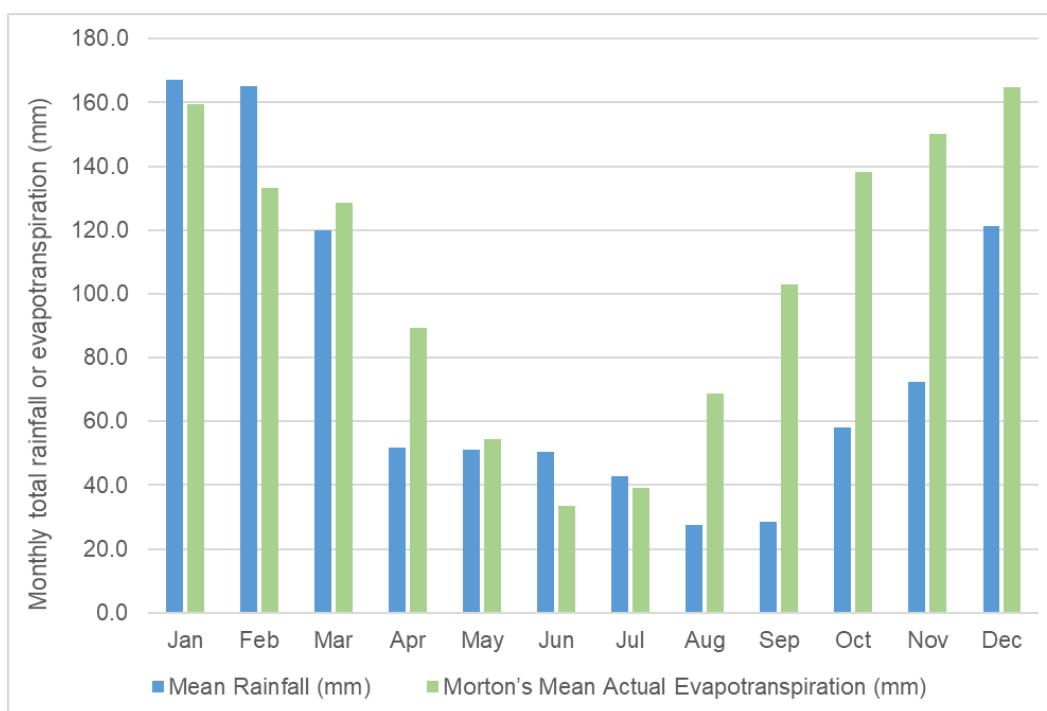
Figure 2.4 Long-term average monthly total rainfall and evapotranspiration (Morton's areal actual)

Additional rainfall and evapotranspiration data were sourced from the Scientific Information for Landowners (SILO) database. SILO is operated by DESI, with data contributions from Bureau of Meteorology. The evaporation rate is highest from November through January. The evaporation rate is lowest from May through July. The only months where the rainfall exceeds the estimated evaporation rates are January and February, June, and July. Mean potential annual evapotranspiration for the region is estimated to be 1,858.1 mm, which is almost double the annual average rainfall of 958 mm. The long-term monthly mean rainfall and evaporation rates from SILO is presented in Figure 2.4.

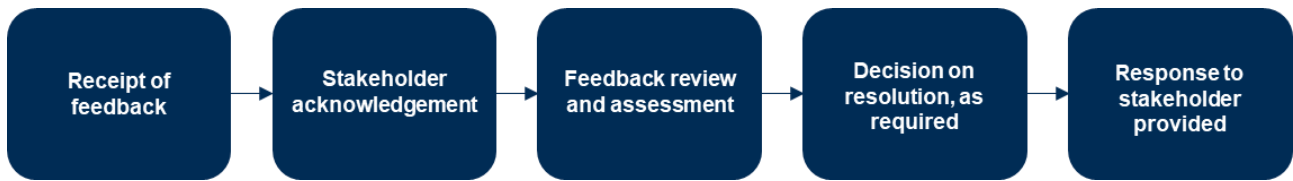
Figure 6.1 Process for handling feedback and comments

The analysis would determine if, and how, the matters raised should be used to inform site rehabilitation activities, with an electronic record of community feedback and comments to be maintained using the template provided in Appendix O. A conceptual flow chart of the feedback and comment handling process is provided in Figure 6.1.

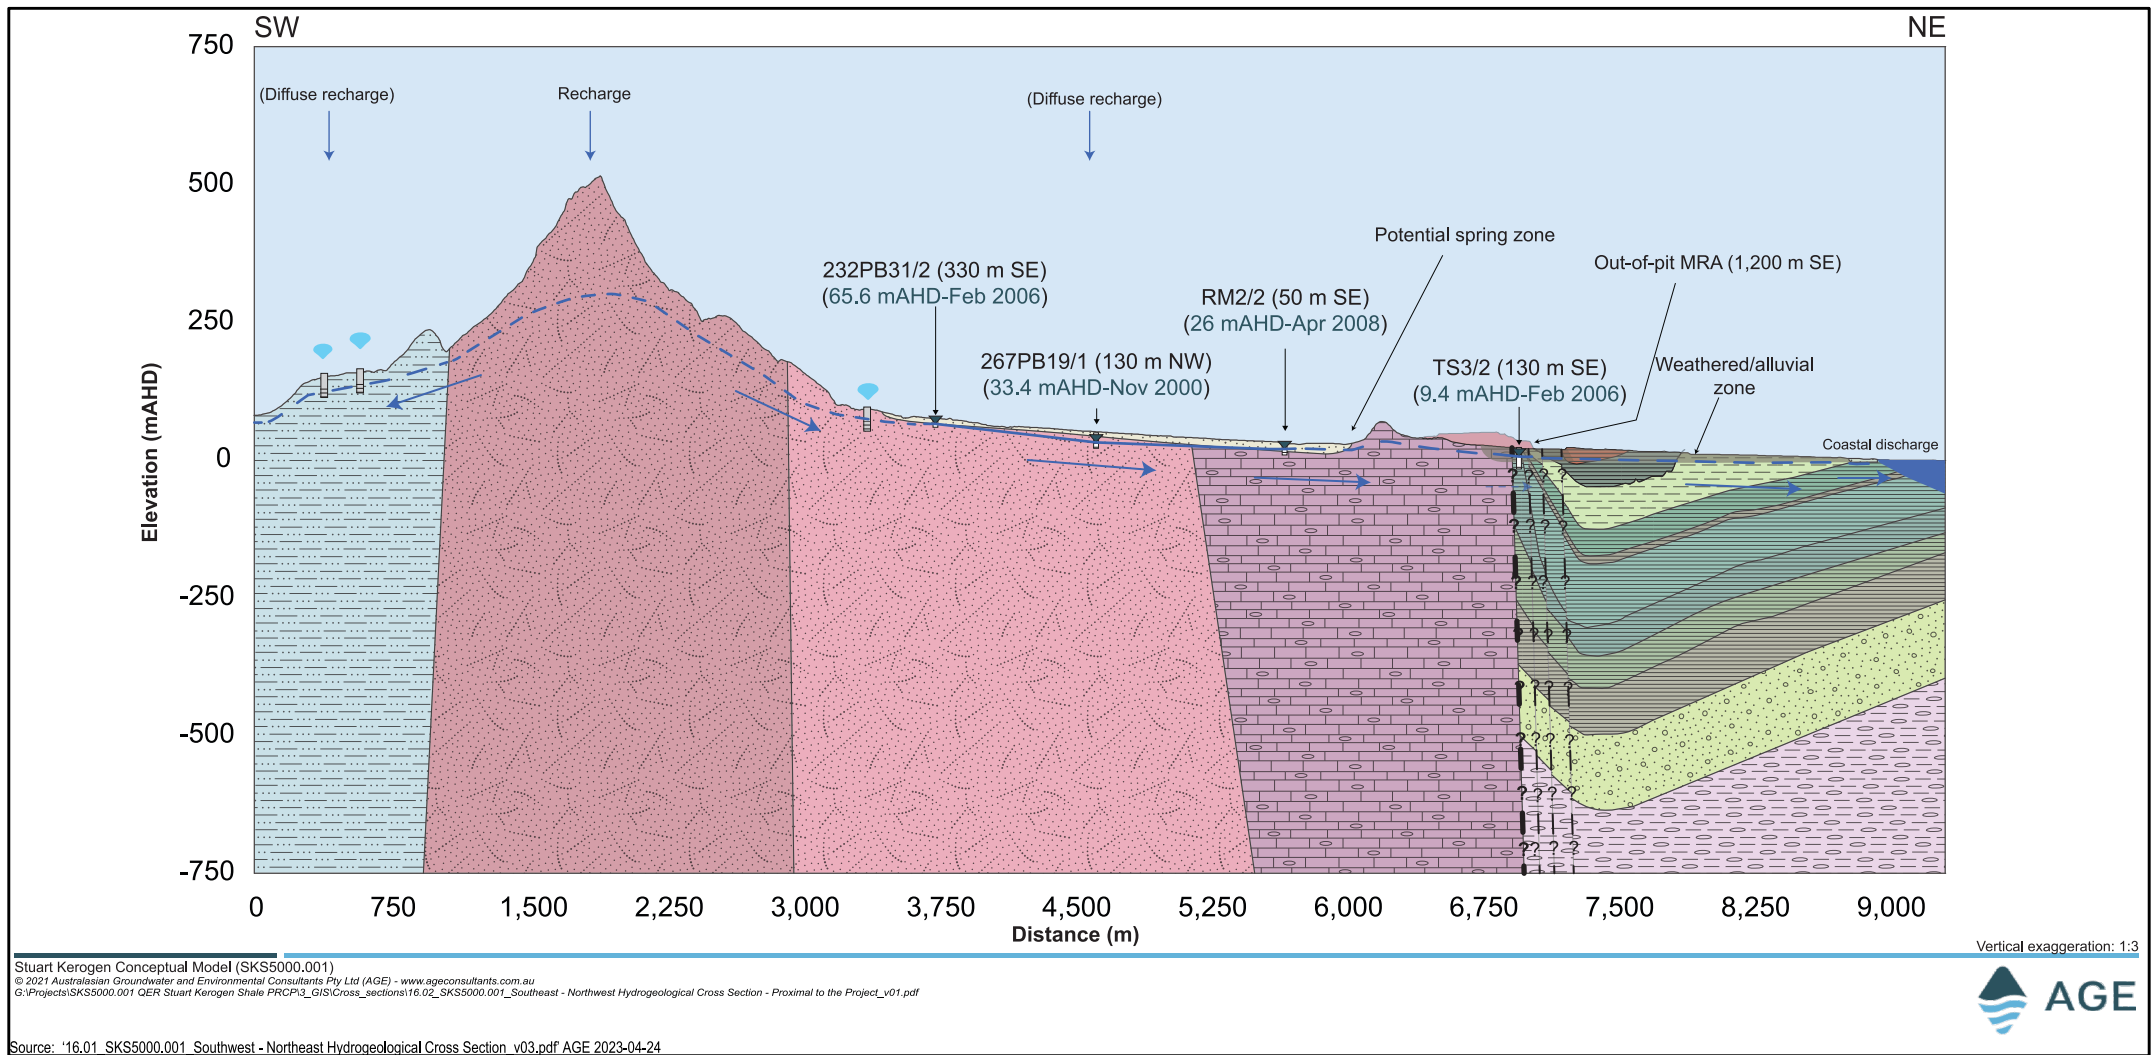
Hydrogeological conditions of the Project site are conceptualised for closure conditions in the third cross section (Figure 7.3), with the primary difference between Figure 7.2 (current conditions) and Figure 7.3 (closure conditions) being the presence of the final void. The final pit void is depicted as a groundwater source, based on the results discussed in this section.

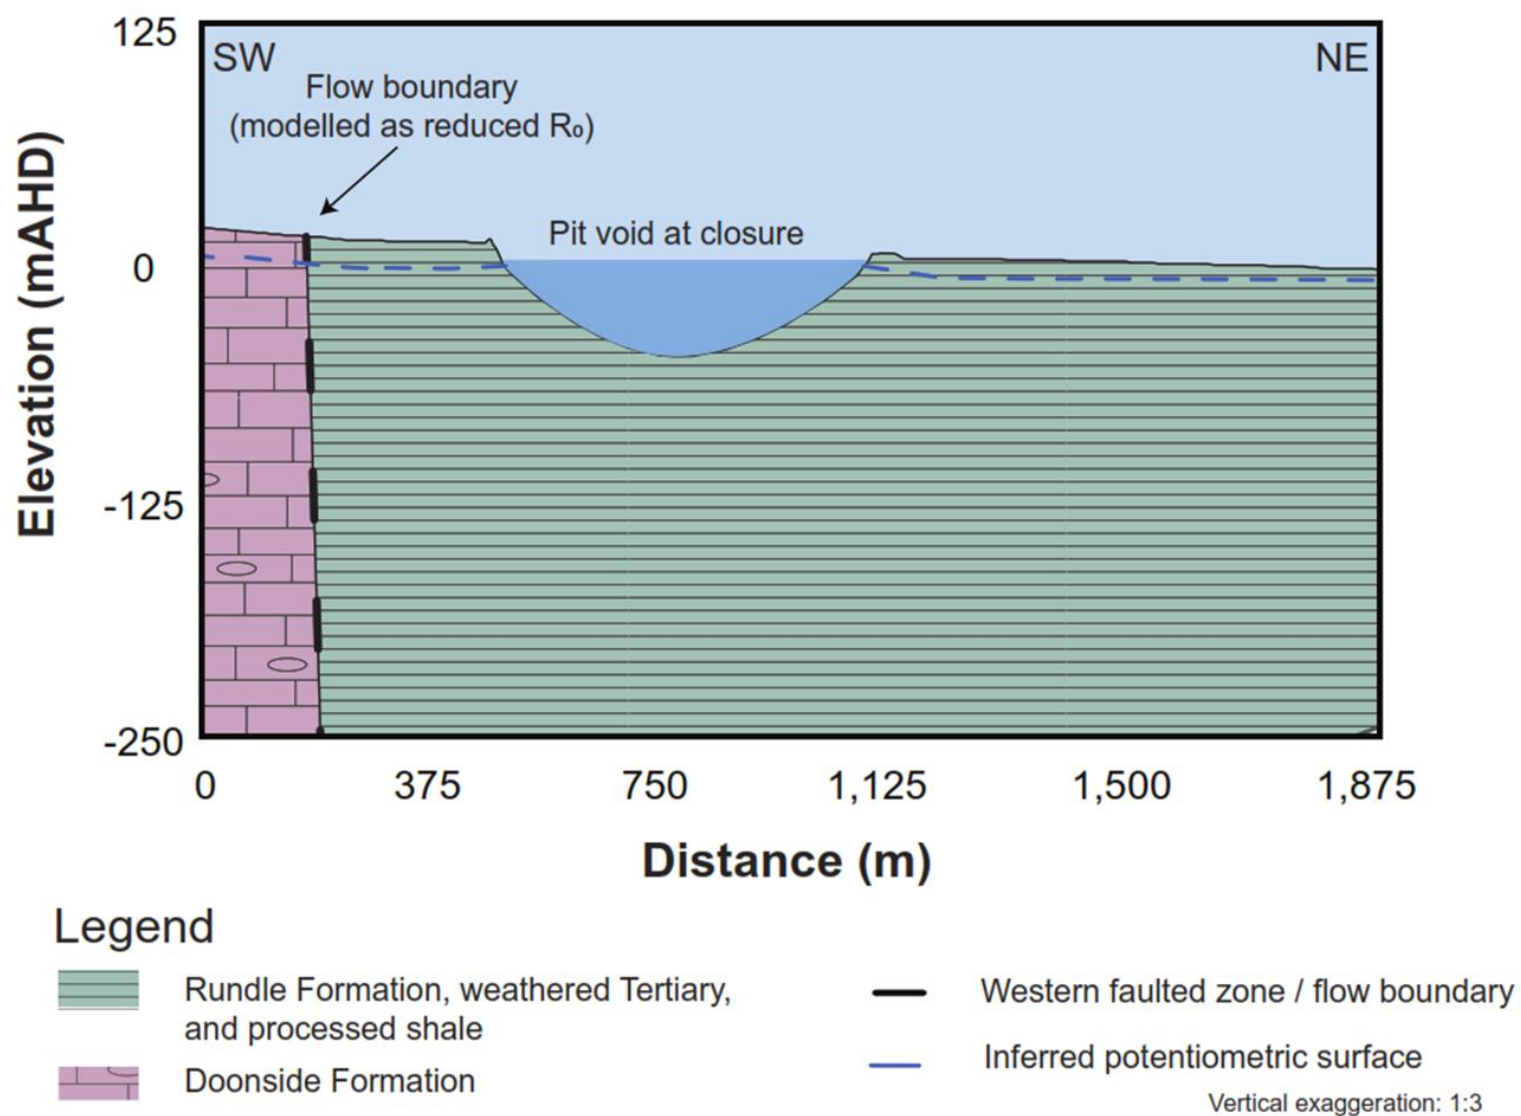
Figure 7.4 Conceptual cross section of the final void showing model assumptions

A source-pathway-receptor summary is provided to assess potential impacts for the Project site, the analysis summarises the critical impact assessment data for the Project site in Table 17.4 (*Source-Pathway-Receptor analysis for the Project*) of Appendix L.

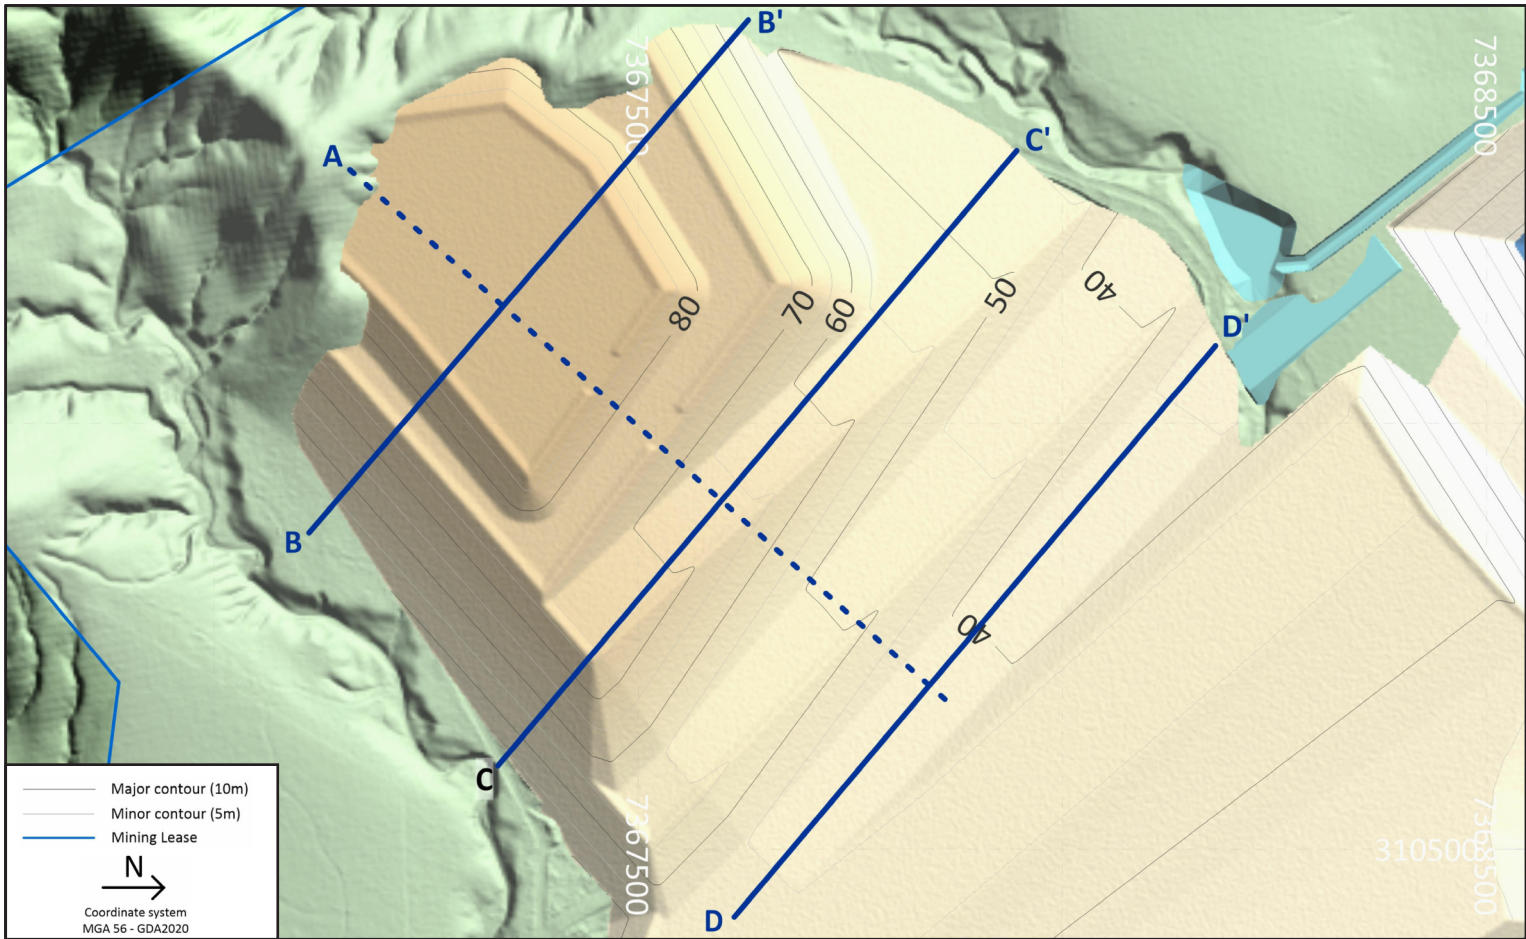
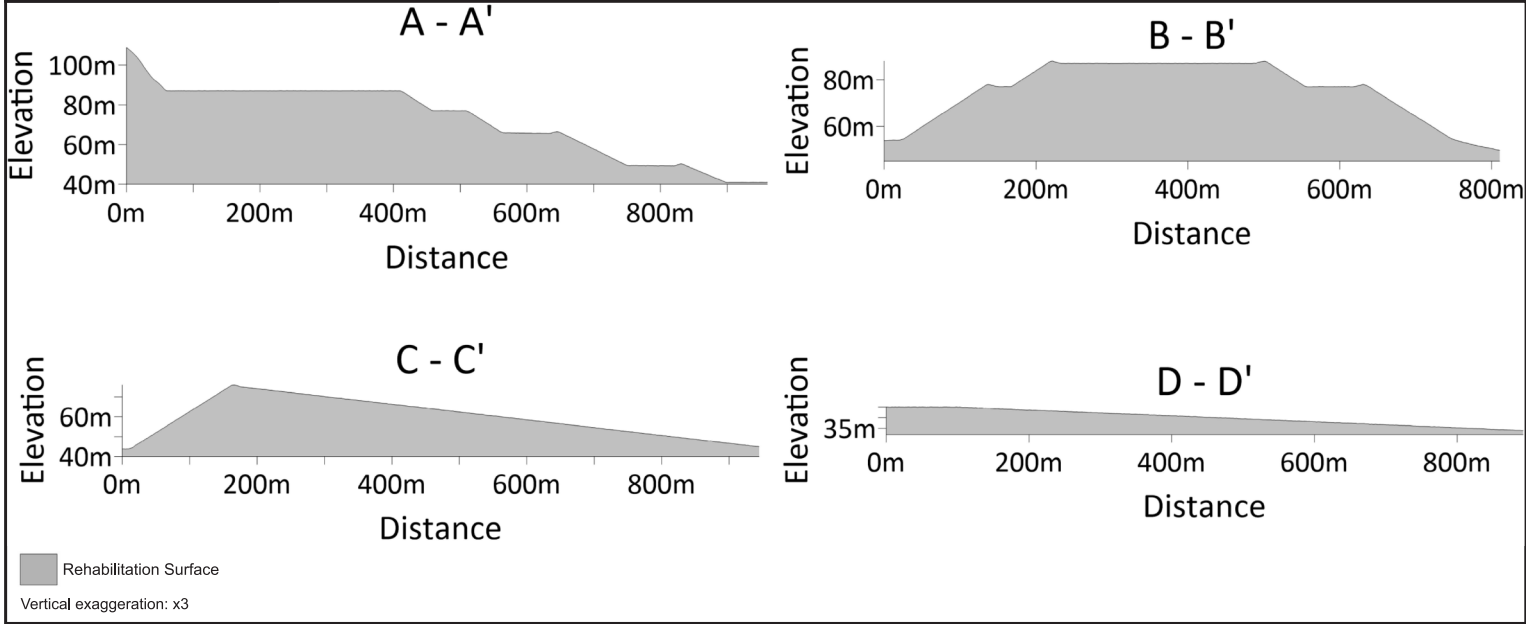
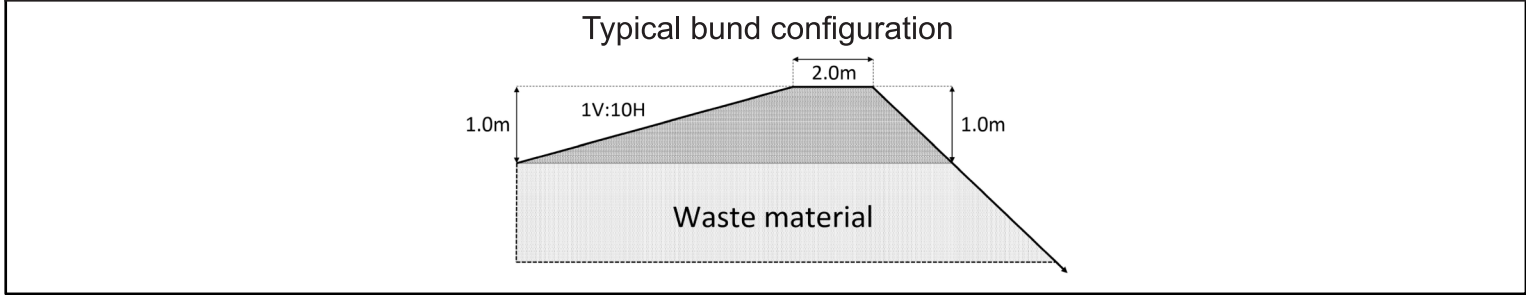
| | <b>Figure 7.11</b><br>Cross section locations for the<br>Out-of-pit MRA & road alignment (top),<br>and cross section views for these<br>locations (bottom) (Landloch, 2024b) | | <b>QUEENSLAND ENERGY RESOURCES</b><br><b>Stuart Kerogen Shale Project</b> |

The method of construction of the Out-of-pit MRA, including road access area, is described further in Section 7.6.4.

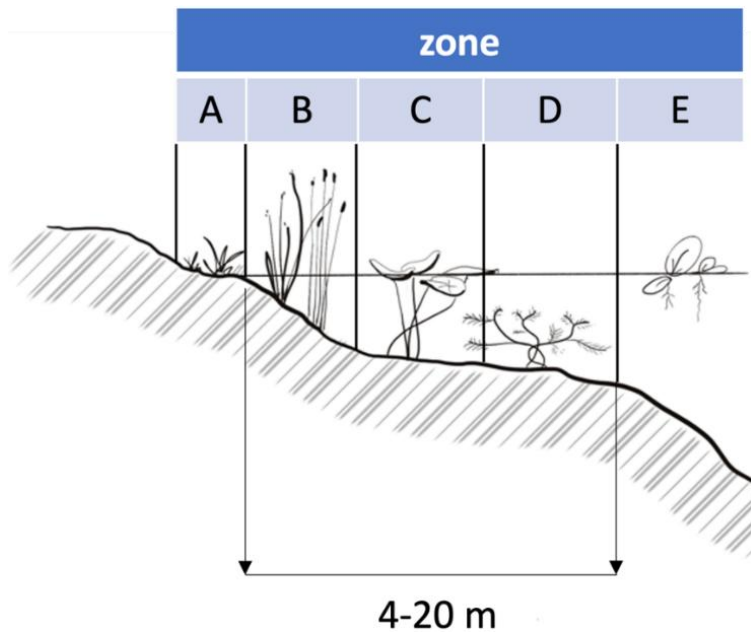
Figure 7.18 Conceptual diagram showing relationship of aquatic habitat zones around the final void lacustrine wetlands (RA12)

The location of the zones in the freshwater wetland (lacustrine) is shown diagrammatically in Figure 7.18.

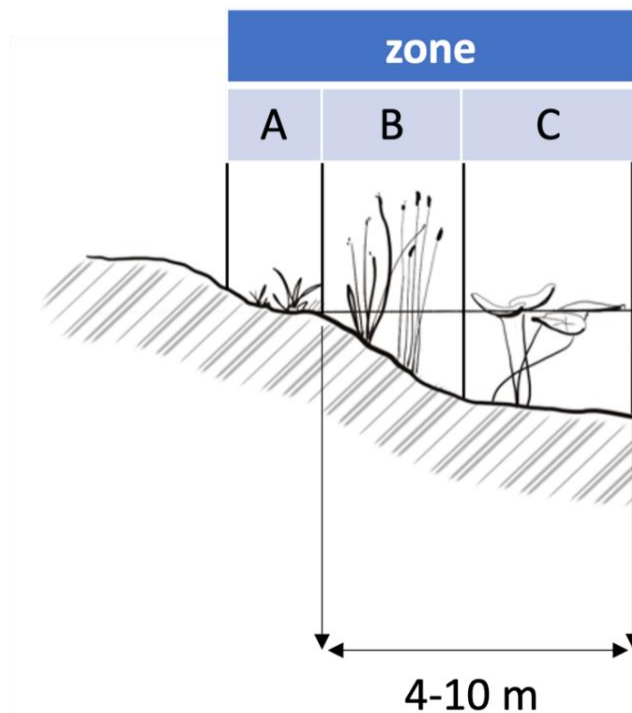
Figure 7.19 Conceptual diagram showing relationship of aquatic habitat zones around the fringing palustrine wetlands

While subject to further detailed design, the fringing palustrine wetlands around the perimeter of the final void are expected to be shallow (< 5 m), ephemeral, with gentle slopes and fed mainly by overland flow from rainfall within their catchment. Deep water habitats will not be present within the fringing palustrine wetlands, so rehabilitation will be confined to the establishment and maintenance of Zones A to C with an expected maximum total width of approximately 10 m (Figure 7.19).

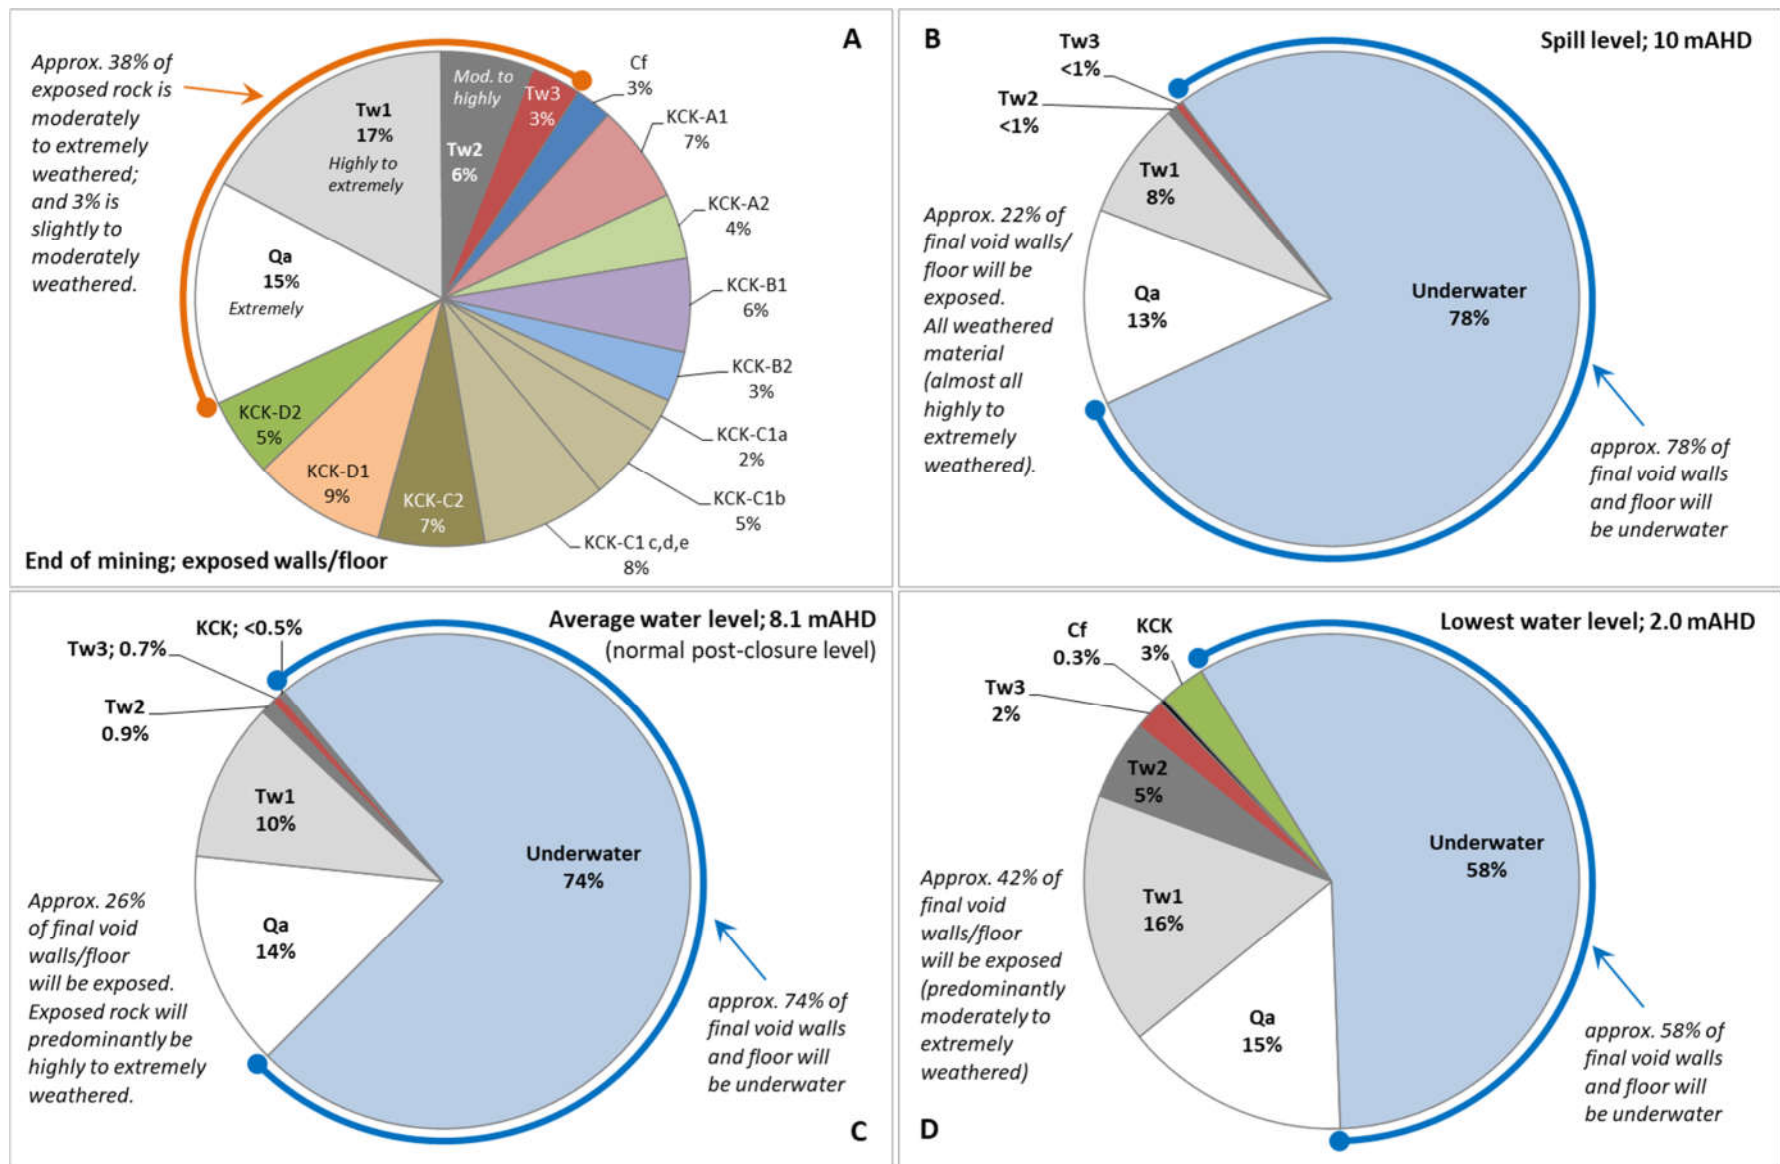
Figure 7.20 Estimated final void wall/floor exposure (surface area exposure) by material type at selected void water level scenarios

For the post-closure normal water level scenario, after wall/floor rock has been covered/capped and the final void has filled with water to 'normal' post-closure water level (approximately 8.1 mAHD), approximately 12.5% of the exposed void walls/floor (combined) is estimated to be PAF, which includes material classified as UC(PAF), PAF-LC, and NAF-S. As such, the assessment has found that AMD generation from the partially exposed final void walls/floor (exposed above water level) is **Low to Moderate** and AMD generation from the partially exposed walls/floors is **Highly Unlikely**.

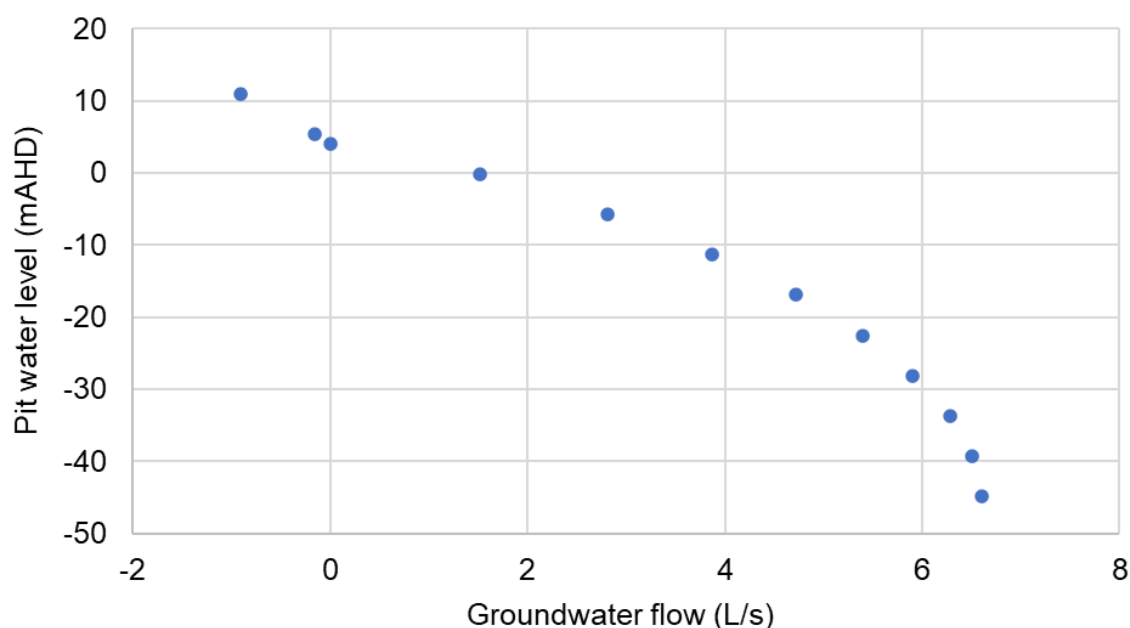
Figure 7.21 Groundwater model results

The modelled inflow and outflow as a function of elevation is show in Figure 7.21 and the derivation of the height dependant inflow and outflow relationships is shown on Figure 7.22 and Figure 7.23, respectively.

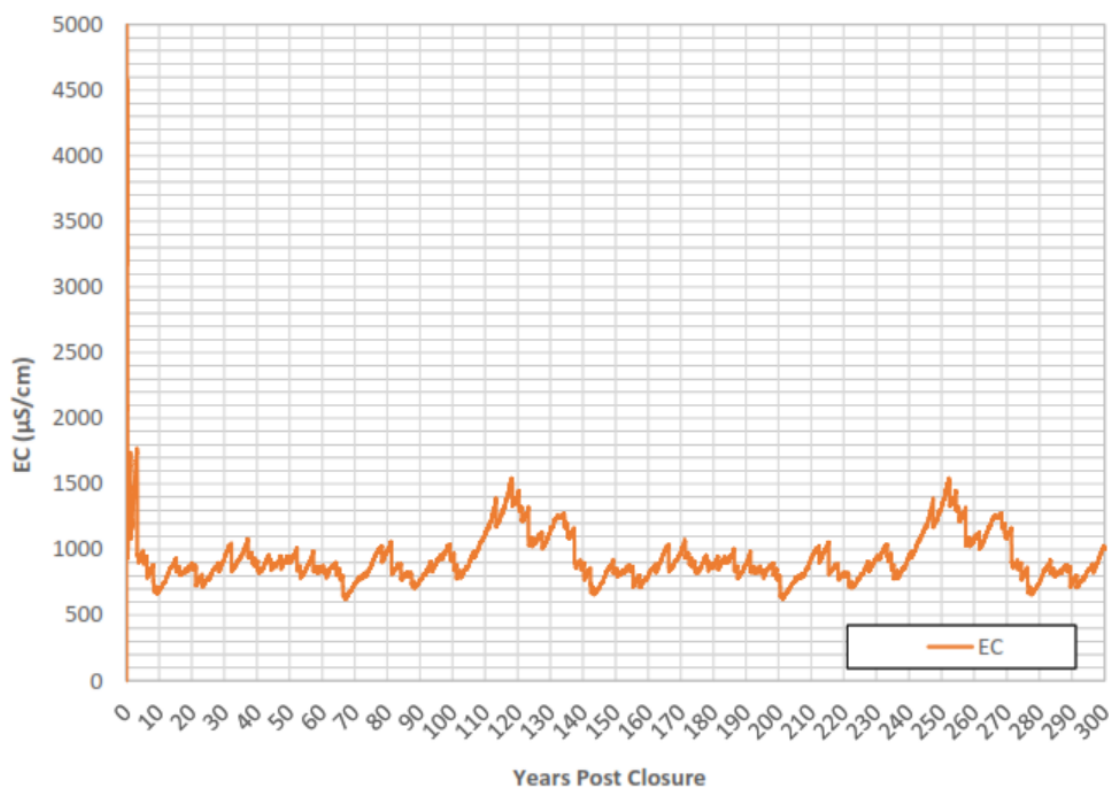
- During extended dry periods, for example between modelled years 105 and 120 post closure, EC increases in the final void as a result of evapo-concentration.
- EC in the final void fluctuates between 620 and 1540  $\mu\text{S}/\text{cm}$  following the initial filling period, with the EC in the final void remaining relatively stable at approximately 900  $\mu\text{S}/\text{cm}$  when the void lake level is around the equilibrium level (e.g. between 20 and 60 years post closure).
- As the final void is predicted to spill in 26% of years, no longer term evapo-concentration is observed.

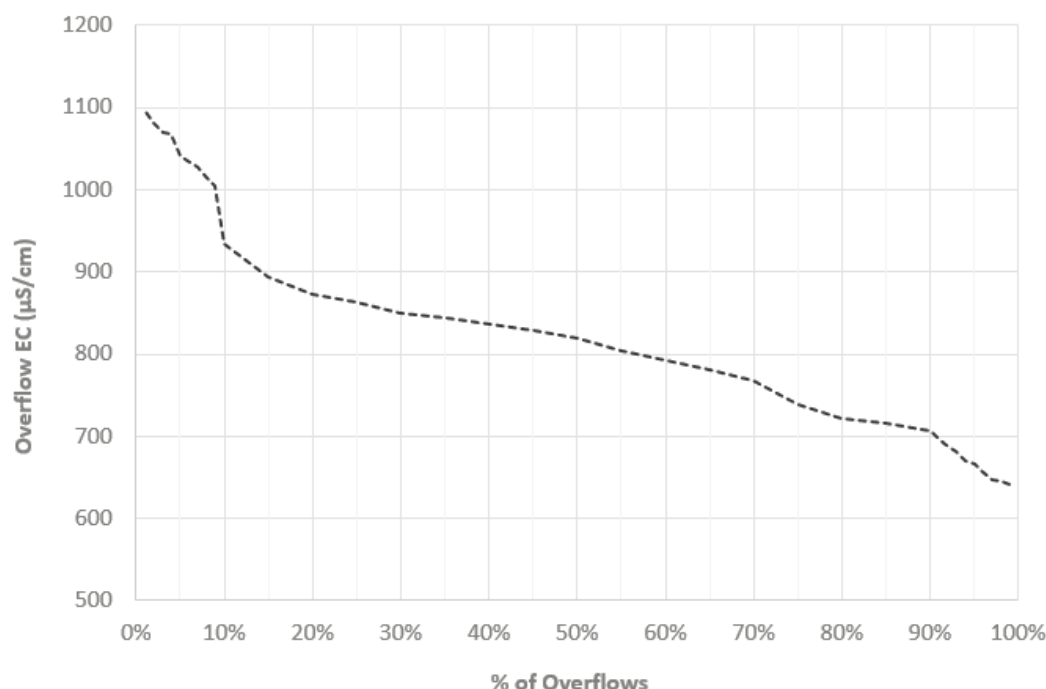
Fluctuations of void water quality are expected to occur during prolonged wet and dry periods, with the EC of the pit lake during overflow events expected to be between 623  $\mu\text{S}/\text{cm}$  and a maximum of approximately 1,100  $\mu\text{S}/\text{cm}$ ; however, 80% of overflows are below 720  $\mu\text{S}/\text{cm}$ . The maximum level of 1,100  $\mu\text{S}/\text{cm}$  is below values recorded from monitoring in the existing gullies. Water quality monitoring of the existing Gully E show background EC is generally below the modelled ranges in the pit lake; however, Gully E is highly ephemeral and sampled in response to rainfall runoff events with large dilution. The percentage of total overflows plotted against the corresponding overflow EC is shown in Figure 7.26.
