# PRCP schedule

## P-PRCP-100886173 Stuart Kerogen Shale Project

**PRCP schedule:** P-PRCP-100886173\_V2

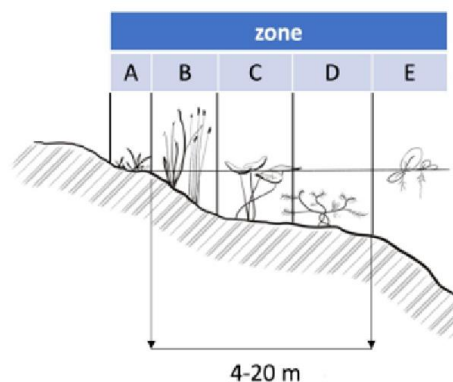
**Diagram 1** Conceptual diagram showing relationship of aquatic habitat zones around the final void and lacustrine wetlands (RA12)

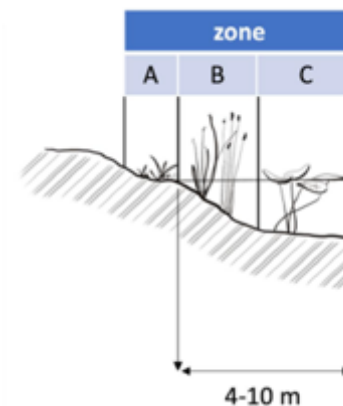
**Diagram 2** Conceptual diagram showing relationship of aquatic habitat zones around the fringing palustrine wetlands (RA14)
