# New Oakleigh Coal

## **Native Ecosystem Rehabilitation Plan**

**January 2007**

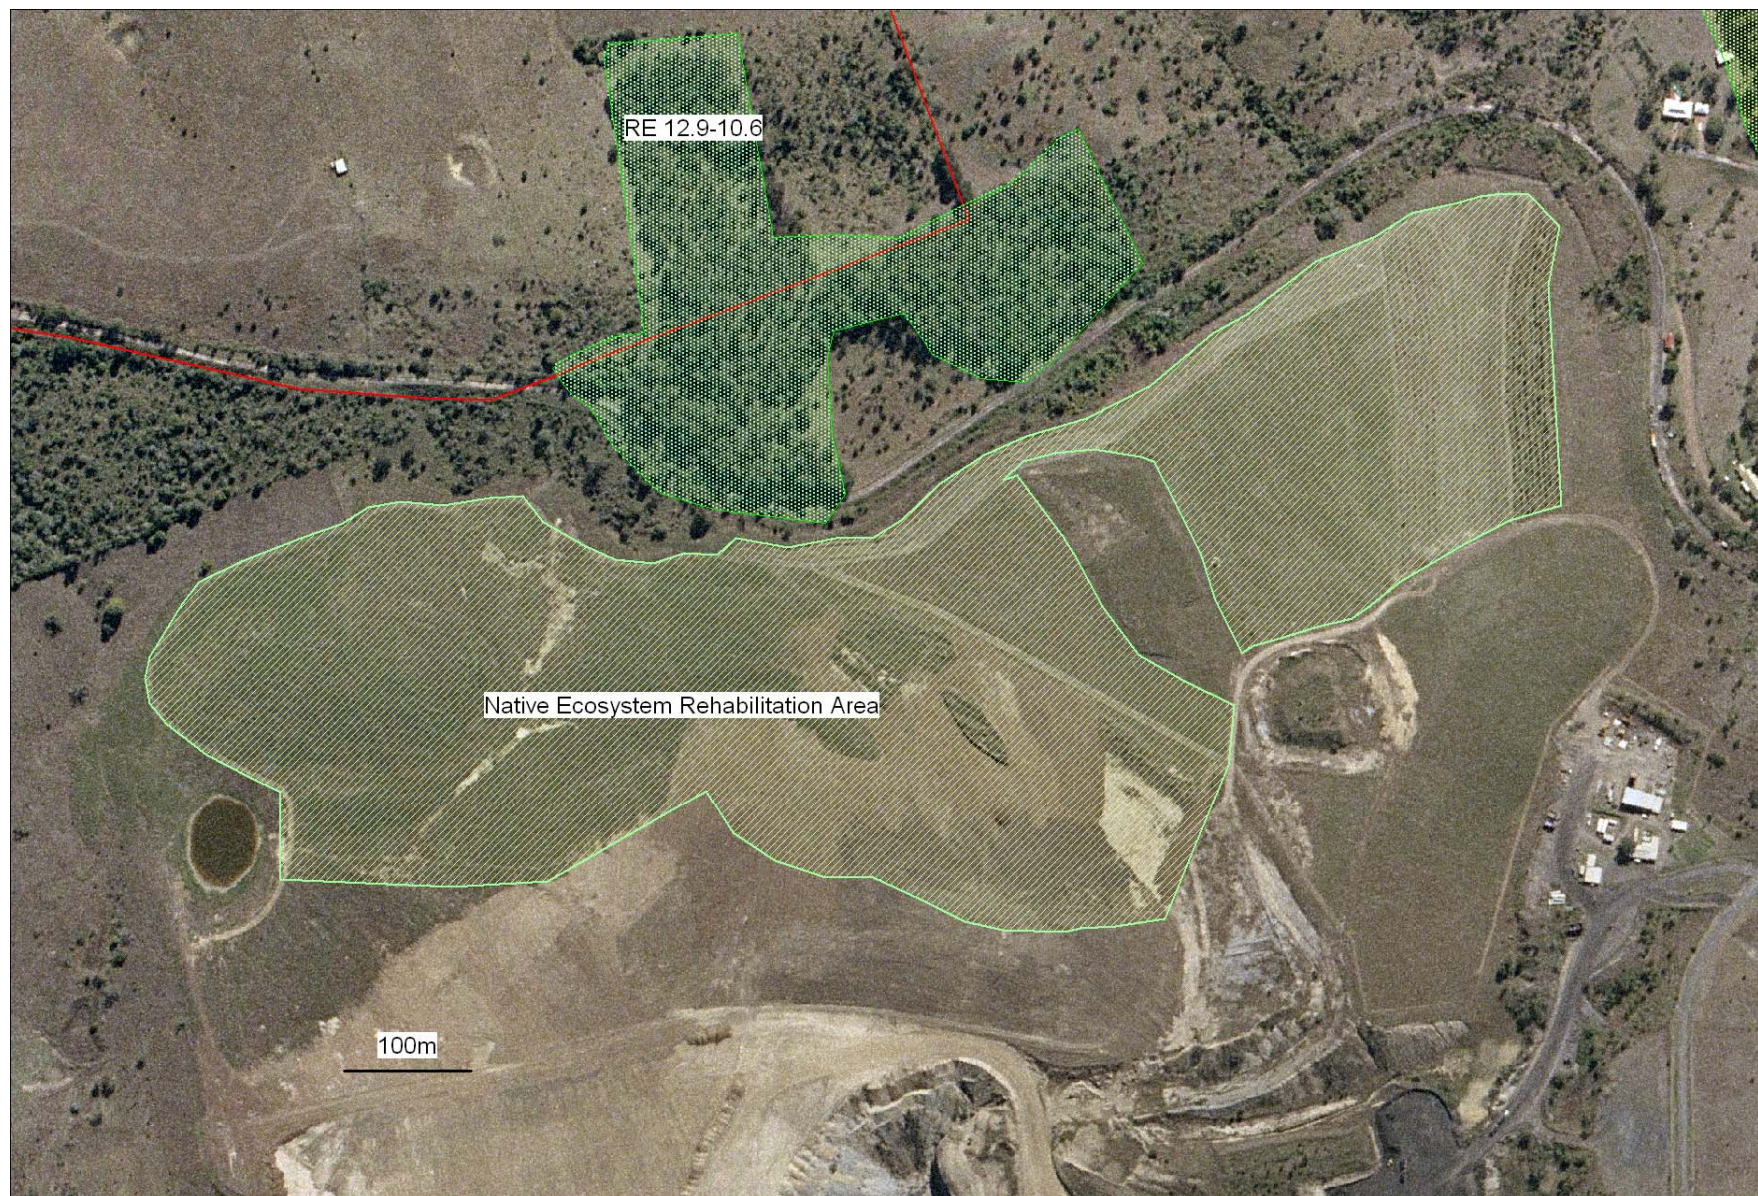
**Figure 2-1 Native Ecosystem rehabilitation area at New Oakleigh Coal Mine**

Figure 2-1 shows the location and nominal extent of the proposed NE rehabilitation area and the area of remnant vegetation. Two topsoil stockpiles are present on the top of the dump, one of which lies within the NE area. This topsoil is being retained for use in rehabilitating the final in-pit dump area and as such will remain in place until the end of active mining. Rather than shifting the stockpile which reduces the viability of the topsoil and results in excess costs due to double handling, the rehabilitation area has been extended to the west to meet the 30ha requirement. It is anticipated that the 1.7ha left open due to the stockpile space will become vegetated through natural regrowth with seed stock from the adjoining planted areas. This 1.7ha will therefore be additional NE in excess of the area required under the EA.

The northern edge of the NE area is defined by the top of a gully which runs down to the railway easement. The steepness of the gully precludes planting in this area due to safety issues however it is anticipated that natural regrowth will result in the extension of the NE area towards the edge of the existing remnant vegetation patch. The north-western edge of the NE area is defined by the area disturbed by mining and limited by a buffer zone established prior to mining to protect existing vegetation further to the west and south of the railway line.

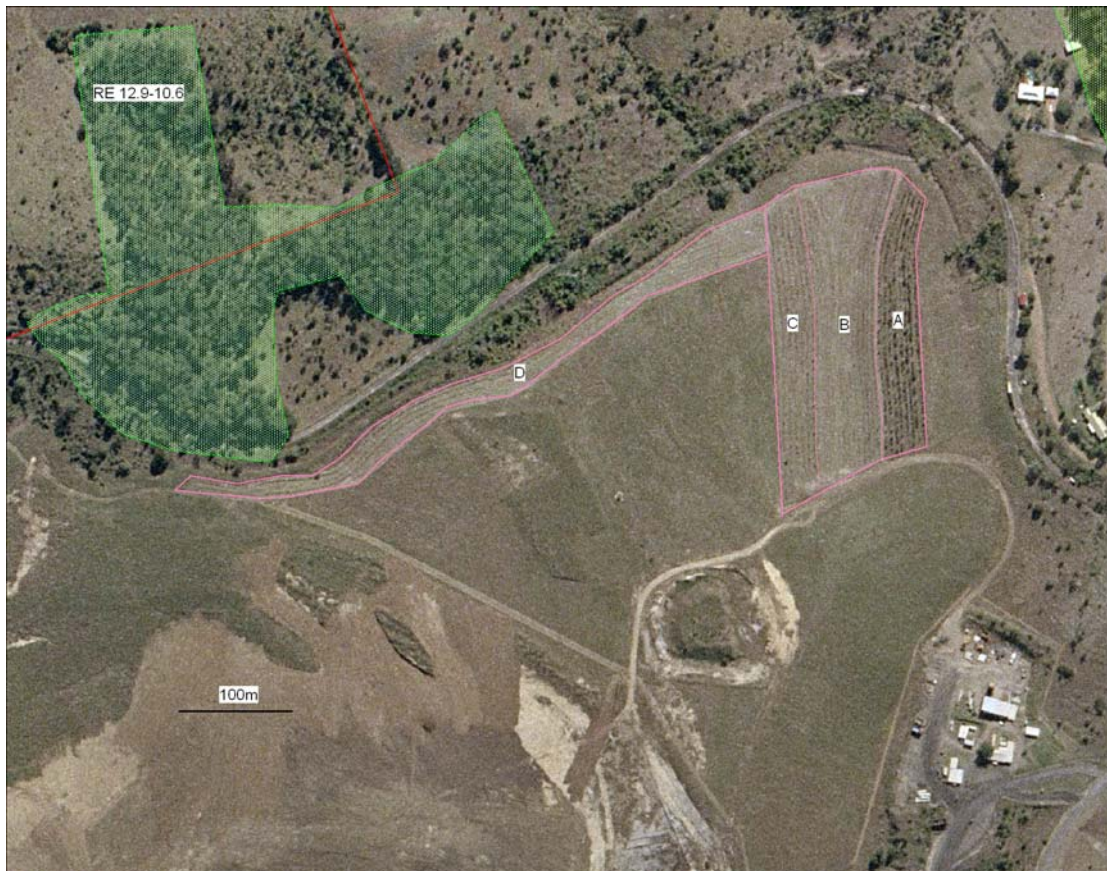
**Figure 4-1 Existing NE rehabilitation areas as at October 2006**

Figure 4-1 shows the location of the existing NE rehabilitation areas with the details of each area presented in Table 4-1.

Survival and growth rates in areas B, C and D have been affected by the drought conditions and it is likely that some supplementary planting will be required in these areas.
