# Progressive Rehabilitation and Closure Plan

## Wards Well Mine

| <b>Document title</b> | Progressive Rehabilitation and Closure Plan |
| <b>Version number</b> | V3.0 |

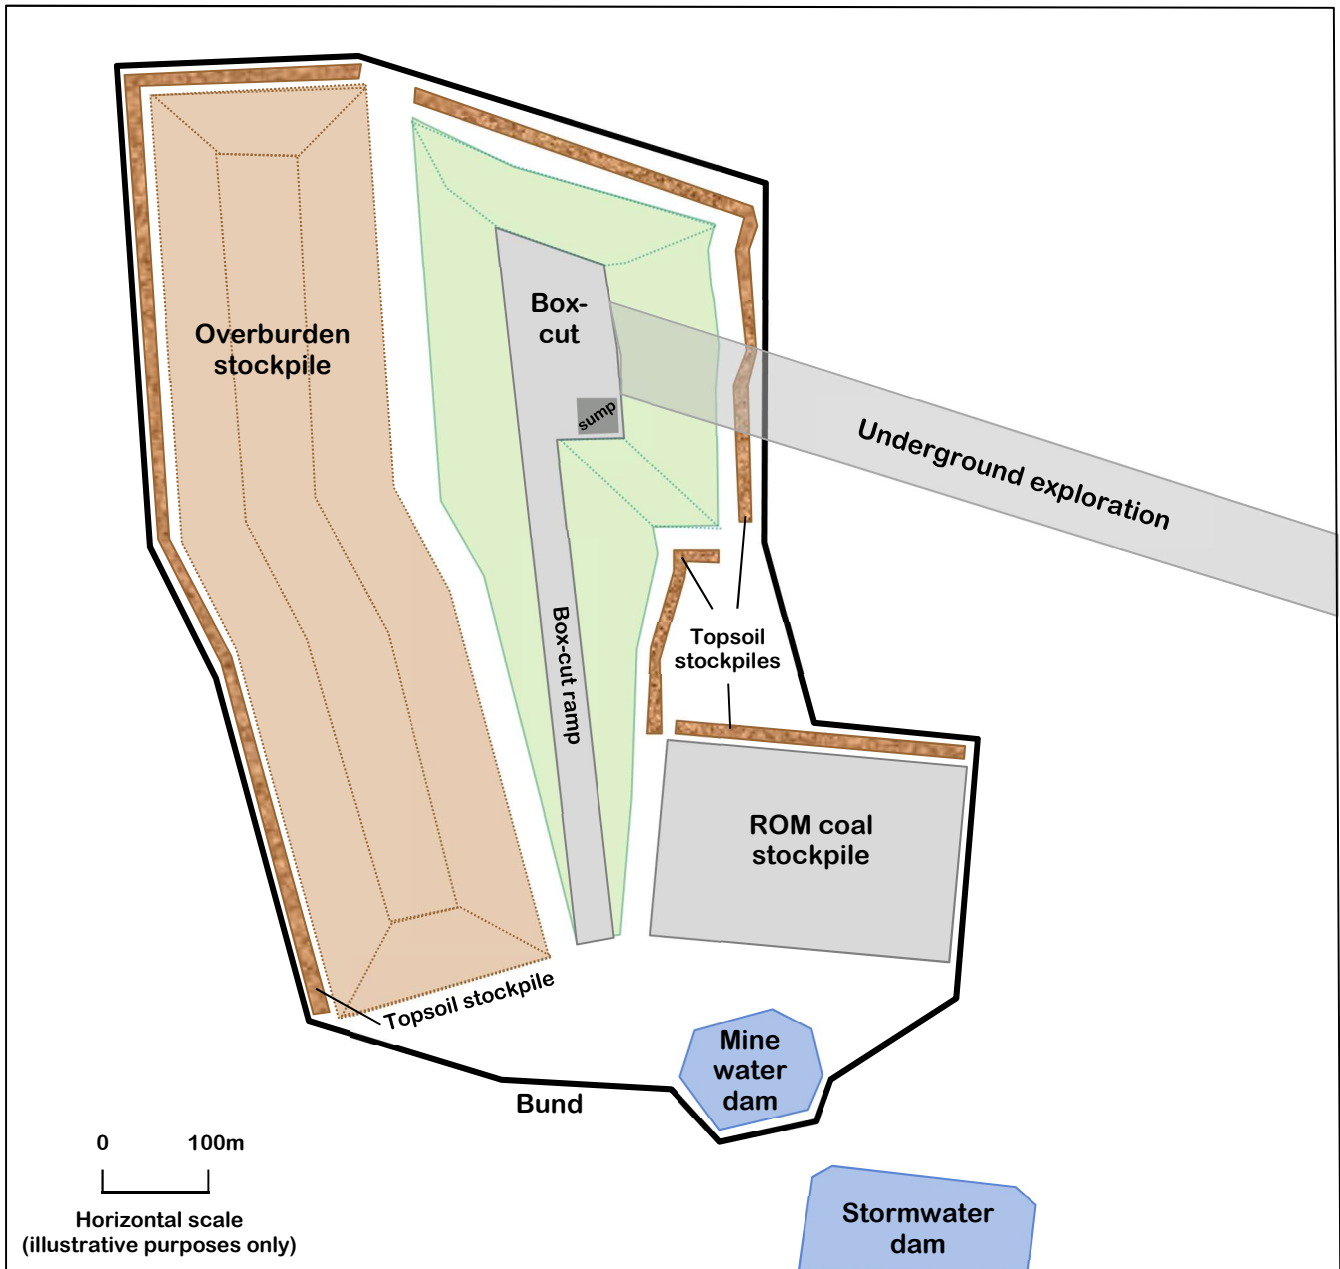
**Figure 4: Wards Well conceptual bulk sample layout**

Figure 4 further schematically illustrates the conceptual bulk sample layout with reference to some of the primary mine features and maintained infrastructure.

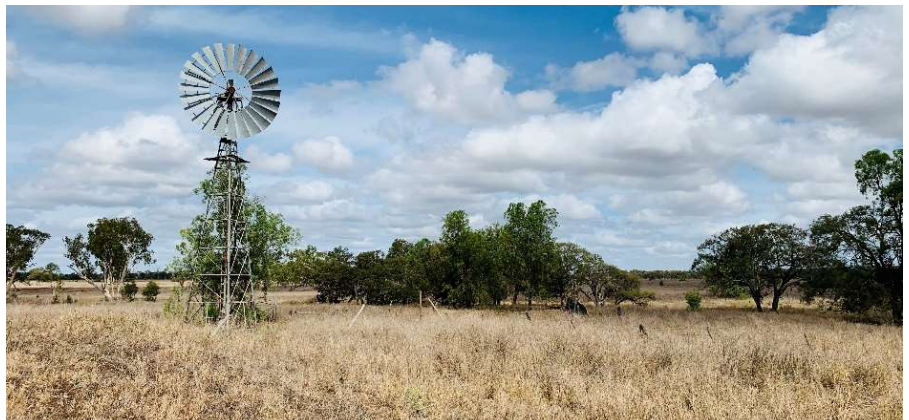
**Figure 5: General site topography at Wards Well**

The site's topographical features are consistent with the regional landscape and consist of level plains and gently undulating plains and rises. The slope across the majority of the site is between 1-2%, sloping gently towards the southwest (Figure 5). Steeper slopes up to 11% exist in the far north and on the south-eastern parts of the site. Within the footprint of the Wards Well area, the highest ground elevations lie within the north-west (about RL380) with the lowest in the middle of the area toward the western boundary (about RL310).

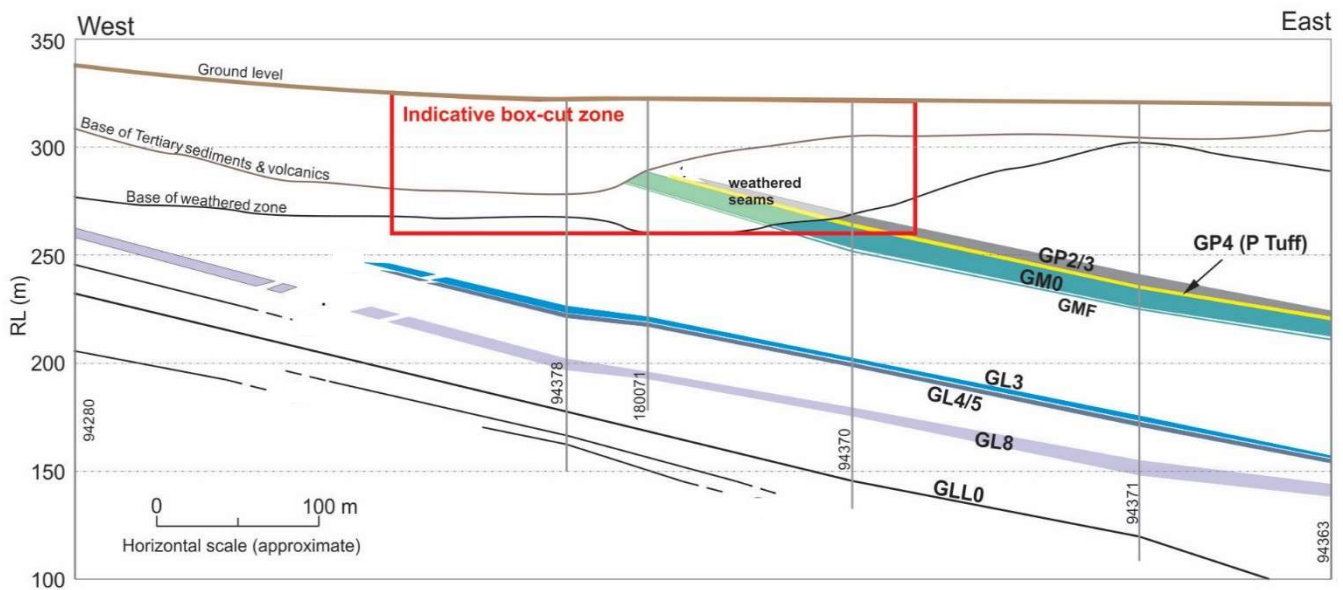
**Figure 6: Geological cross-section from west to east through the Wards Well box-cut**

The Goonyella Lower (GL) seam, which lies below the GM seam, is not expected to be encountered within the box-cut. Each seam group has several plys, which split and coalesce. The 'target' seam for the underground exploration is the GM0 ply of the GM seam. The coal seams are named using the standard convention for the region.

Geological units in the box-cut area are diagrammatically shown in a geological cross-section from west to east through the box-cut (Figure 6). The coal measures are overlain by Tertiary sediments and weathered and fresh Permian.

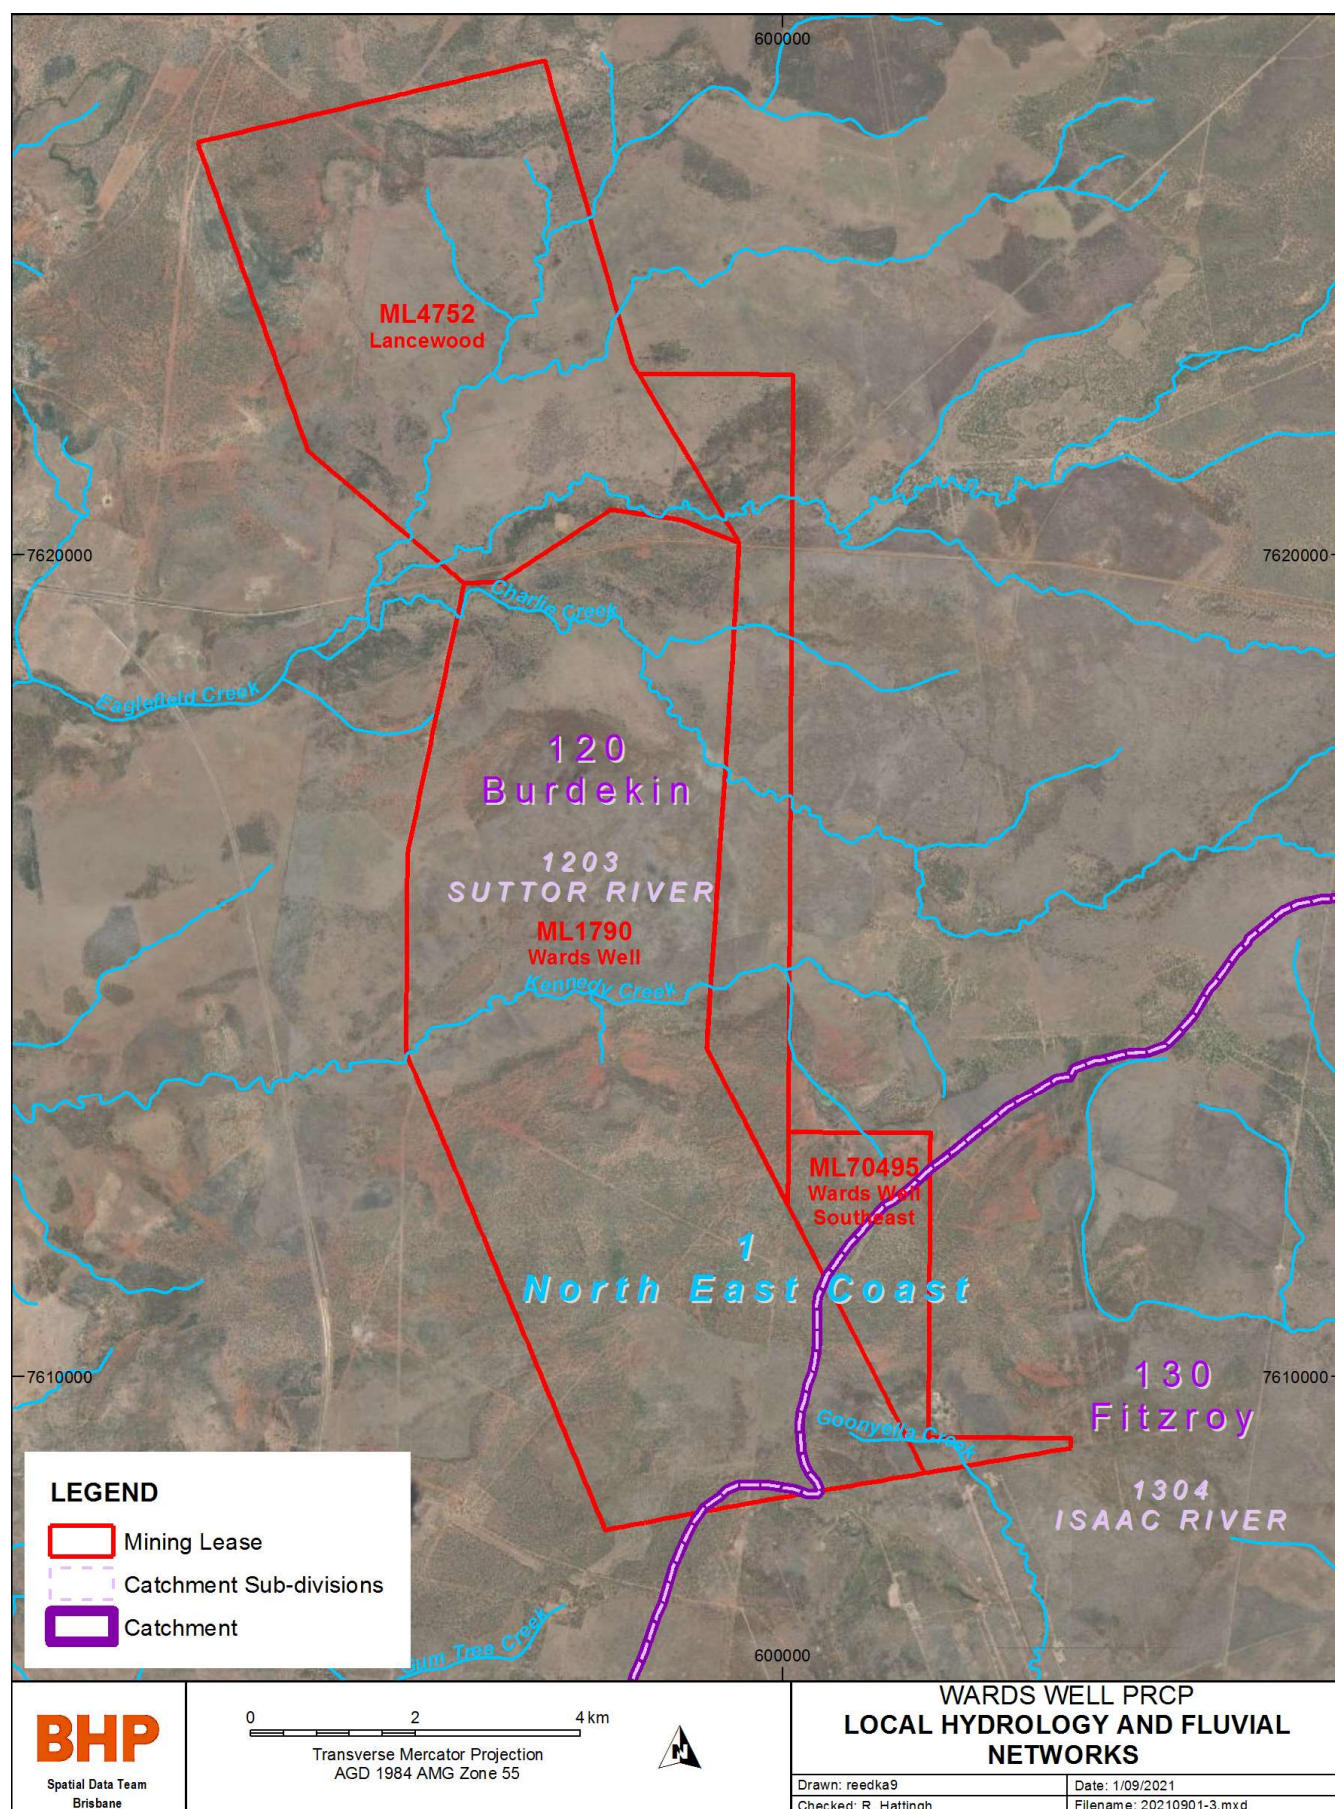
Figure 8: Wards Well fluvial networks and basins

The location of the approved box-cut and bulk sampling activities under the EA are located on ML4752, which is entirely located within the Burdekin Basin. The area of the approved activities predominantly slopes towards the south/south-west towards an unnamed ephemeral tributary of Eaglefield Creek.

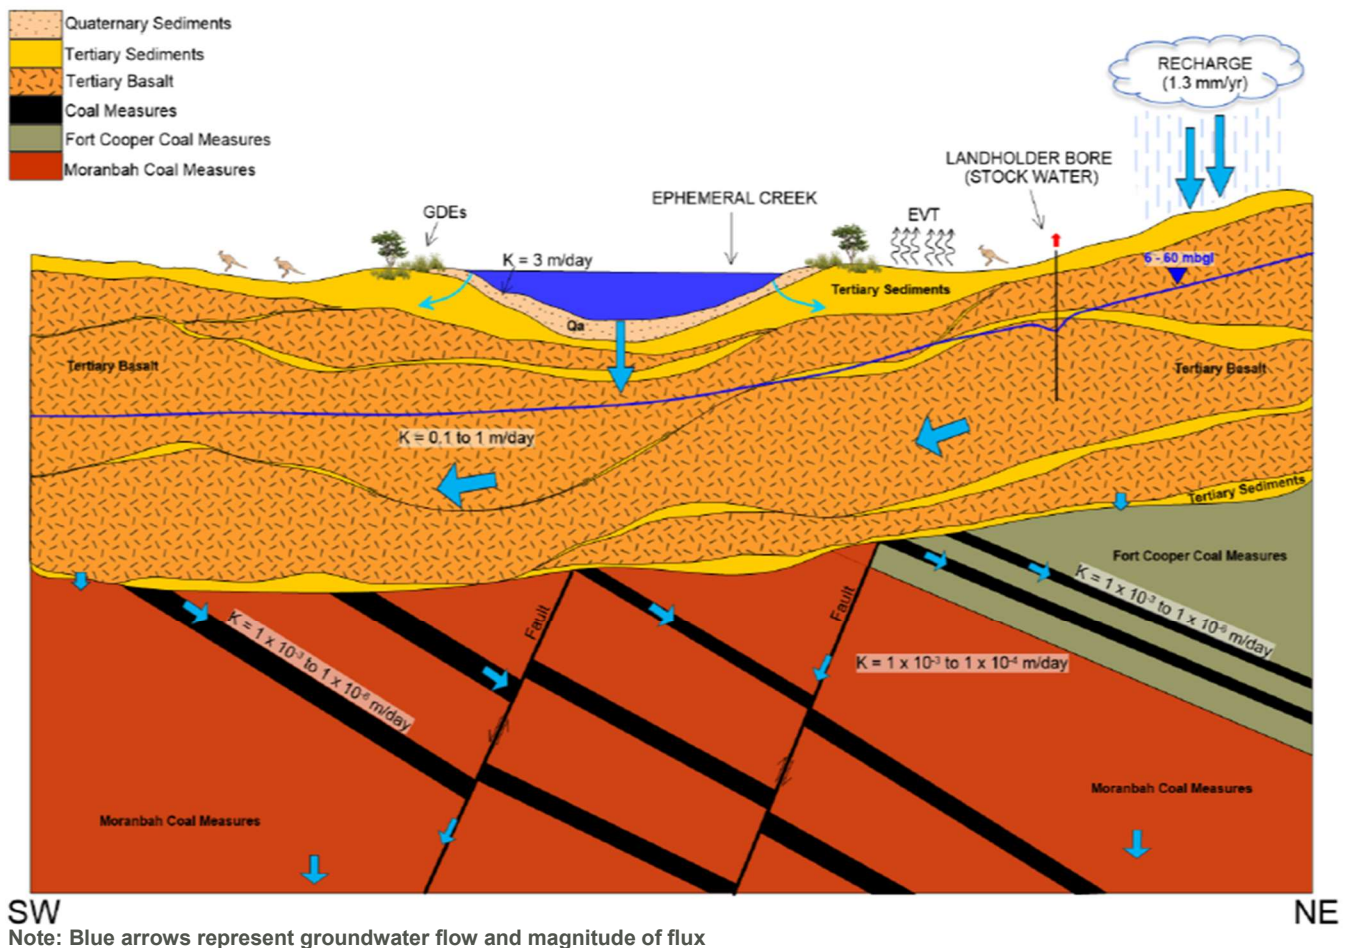
**Figure 9: Wards Well baseline hydrogeological conceptual model (Golder, 2020)**

The groundwater levels and properties for the identified hydrostratigraphic units at Wards Well include the following:

A baseline hydrogeological conceptual model<sup>11</sup> illustrating the above hydrostratigraphic units and groundwater flows is illustrated in Figure 9.

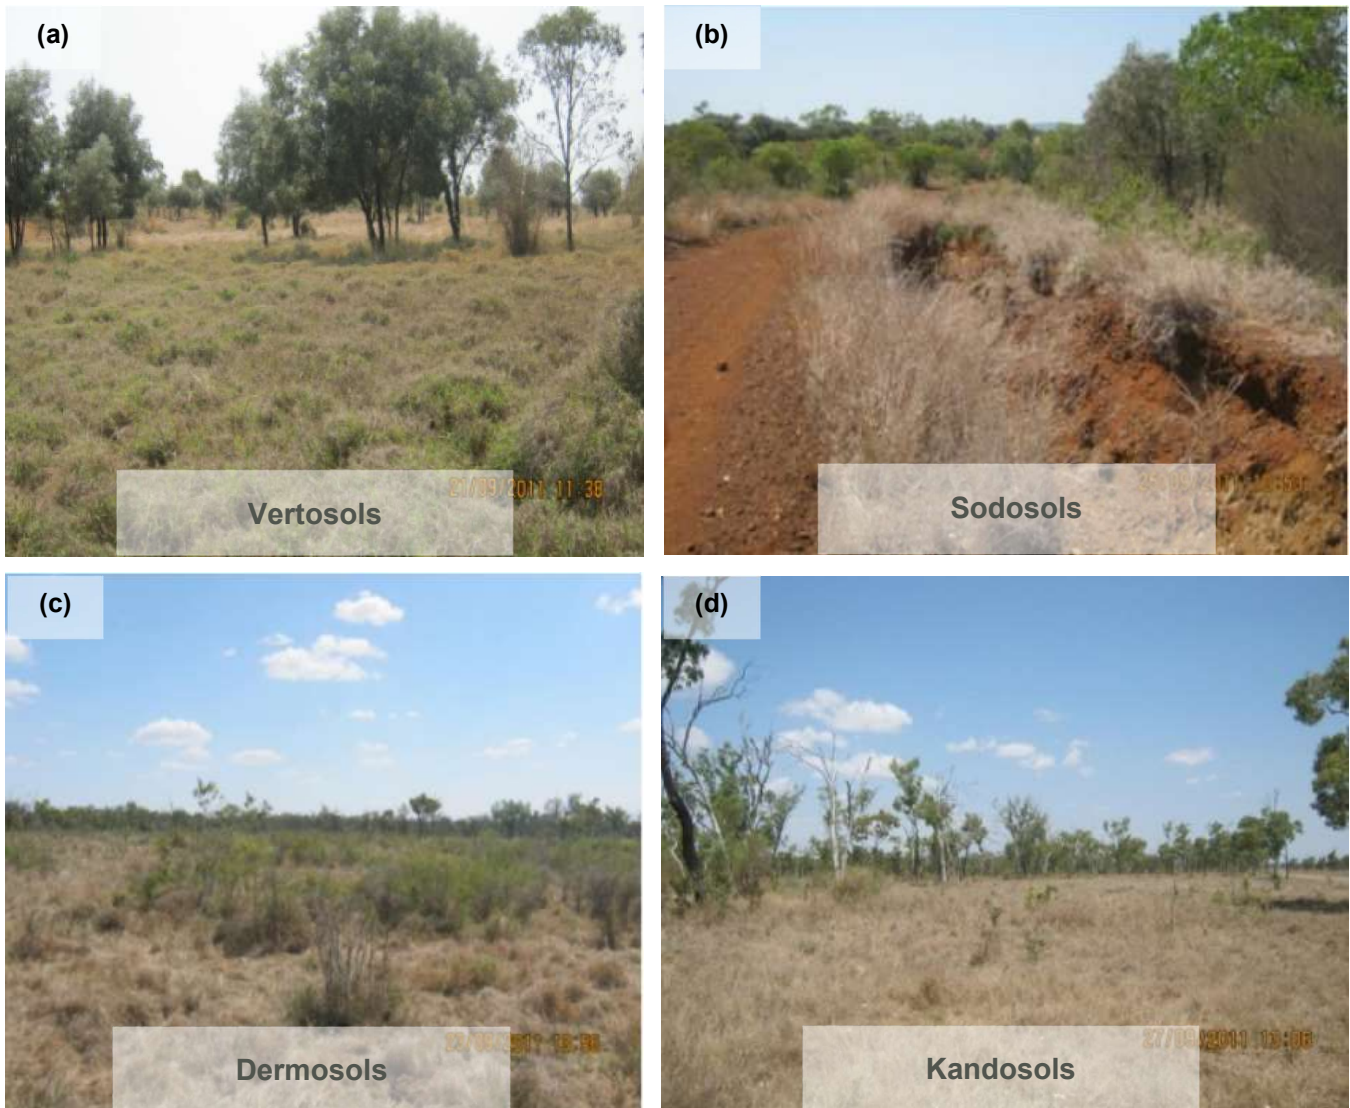
**Figure 12: Areas in Wards Well that are characteristic of the local soil types and associated vegetation - (a) Brigalow and grasslands with cattle grazing on cracking clay Vertosols; b) Ironbark, Brigalow and erosion-prone areas on Sodosols; c) Low shrubs and grassland with cattle grazing on Dermosols and d) Open grasslands with remnant vegetation and cattle grazing on Kandosols**

Figure 12 illustrates various areas in Wards Well that are characteristic of the local soil types and associated vegetation.

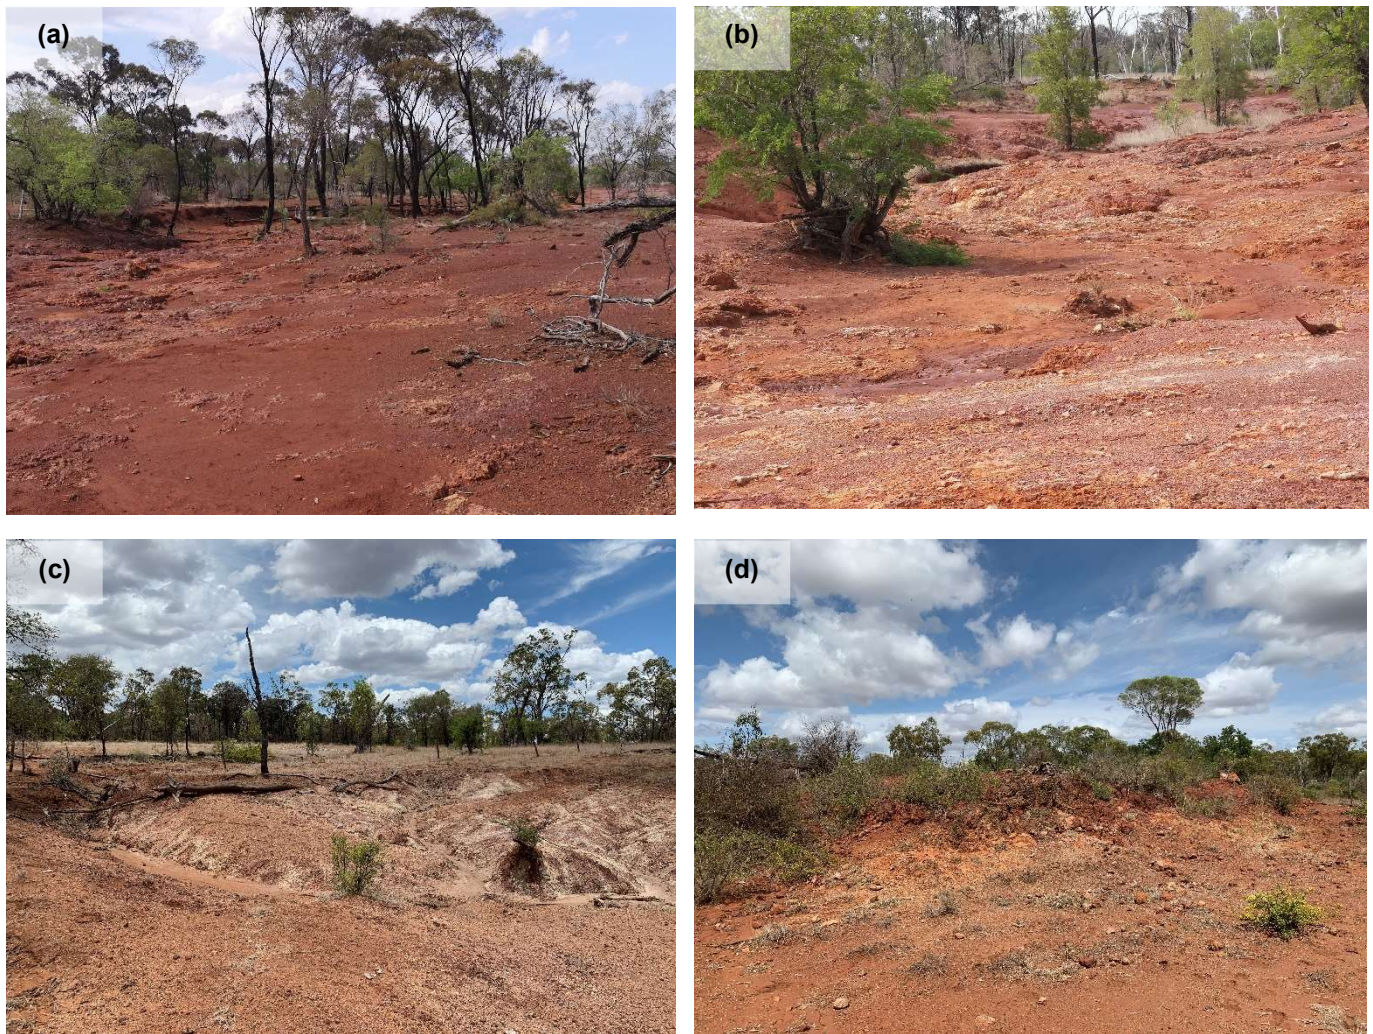
**Figure 13: Evidence of surface erosion due to existing grazing activities and historical land clearance in the Wards Well area - a) Sheet erosion adjacent to creek; b) Stream bank erosion; c) Sheet erosion leading to flow concentrating features and d) Stream bank erosion**

The regional topography is dominated by flat to gently sloping landforms which is consistent with the landscape at Wards Well. In the context of land stability, erosion is isolated to areas of the landscape where land use has exposed soil types with limited erosion resistance. Pre-mining surface erosion in drainage areas and creek crossings is evident across the site and is mainly associated with existing grazing activities and historically cleared areas. During the soil survey, erosion was noted at 16 of the 98 sample locations and on all four soil types. Erosion was most prevalent on Sodosols in the north-east of Wards Well and will have a tendency to be unstable if not ameliorated post-disturbance. Stream bank erosion was also identified within drainage lines, and sheet erosion on land adjacent to dirt tracks (Figure 13).

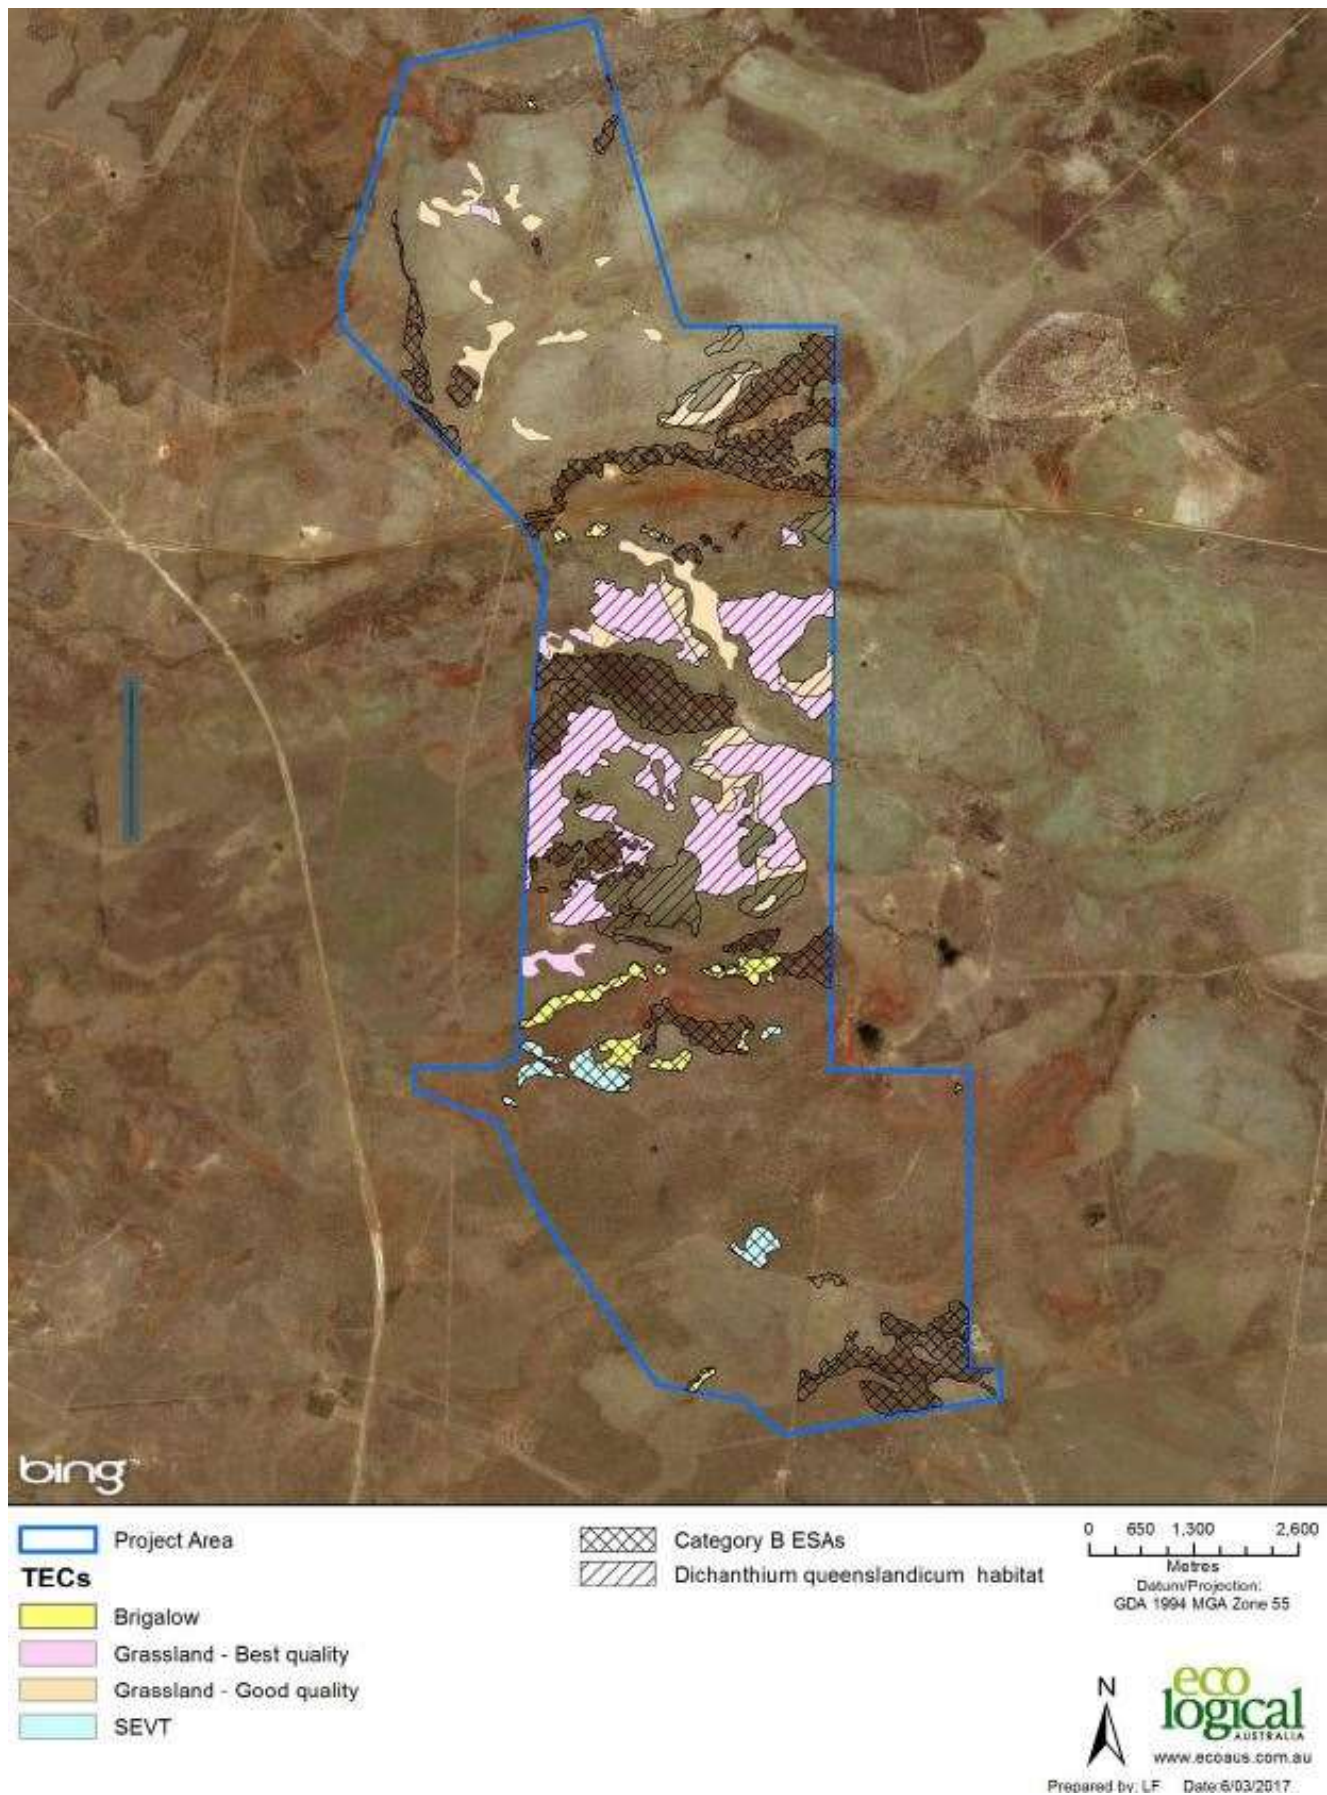
Figure 14: Wards Well Threatened Ecological Communities mapping

The Brigalow TEC was identified in small patches across the site, within a total area of 91.2ha (Figure 14). Natural Grasslands dominate the centre and north of the area - patches meeting the key diagnostic and condition threshold of the TEC in good quality were identified within an area of 234.0ha and best quality within 552.4ha (Figure 14). SEVT TEC was identified in small patches in the south, within an area of 57.5ha (Appendix 6) (Figure 14)<sup>16</sup>.

Figure 3 indicates the initial mapping of Category B ESAs associated with Endangered REs as approved under the EA and includes a 500m shaded buffer area; Figure 14 indicates updated ESA mapping from ground-truthed surveys (Appendix 5 and Appendix 6).

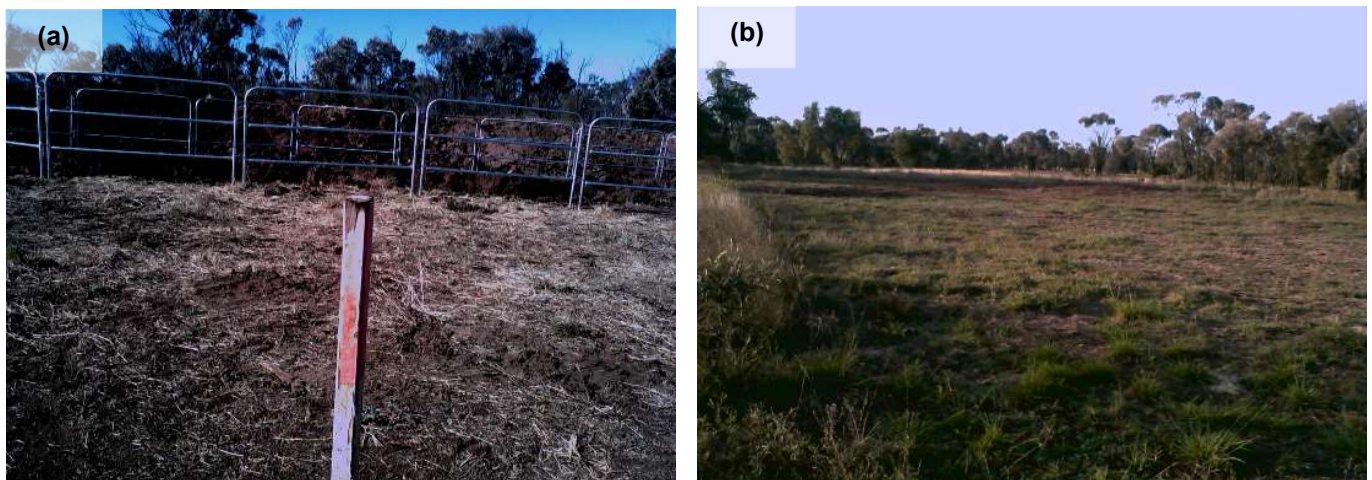
**Figure 17: Wards Well drill site ML1790 DB12 before and after rehabilitation – a) prepared for drilling, and b) rehabilitated**

The existing rehabilitation of drill sites – and the subsequent trajectory towards achievement of milestone criteria, has been determined based on a combination of aerial imagery analysis before and after approved drilling programs, as well as by field visits which have indicated the self-regeneration of pastures on rehabilitated drill sites (Figure 17b).

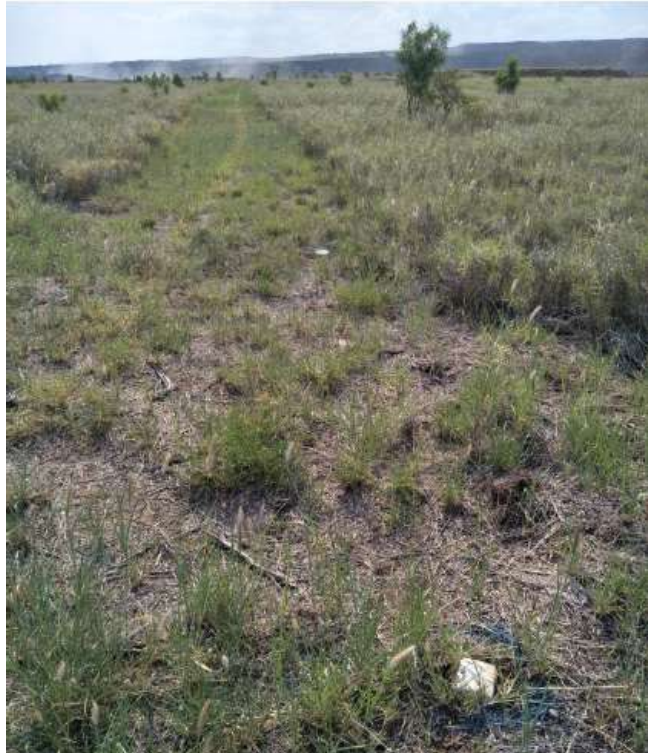
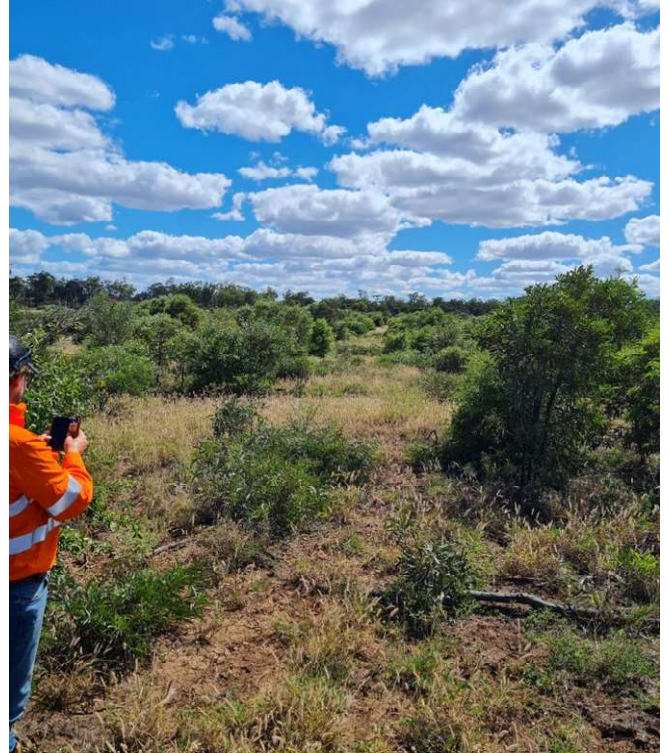
**Figure 18: Wards Well seismic activities – comparison on slashing and natural regeneration re-growth**

BHP Coal has adopted a minimal disturbance approach for line preparation for 3D seismic programs. Where possible, slashing-only is adopted as the preferred practice, leaving grass at 10cm high (Figure 18a).

**a) Slashed seismic lines**

**b) Re-growth (natural regeneration) through seismic lines**

Due to the minimal disturbance approach when undertaking seismic assessments, the rehabilitation process for seismic disturbance is 'natural regeneration.' This approach is illustrated for grassland vegetation and regrowth vegetation at Wards Well in Figure 18(b). The seismic activities do not disturb the ground or topsoil layer, and therefore no soil rehabilitation is required. Furthermore, as the existing vegetation is only slashed, the vegetation and plant species disturbed reshoot from their stable root bases. The same species are therefore present after seismic activities as prior to disturbance, negating the need for any revegetation activities.

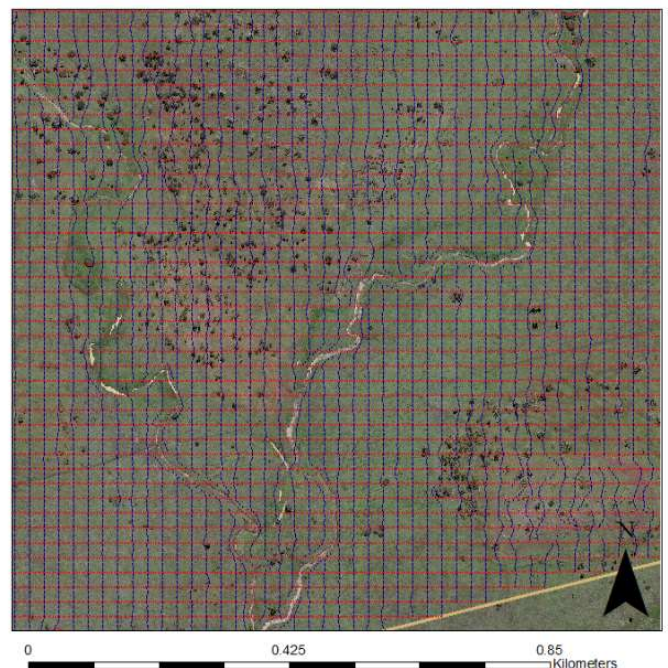
**Figure 19: Example 3D seismic program – minimal disturbance approach**

Seismic programs are typically 50m x 50m grid patterns with 3m wide paths. The grid lines are accessed by light vehicles and a medium sized seismic vehicle. Figure 19 depicts the results of 3D seismic at Wards Well, indicating where creeks and specific vegetation was avoided by vehicle tracks (blue); the red points were receivers which had the option of being hand carried, enabling the points to be positioned as designed without disturbance.

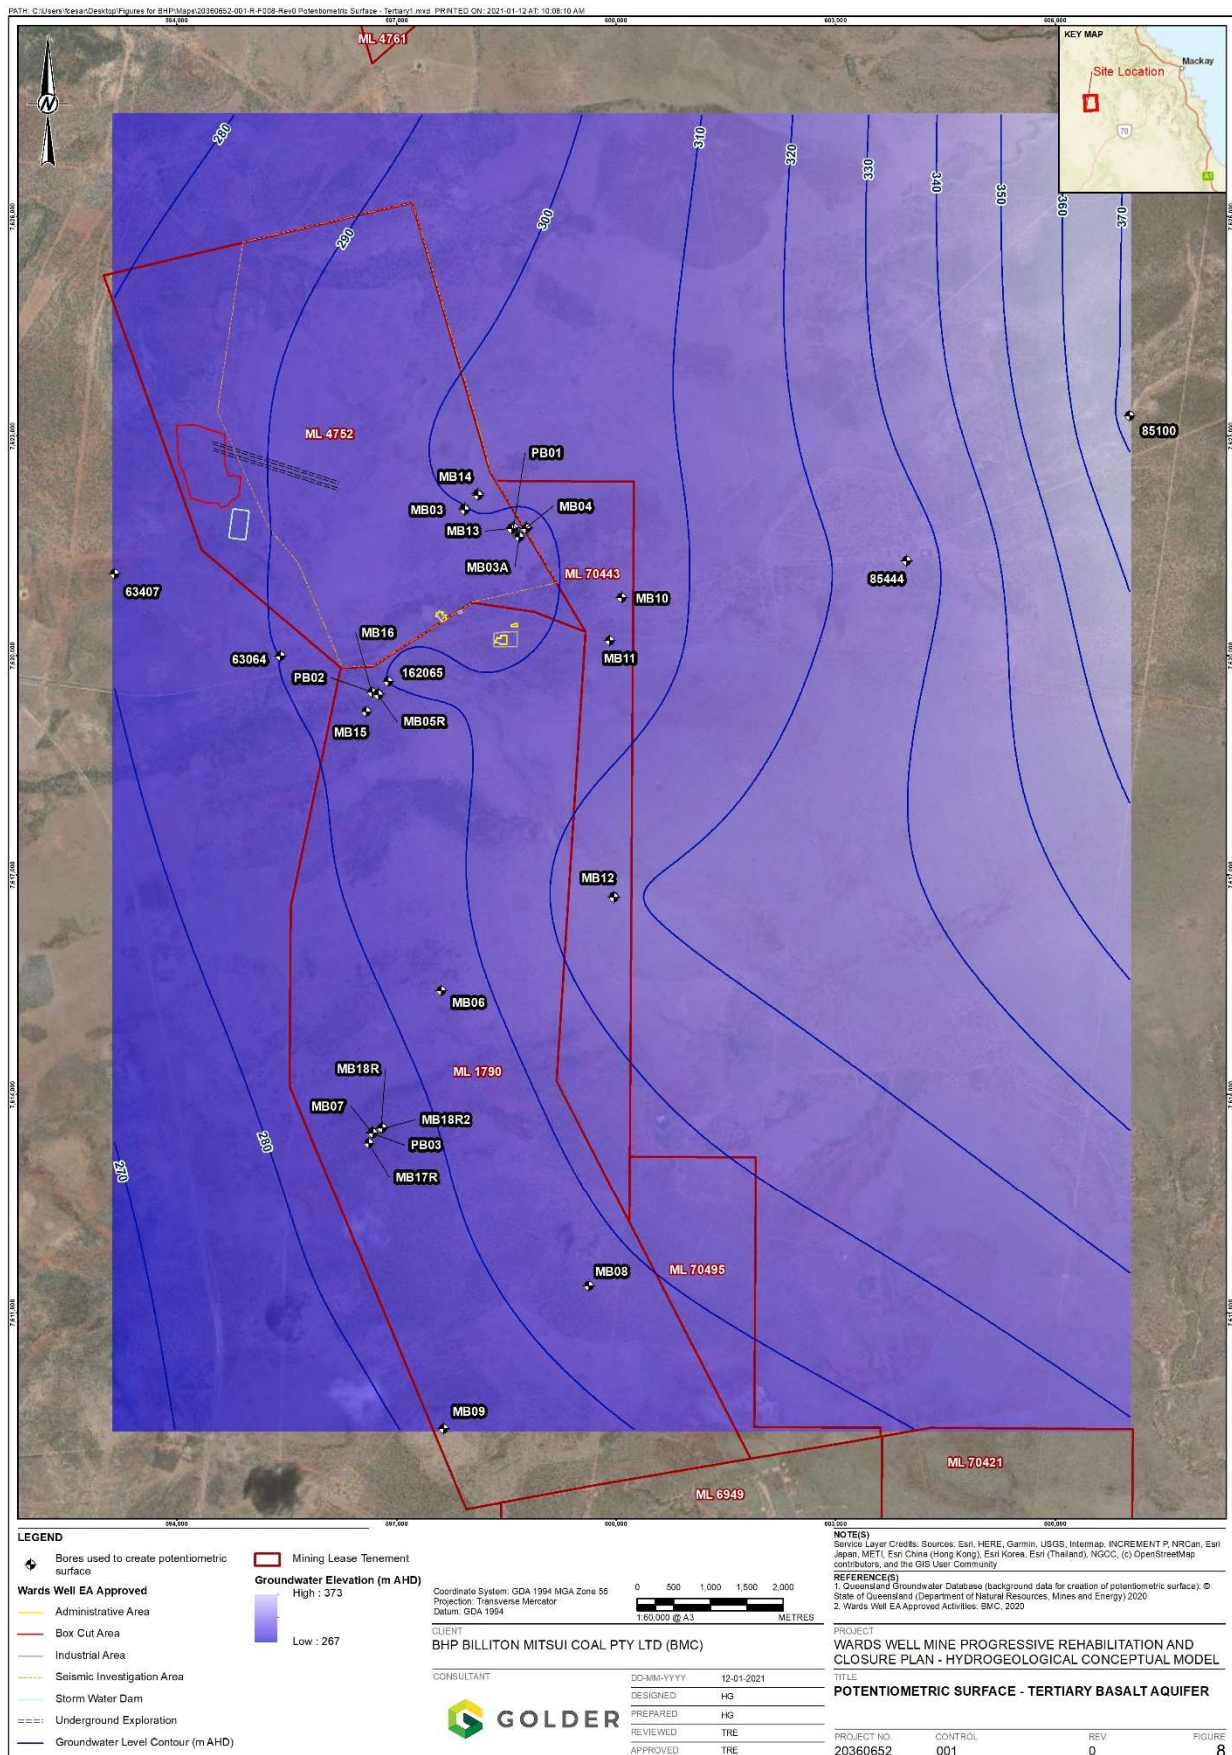
Figure 20: Potentiometric surface-tertiary aquifer for Wards Well area

Due to the compartmentalised nature of the basalt aquifers, and the relatively small footprint and depth of the box-cut, the spatial propagation of the basalt aquifer drawdown is expected to be limited. In addition to this, as the void is to be backfilled, it not expected to act as a long-term sink for the basalt aquifer. As the basalt aquifer is readily recharged by seasonal rainfall infiltration, any draw down that occurs during excavation works is expected to recover post backfilling to levels that are representative of pre-mining conditions. Therefore, impacts on local groundwater use are expected to be negligible and existing registered bores are unlikely to be impacted.

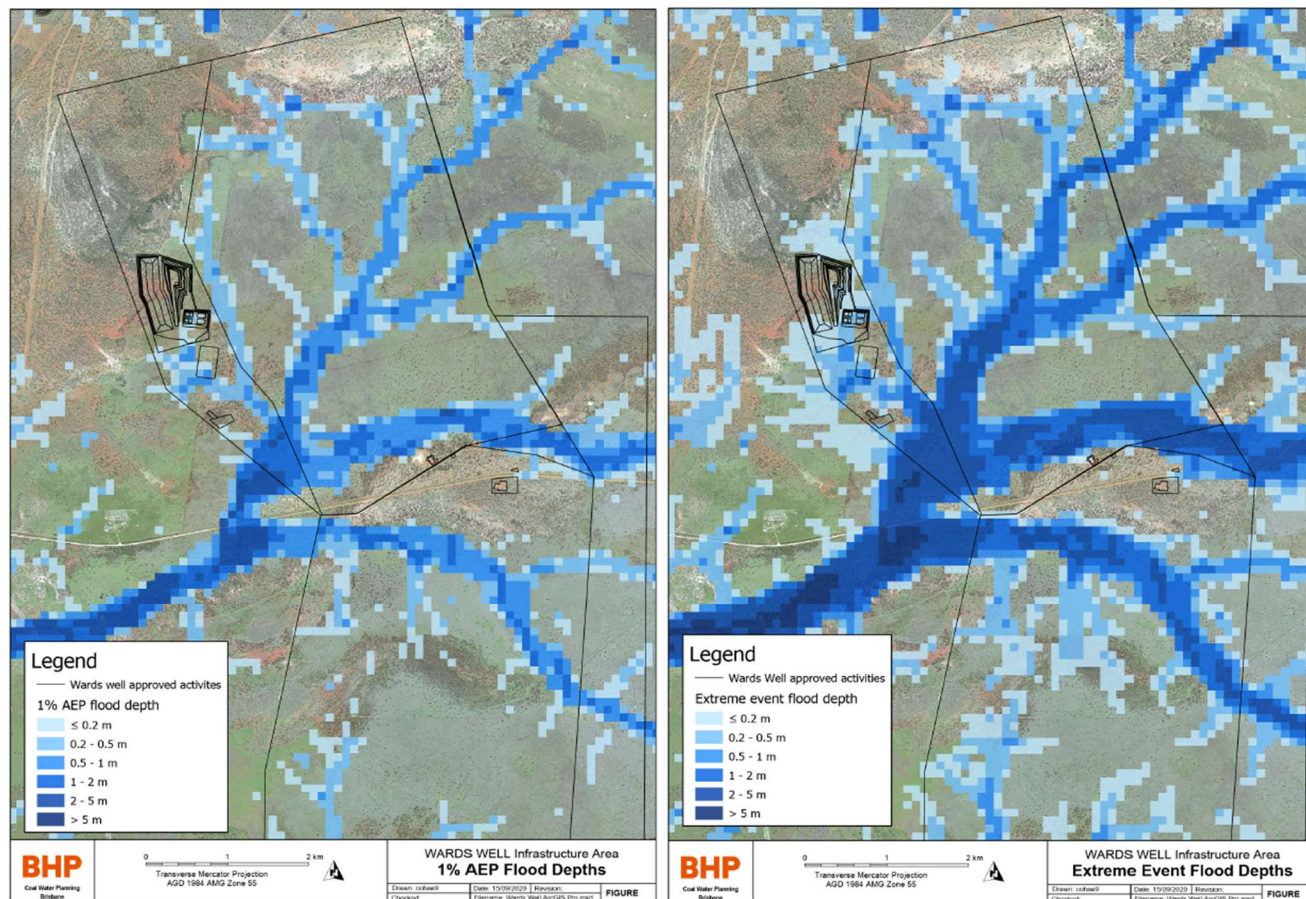
Figure 22: DNRME 1% AEP flood depths (left) and extreme event flood depths (right)

- The DNRME flood mapping (Figure 22) indicates only limited impact to the undisturbed and seismic areas from a 1% AEP flood event, with no flood impact on the box-cut area. The Extreme Event flood impact is predicted to be limited to  $\leq 0.2\text{m}$  flood depth on the south-east of the backfilled box-cut (noting the final landform level will be 0.6m above existing surface and therefore will not be subject to flood inundation);
- The approved activities do not require diversion or interruption of creeks or streams; and
- There are no fourth order or higher streams present on the Wards Well mining area.

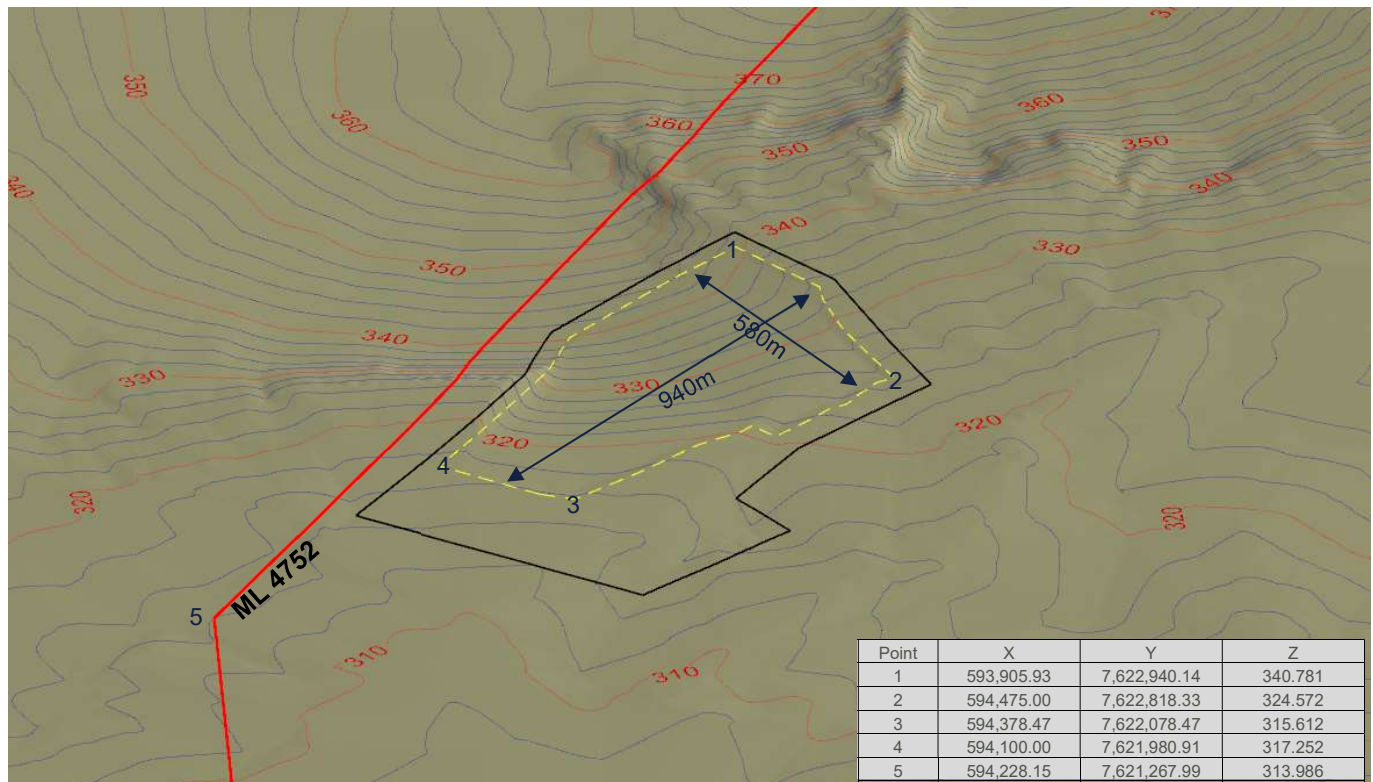
**Figure 23: 3D post-mining landform design – 2m contours, outline of box-cut and overburden stockpile area and key co-ordinates**

The approved activities on-site will result in a final landform virtually unchanged from the pre-mining landform, with only a minor height increase in the box-cut and overburden stockpile area. The 3D post-mining landform design with 2m contours is shown in Figure 23. The black outline represents the black outline of the bulk sample disturbance area as shown in Figure 3; and the yellow dash outline is the box-cut and overburden stockpile area which is approximately 0.6m higher than the pre-mining landform. All area outside of the yellow outline is not altered from the pre-mining landform.

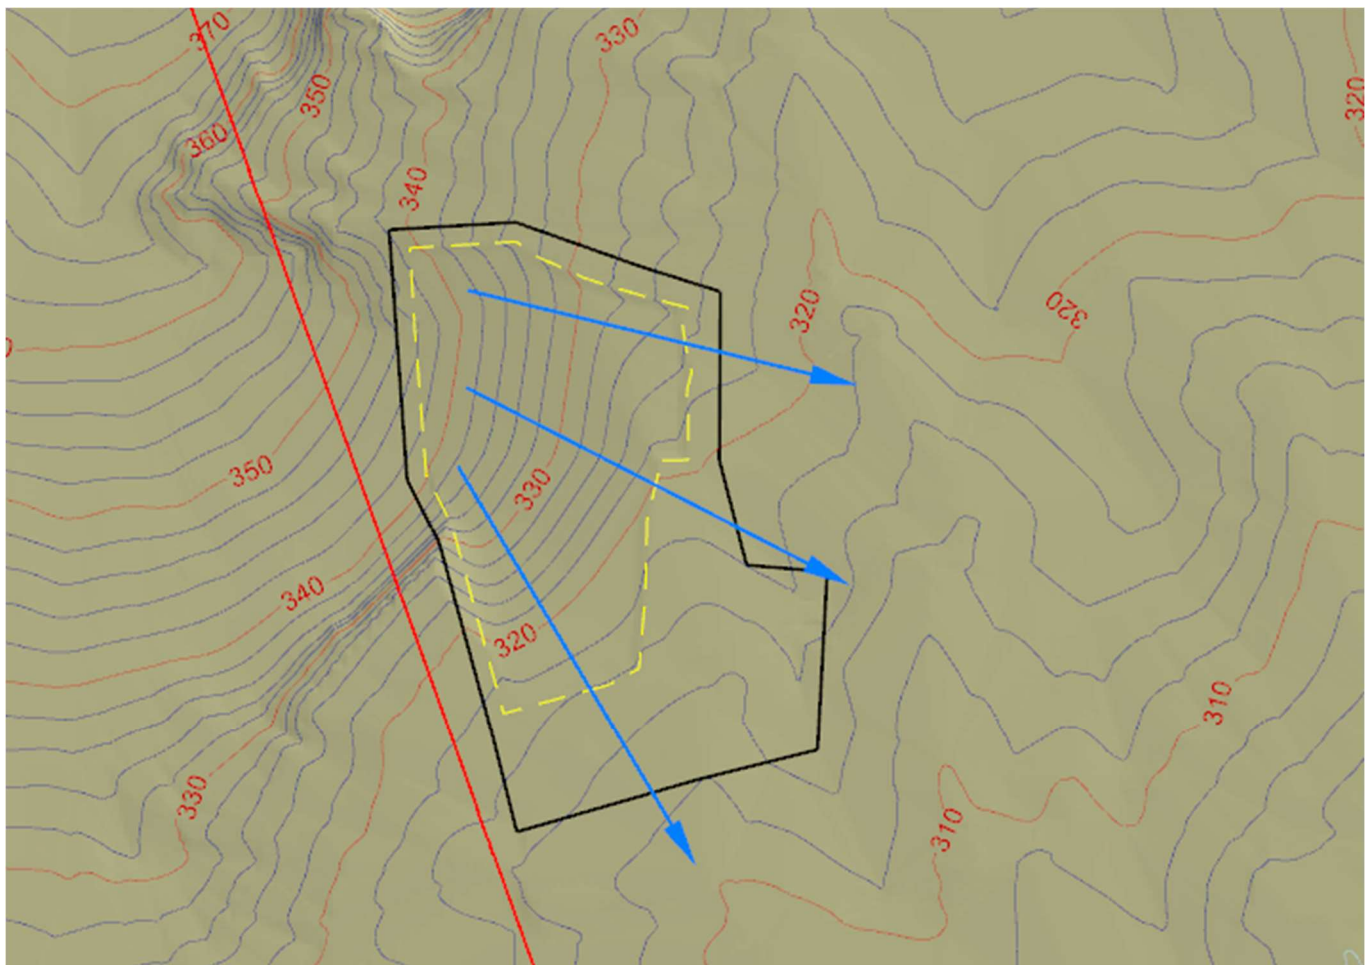
Figure 24: Indicative surface water flow direction of bulk sample area – 2m contours and outline of box-cut and overburden stockpile area

The surface water flow of the bulk sample area is shown in Figure 24.

The black outline represents the bulk sample disturbance area as shown in Figure 3. The final landform will replicate the pre-mining landform except for the box-cut and overburden stockpile area which is an average height of 0.6m above the pre-mining landform (within the yellow dash outline). The ROM pad and dam areas may be slightly altered from the pre-mining levels after the final reshape. The landform will be free-draining and water-shedding and there will be no changes to the pre-mining water flow which directs water towards the south to Eaglefield Creek.
