# Progressive Rehabilitation and Closure Plan

## Wards Well Mine

| <b>Document title</b> | Progressive Rehabilitation and Closure Plan |
| <b>Version number</b> | V3.0 |

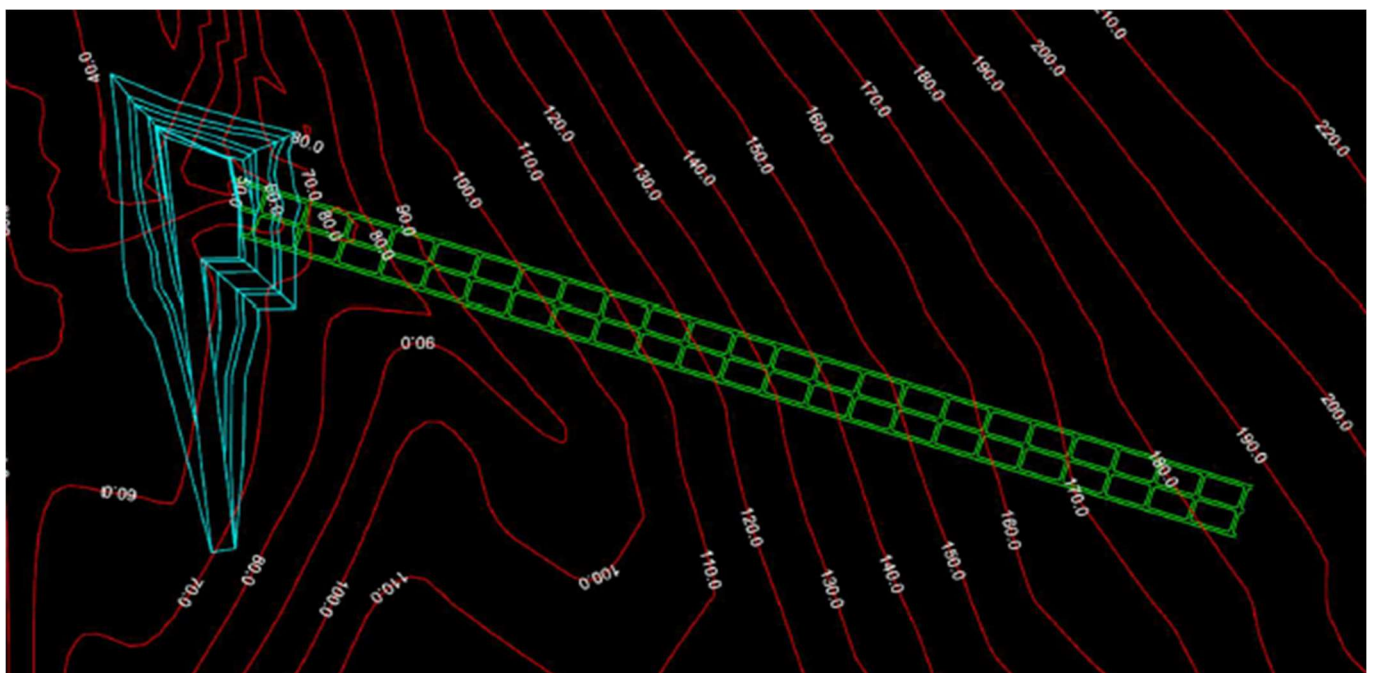
Figure 25: Planned layout of the Wards Well underground exploration area

Three headings are proposed (cutting width of 5.5m and height of 3.4m) and will extend 1800m with pillars 40m wide x 70m long (Figure 25). The three heading system with proposed 45.5m centre to centre spacing provides roadways for ventilation, coal clearance and access. The cut-through width will allow sufficient room for ventilation devices and storage of equipment during the mining processes.

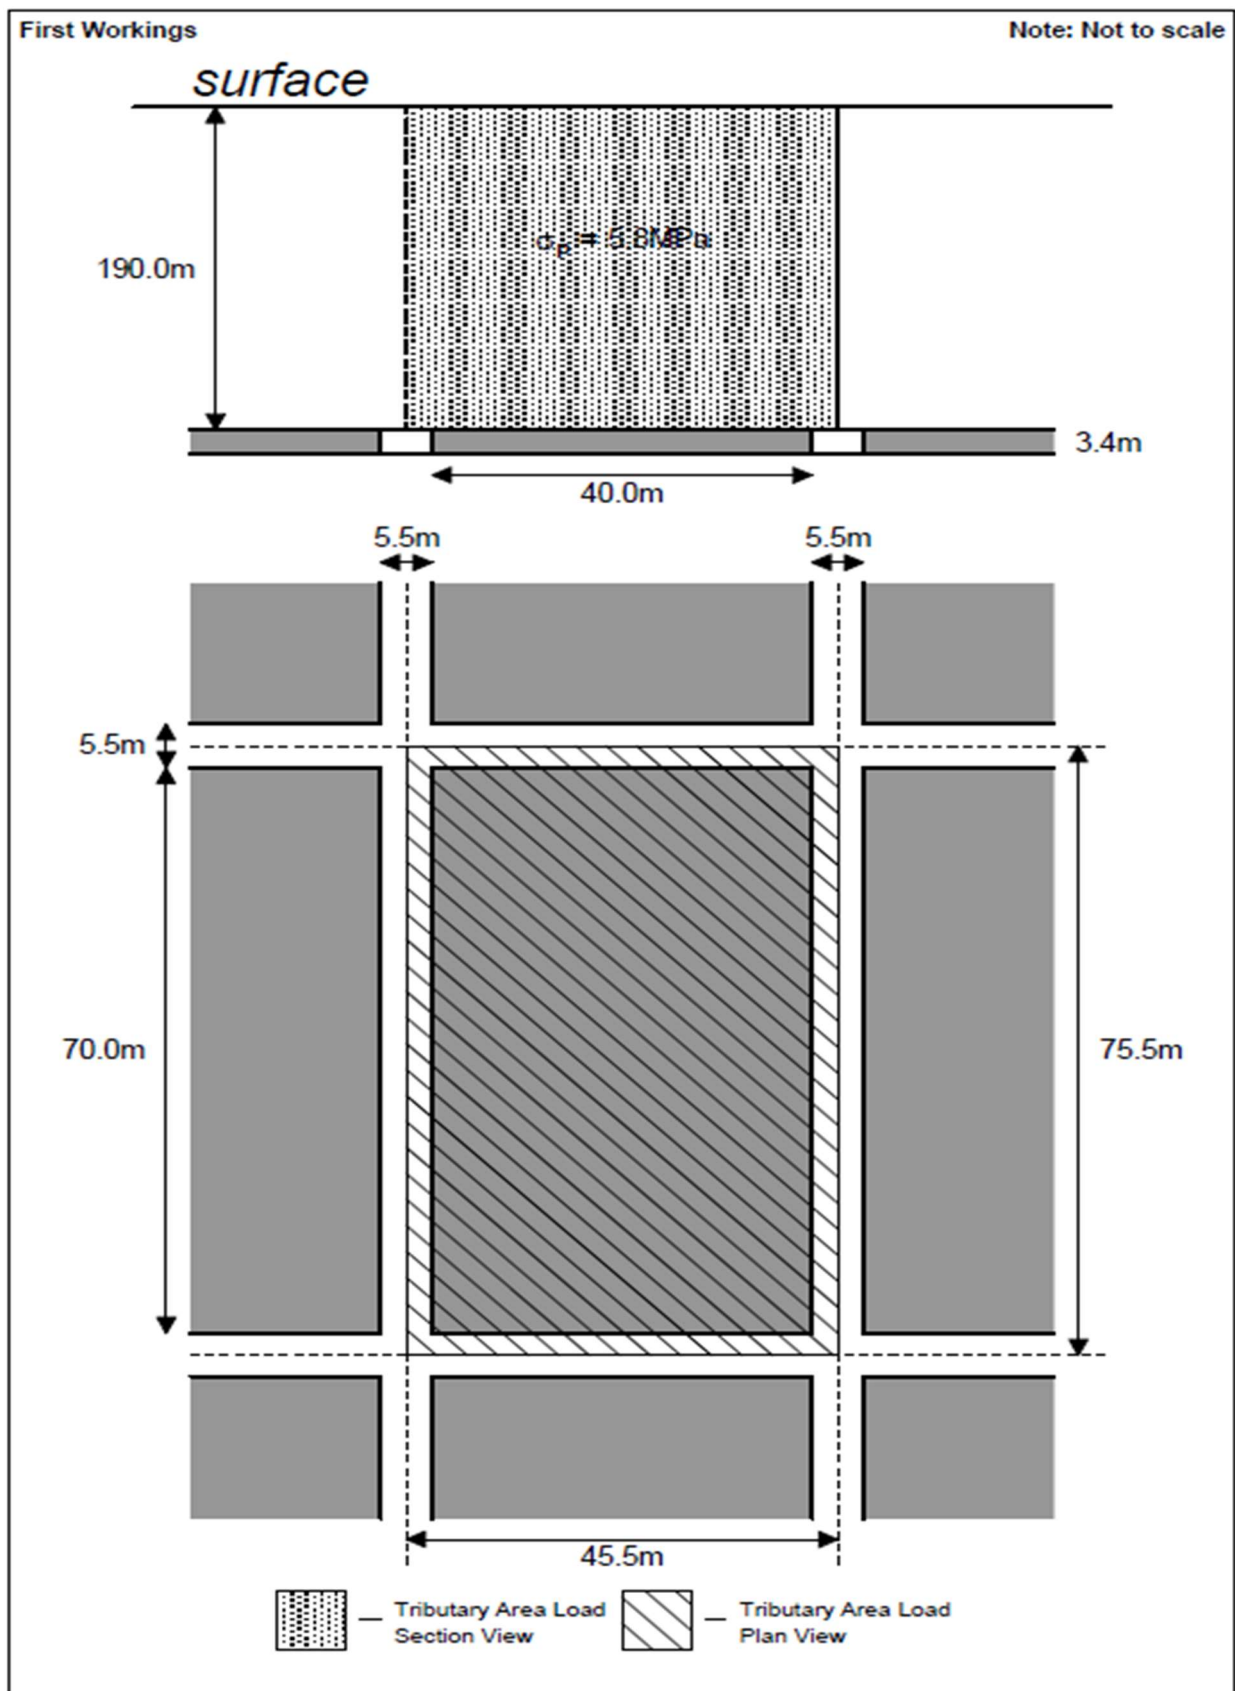
Figure 26: Geotechnical stability analysis (pillar layout, depth) for Wards Well

to the wetting and drying of soils. Therefore, no surface subsidence is expected from the underground exploration.

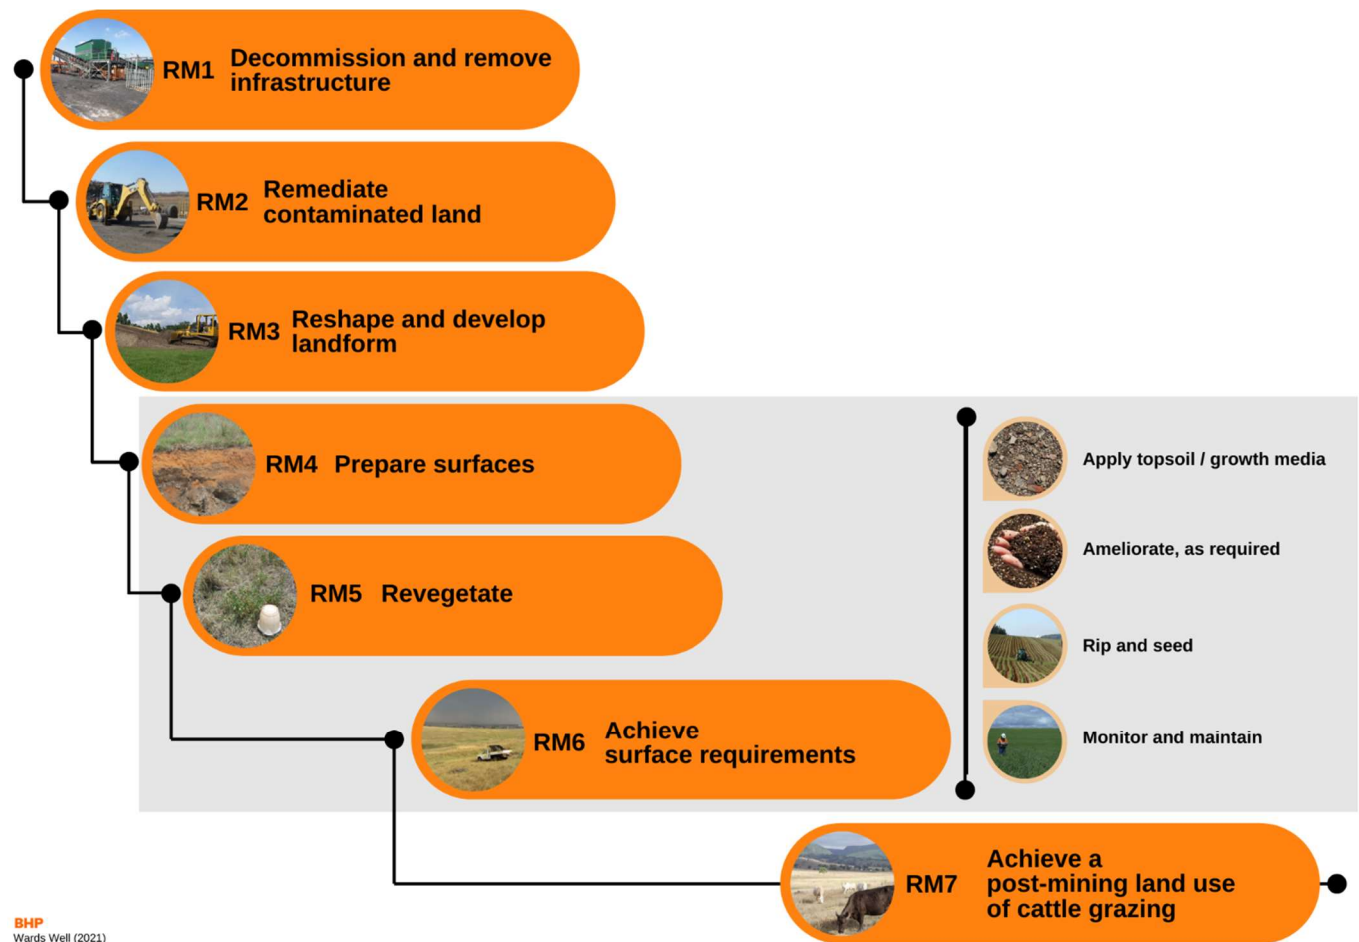
Figure 27: Summary of key rehabilitation and management practices for Wards Well

Figure 27 summarises the Wards Well rehabilitation milestones. Figure 28 provides an indicative timeline that informs the PRCP schedule. Exploration drilling are rehabilitated progressively throughout the timeline.

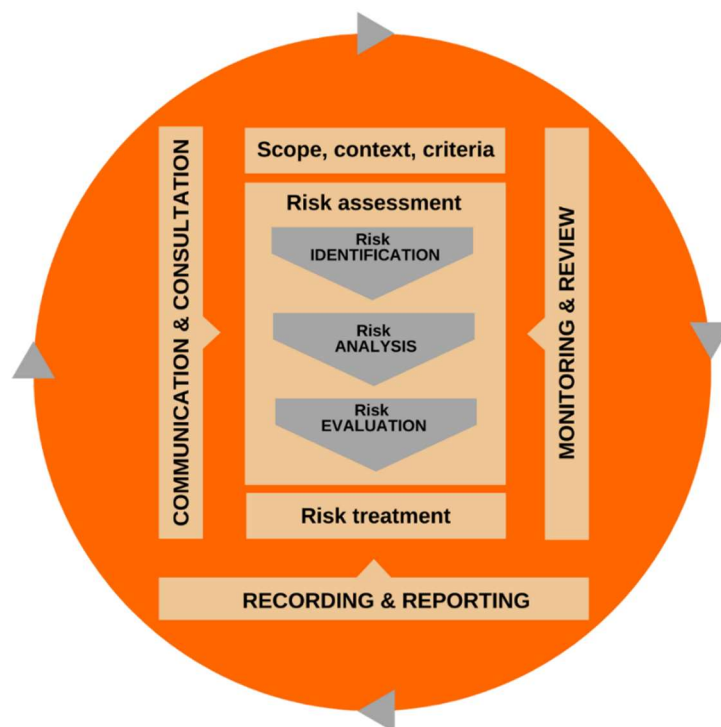
Figure 29: ISO 31000-compliant risk-based approach followed for the Wards Well PRC plan

A risk-based approach to the Wards Well PRC planning has been undertaken (Figure 29).

The risk event - a stable condition for land described as a post-mining land use not being achieved, was assessed per ISO 31000 methodology described in Figure 29 above (the full risk assessment is included in Appendix 12), where stable condition is defined as per section 111A of the EP Act:

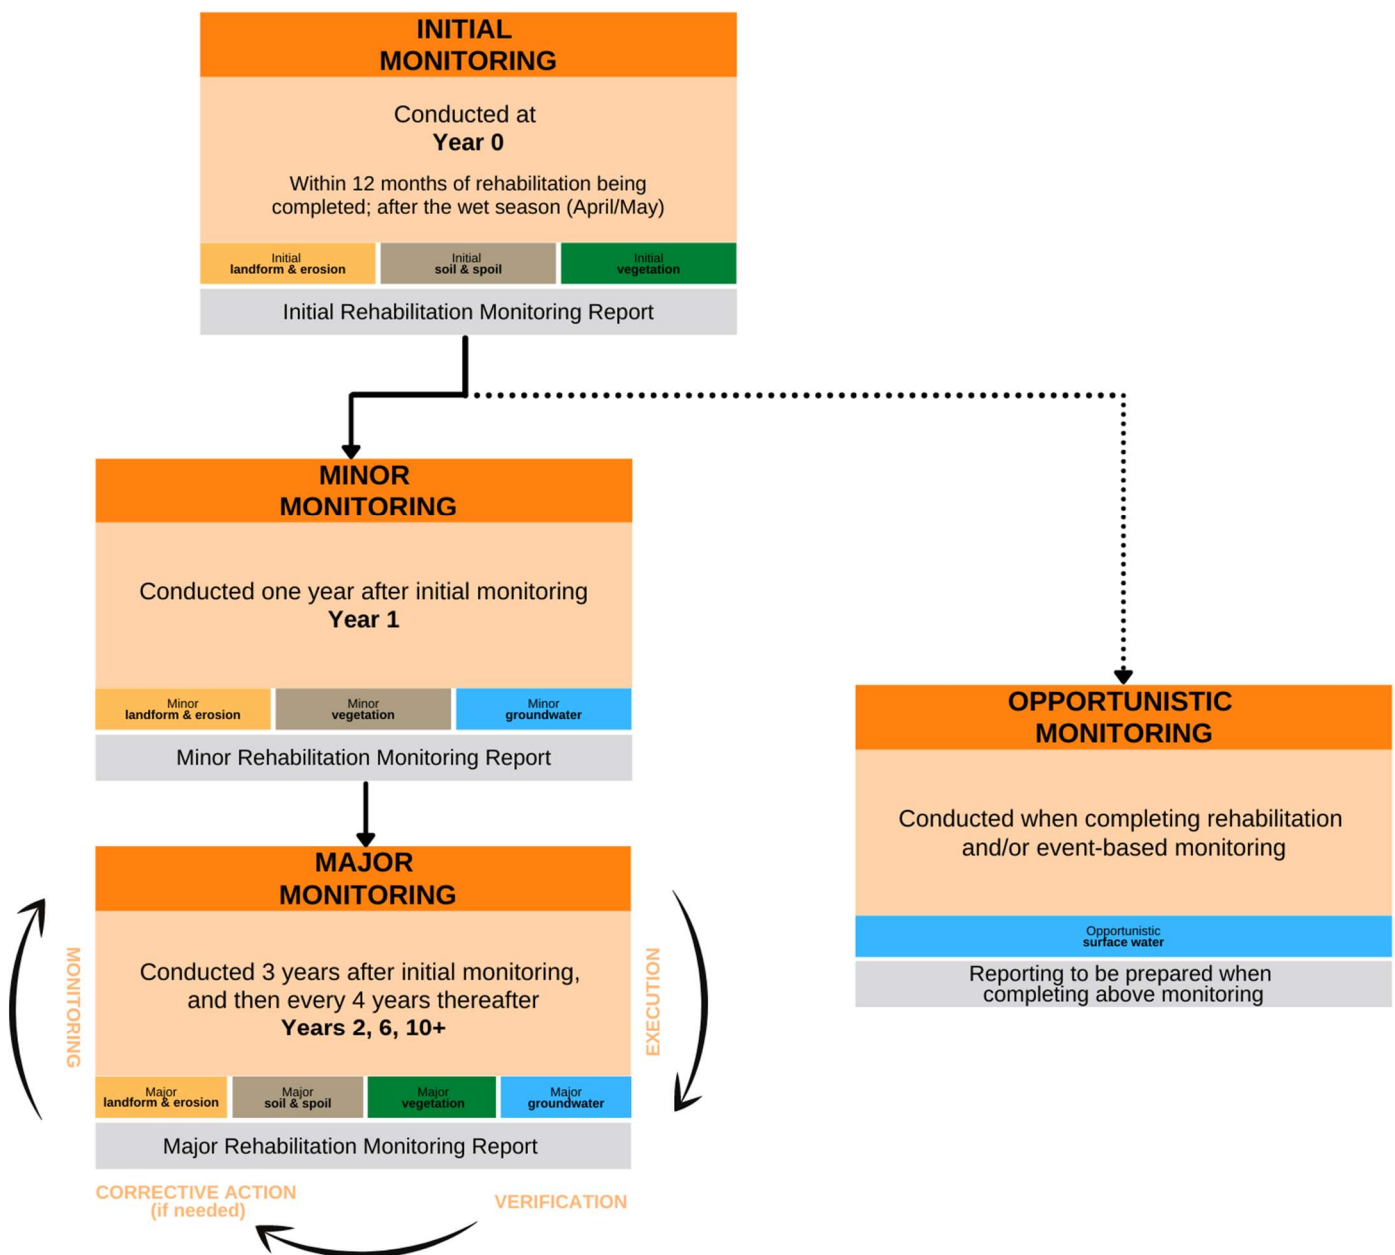
**Figure 31: Flow diagram of the Wards Well rehabilitation monitoring program**

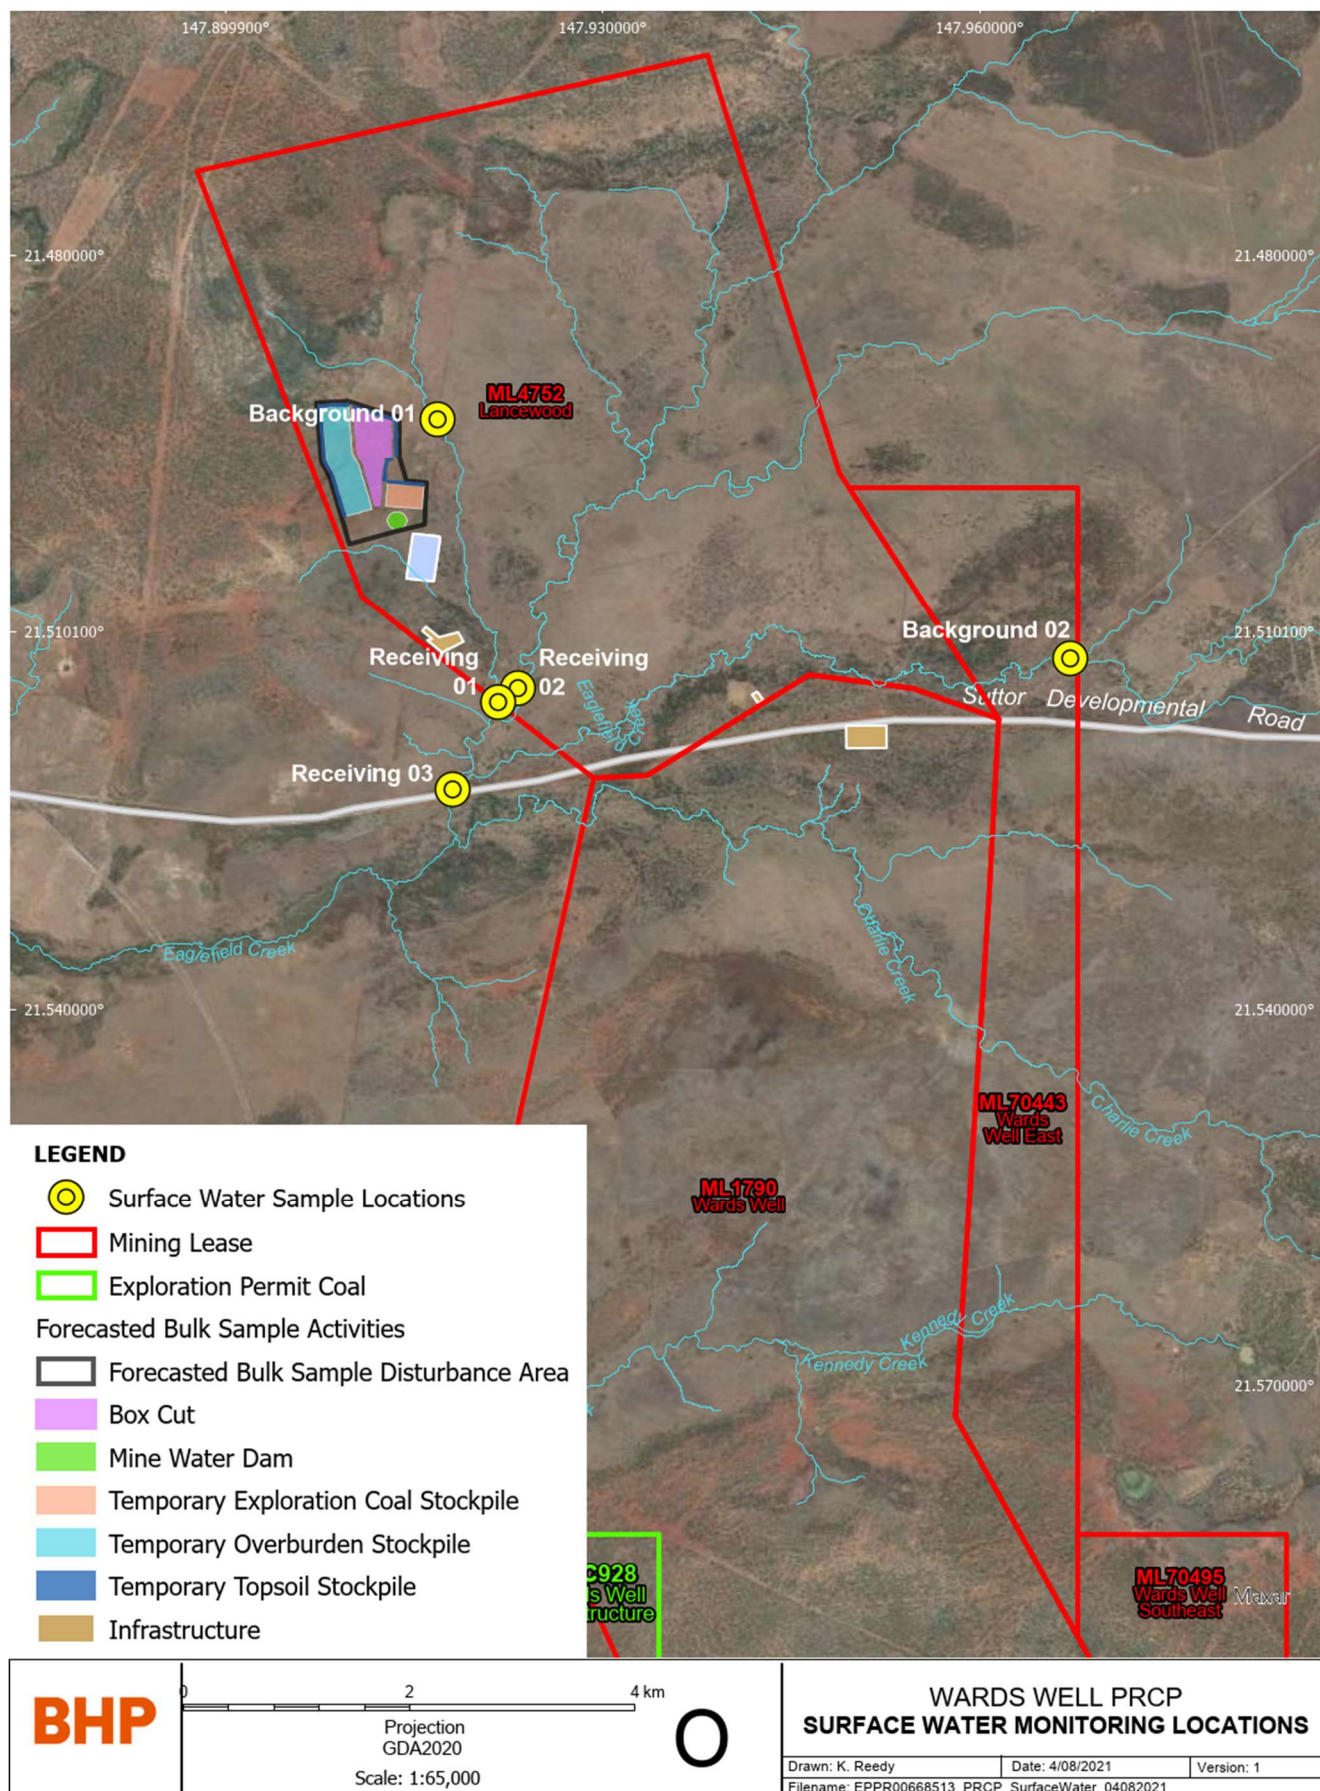
Figure 32: Wards Well rehabilitation-related surface water monitoring locations

The location of the surface water monitoring points for this opportunistic monitoring are illustrated in Figure 32 and summarised in Table 34. Other monitoring locations may be deemed necessary by BMC to demonstrate attainment of the milestone criteria – these will be identified and included in the monitoring program as rehabilitation monitoring proceeds over time.

- Independent Populations: upstream mean and downstream mean (over a maximum monitoring period of five years, sample locations shown in Figure 32, Section 8.5).
- Null Hypothesis: upstream mean = downstream mean.
- Alternative Hypothesis: upstream mean  $\neq$  downstream mean.
- Significance level: 0.1
- The statistical method to be utilised will account for the sample population size and the distribution of the data.

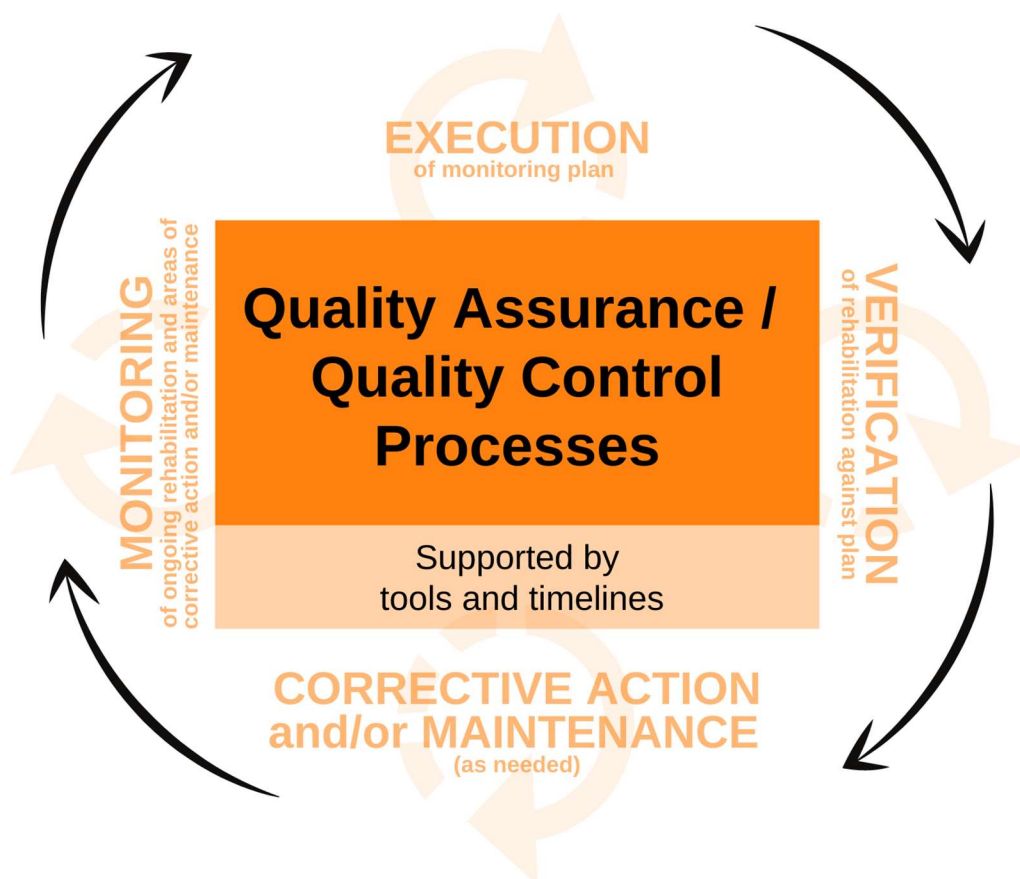
**Figure 33: Quality assurance / quality control process to be followed for ongoing rehabilitation monitoring at Wards Well**

The quality assurance and quality control (QA/QC) process to be followed as part of Wards Well's ongoing rehabilitation monitoring is illustrated in Figure 33. The process provides for initial execution of the rehabilitation in accordance with the rehabilitation measures, followed by verification of how this execution

was undertaken (again, according to these measures). Based on the verification outcomes, allowance is made for implementation of corrective action and/or maintenance, as needed. The rehabilitated areas as well as corrected and/or maintenance areas then undergo further rehabilitation monitoring; and subsequent execution of the rehabilitation measures. This process allows for a repetitive execution-verification-monitoring QA/QC approach, to ensure rehabilitation areas progress on a trajectory towards achievement of milestone criteria and eventual certification.

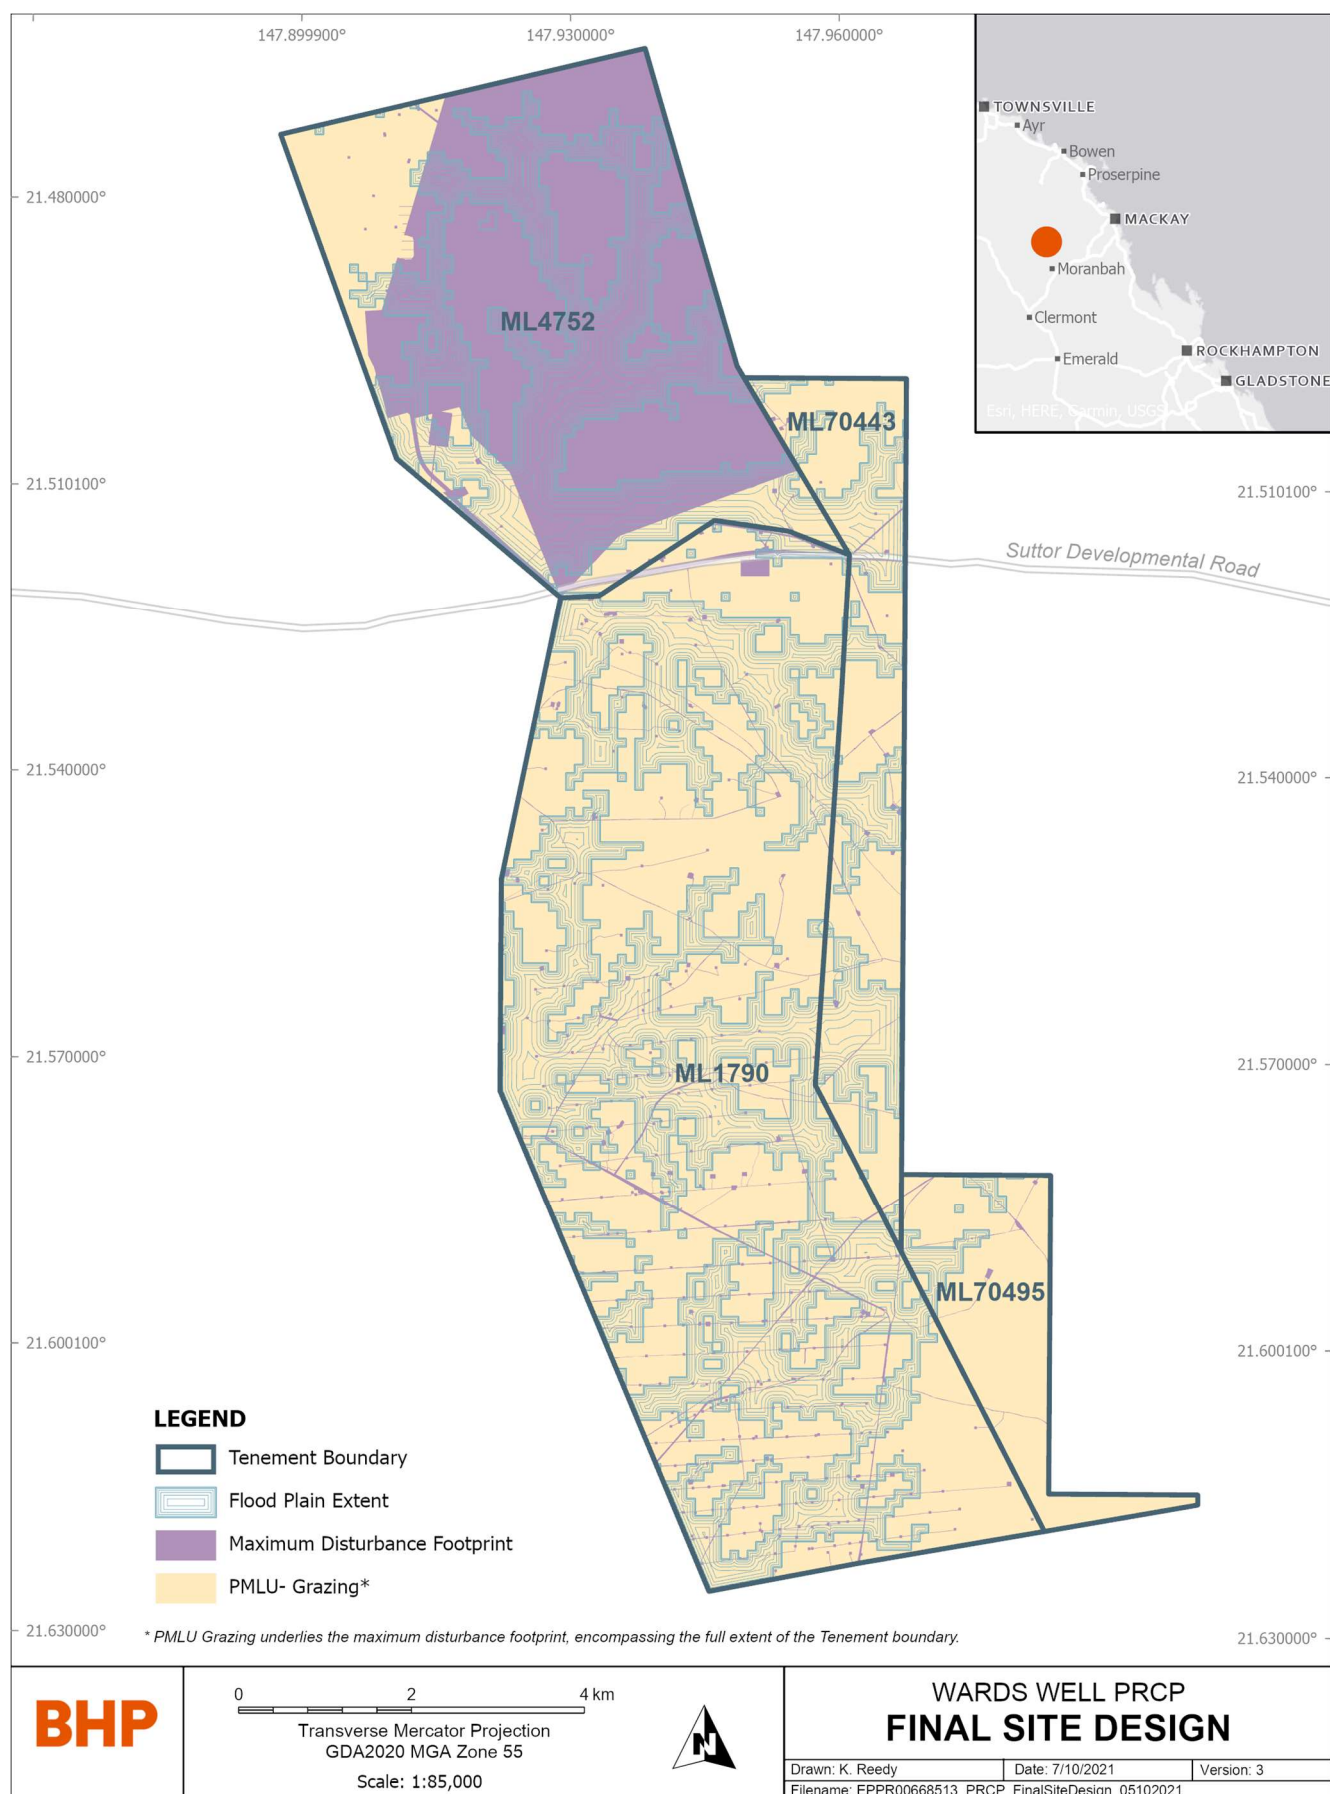
Figure 34: Wards Well final site design

The final site design for Wards Well, including maximum disturbance, tenure boundaries, the PMLU and the extreme event flood plain, is shown in Figure 34.

Pre-BHP involvement, historical exploration drilling and seismic surveys occurred outside the above areas. These historical areas are shown in the maximum disturbance footprint in the final site design map (Figure 34), as well as included in the hectares in the PRCP schedule.

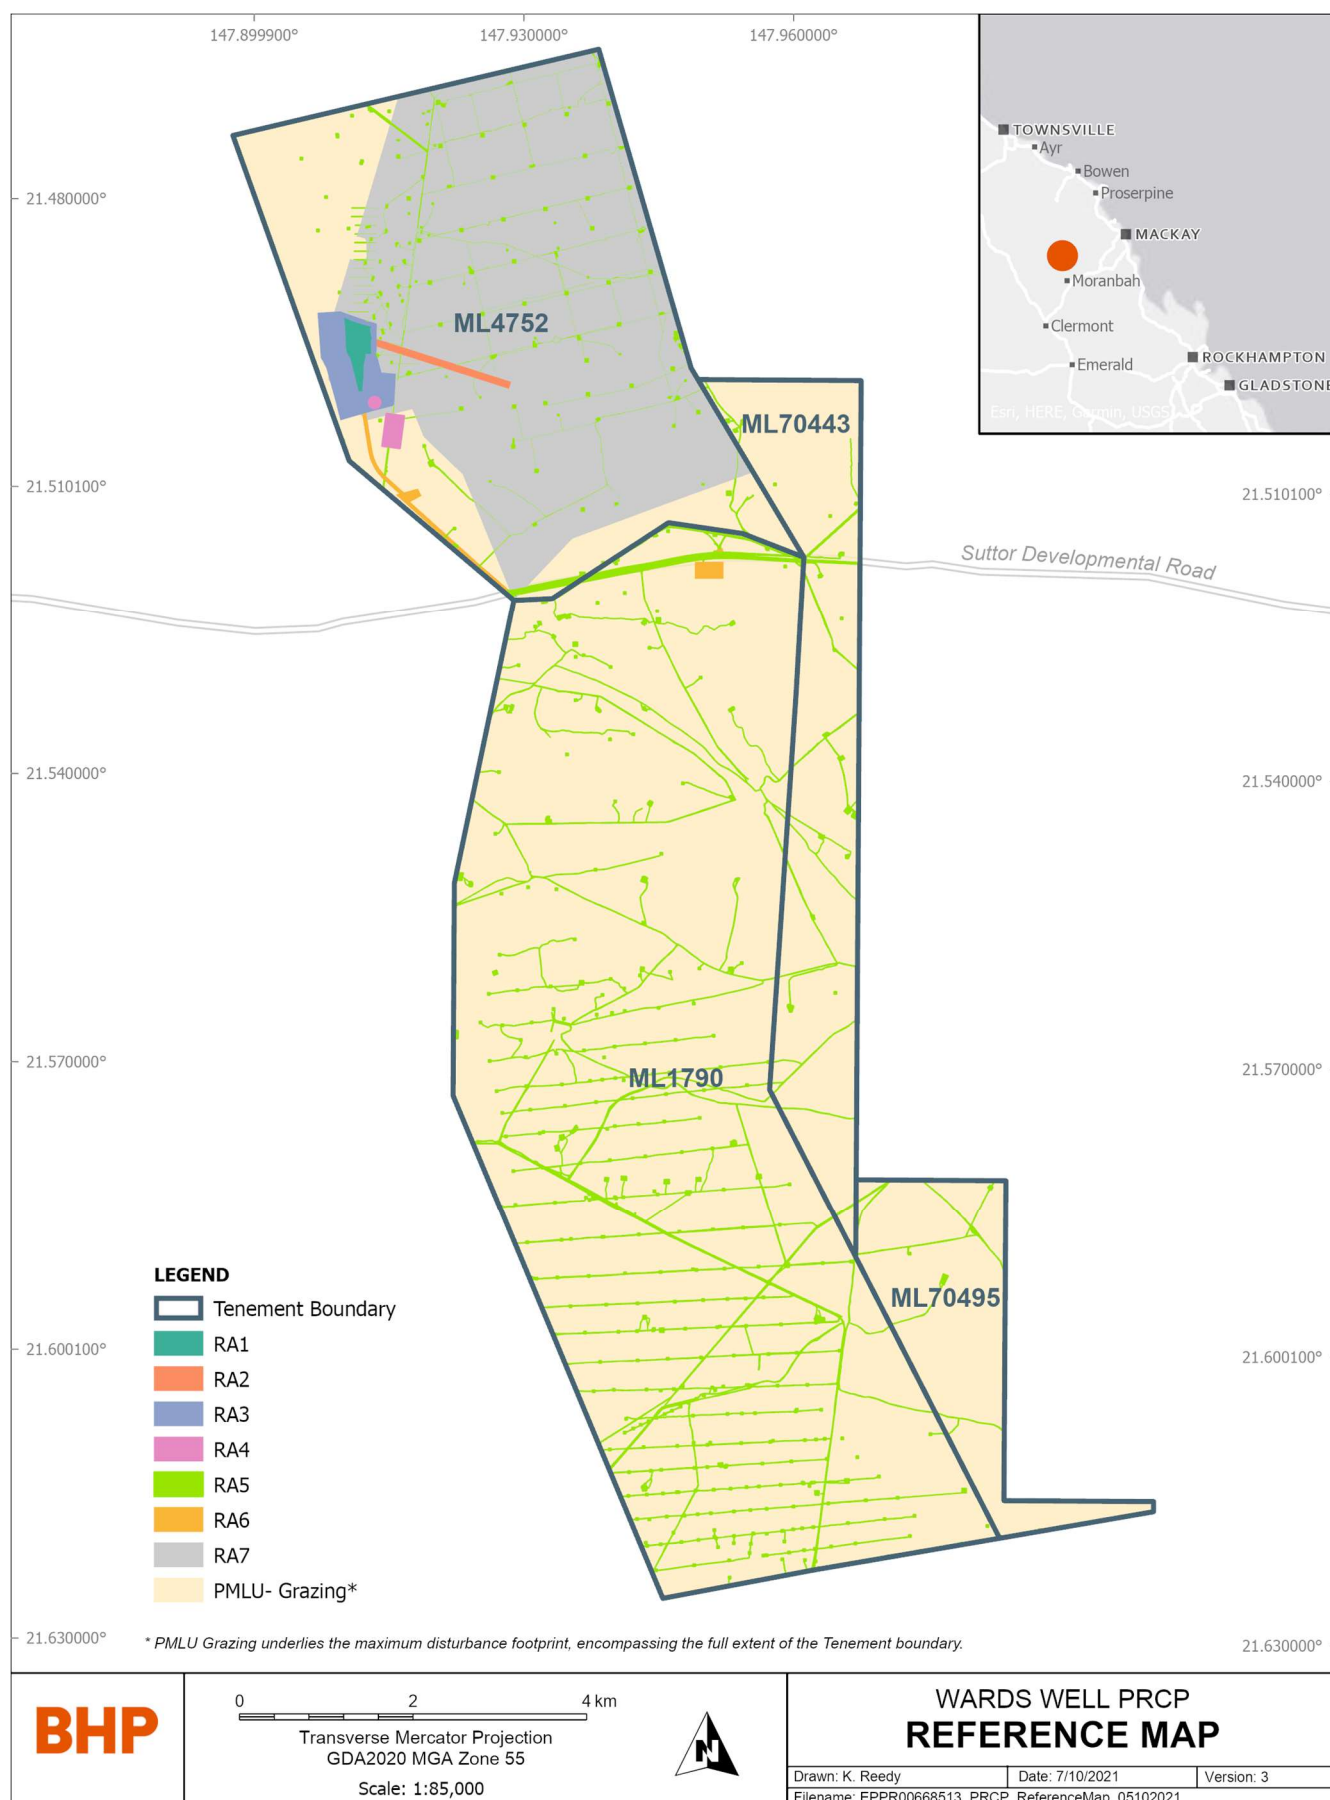
Figure 35: Wards Well reference map

The Wards Well reference map showing the rehabilitation areas is shown in Figure 35.

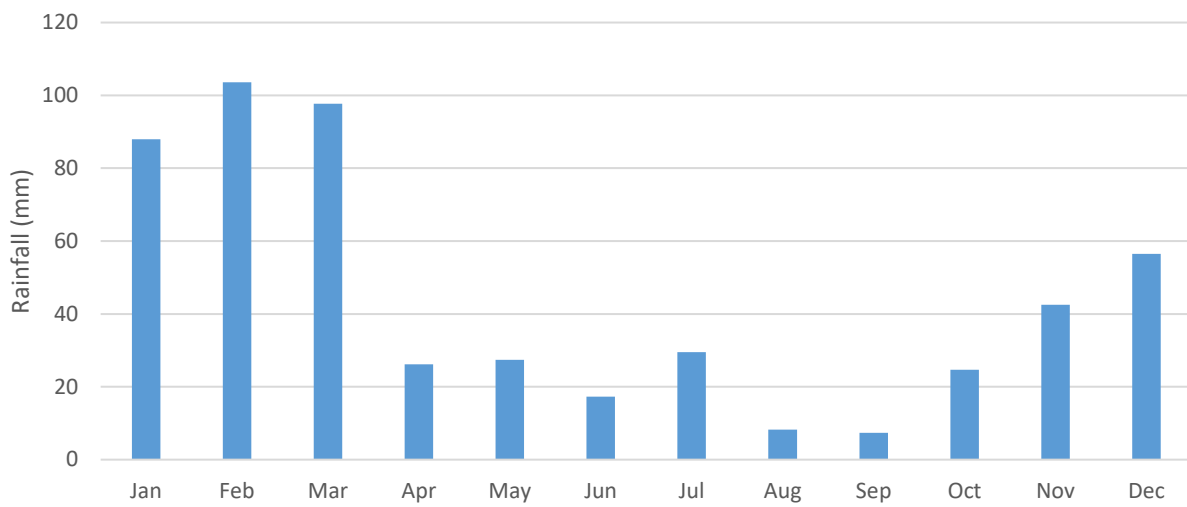
**Figure 2: Average monthly rainfall over the period 2012 to 2020 (station number 34035, BOM 2020a)**

The Central Queensland climate is classified as semi-arid and is characterised by warm, dry winters and hot, humid summers. Almost all rainfall occurs during the wet season, between the months of November and April (BOM, 2020a). Daily rainfall records since 2012 are available from the Moranbah Airport weather station (No. 34035), located approximately 50 km south of the site. The yearly distribution of average monthly rainfall is presented in Figure 2. The average annual rainfall (using rainfall data from 2012 to 2020) is approximately 529 millimetres per year (mm/yr).

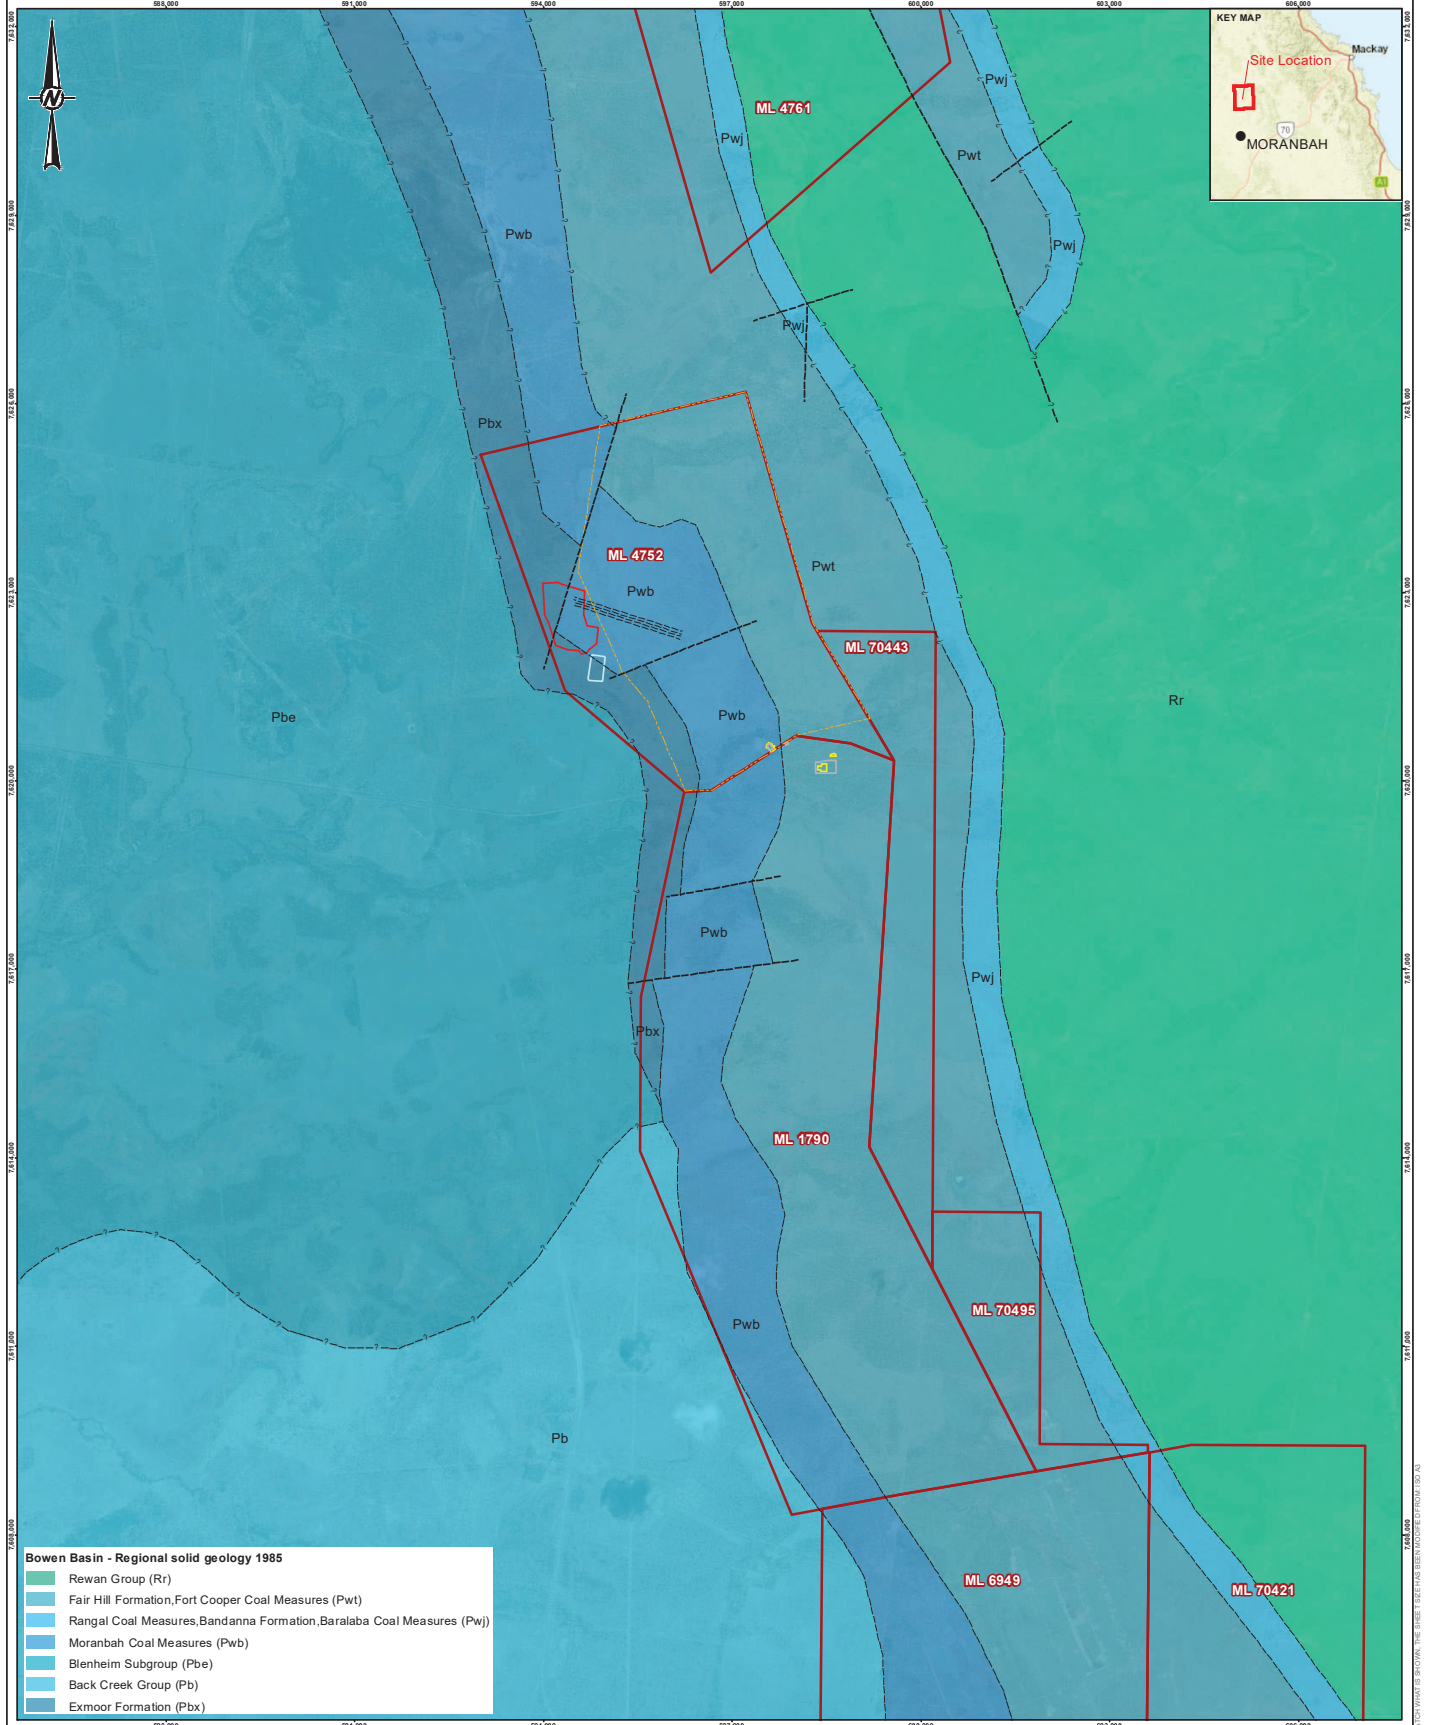
Detailed solid geology and surface geology is displayed in Figure 4 and Figure 5, respectively. Geological structures are included on Figure 4.

Two main fault sets have been identified at the project site during previous site investigations: normal faults striking east-west with a vertical displacement of approximately five to ten metres, and thrust faults striking north-south with approximately three metre upthrust to the east. Exploration drilling also intersected a number of normal and thrust faults located throughout the mining lease areas (AGE, 2012).

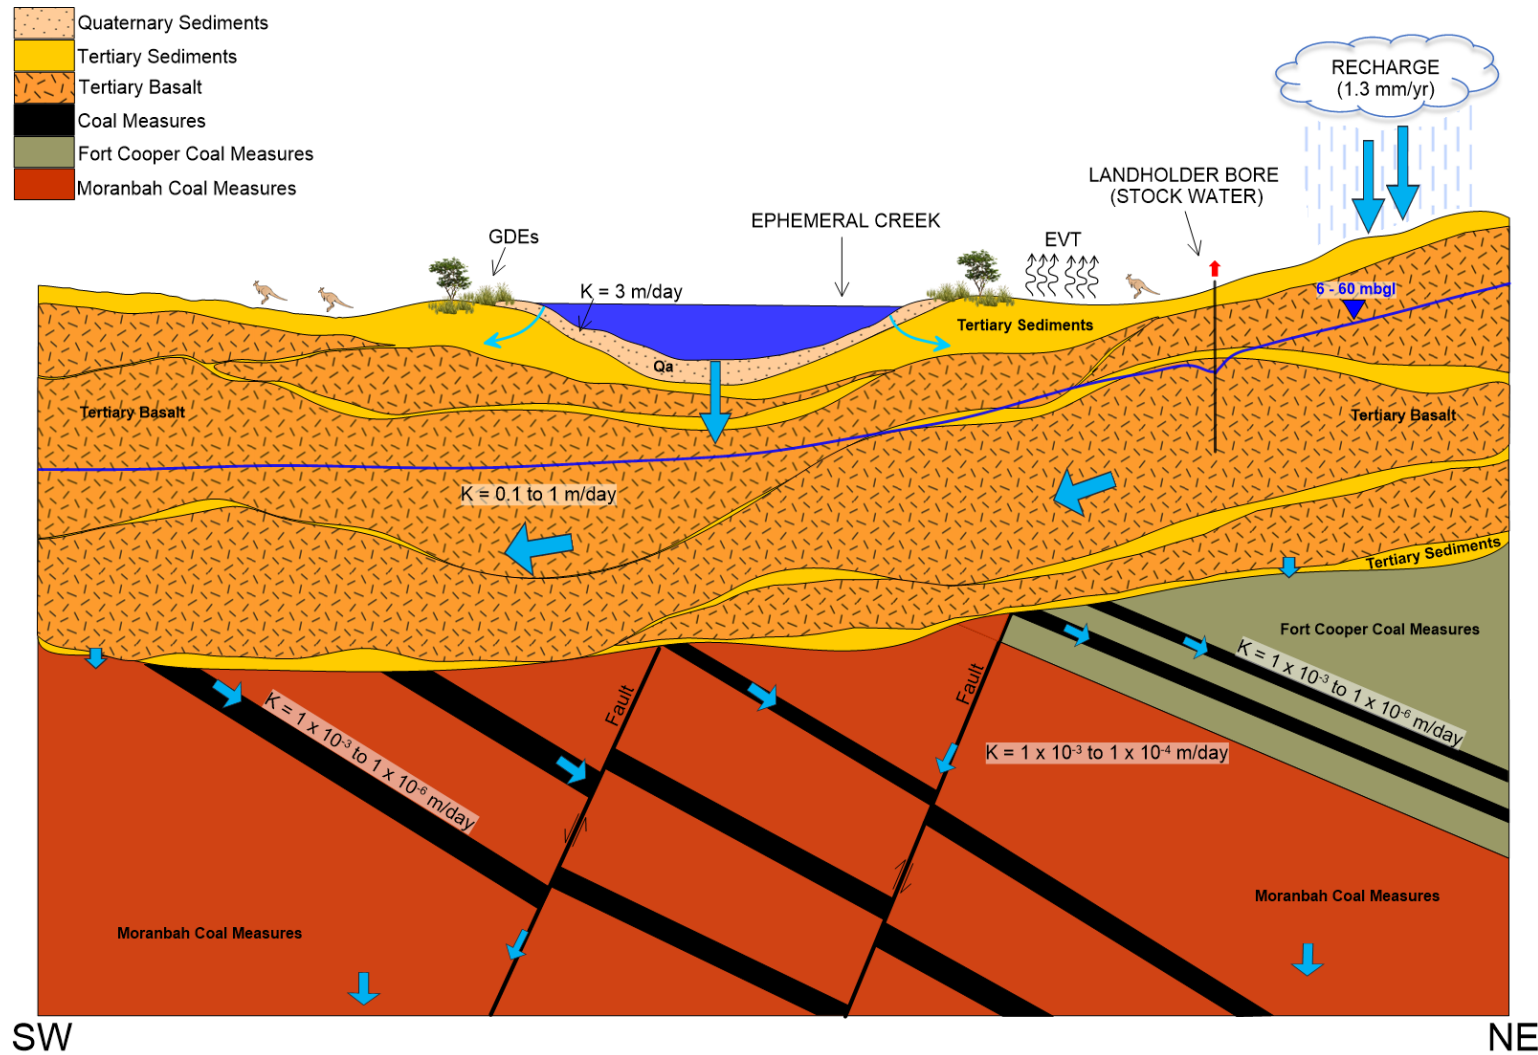
**Figure 6: Baseline Hydrogeological Conceptual Model (BHCM)** Blue arrows show likely groundwater flow directions, with the size of the arrow reflecting the magnitude of groundwater flux.

Groundwater levels in the basalt aquifer typically range between 6 m and 60 m below the ground surface, with groundwater flow in the Tertiary strata (basalts and sediments) flowing from the northeast to the southwest of the project site. Groundwater quality in the basalts is mainly sodium chloride dominated water with Total Dissolved Solids (TDS) concentrations ranging between 480 and 2900 mg/L.

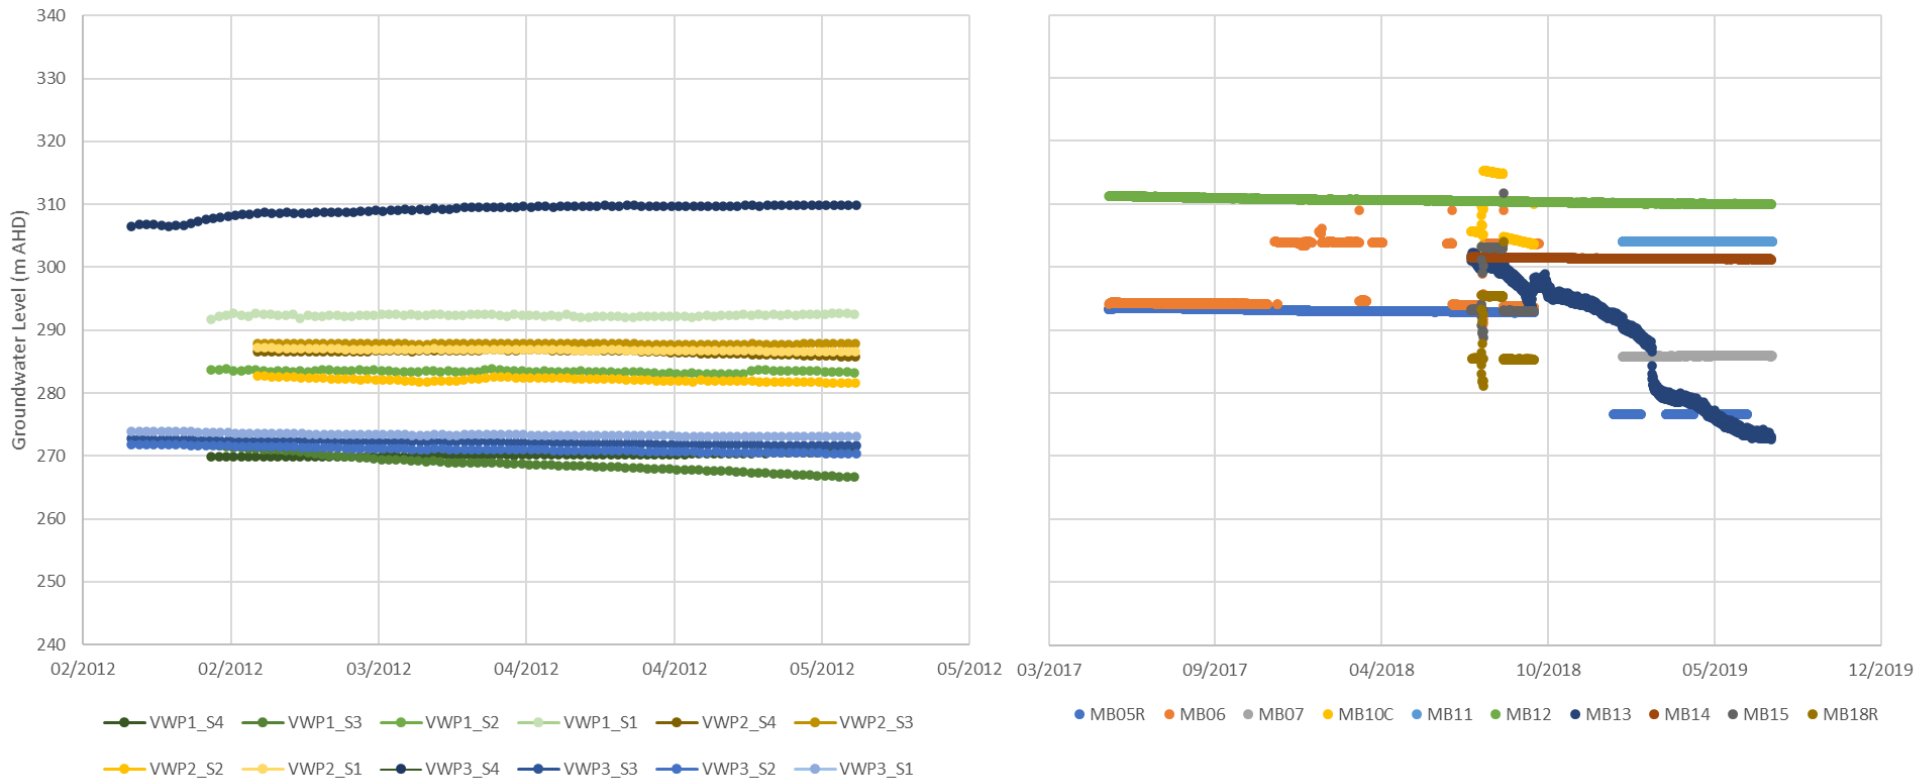
Figure 7: Groundwater Level Hydrographs. VWPs tapping Permian strata are shown on the graph to the left and monitoring bores tapping basalt and sediments shown on the right.
