# Progressive Rehabilitation and Closure Plan

## Wards Well Mine

| <b>Document title</b> | Progressive Rehabilitation and Closure Plan |
| <b>Version number</b> | V3.0 |

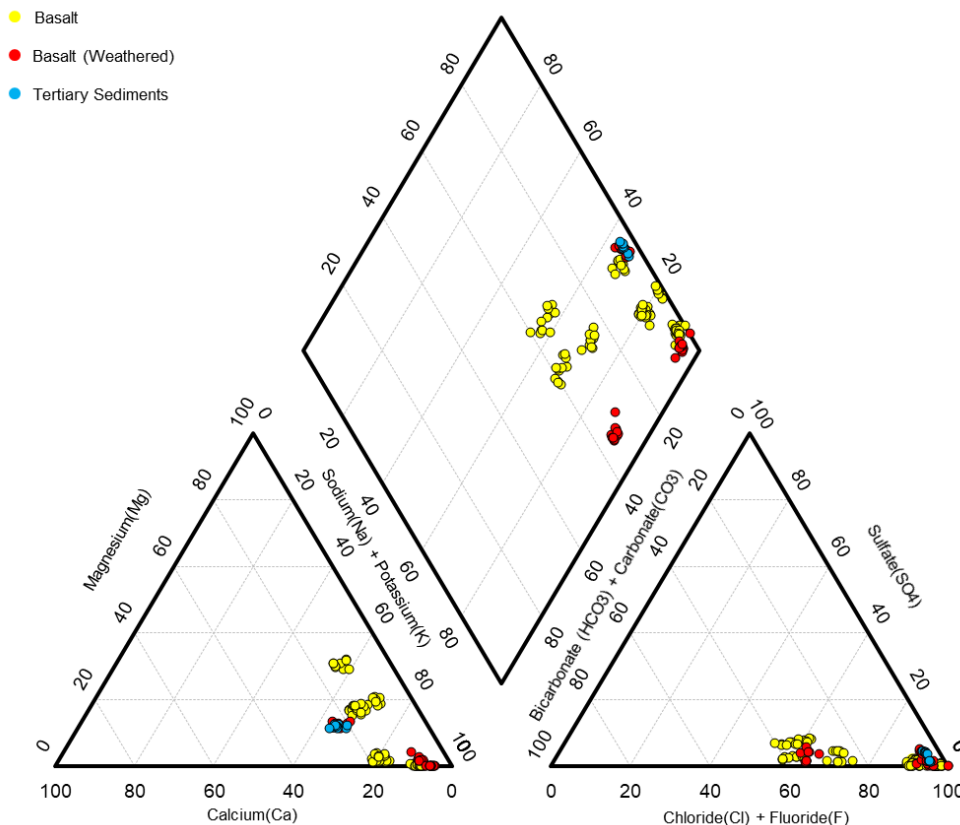
**Figure 9: Piper Plot - Tertiary Basalts Water Quality**

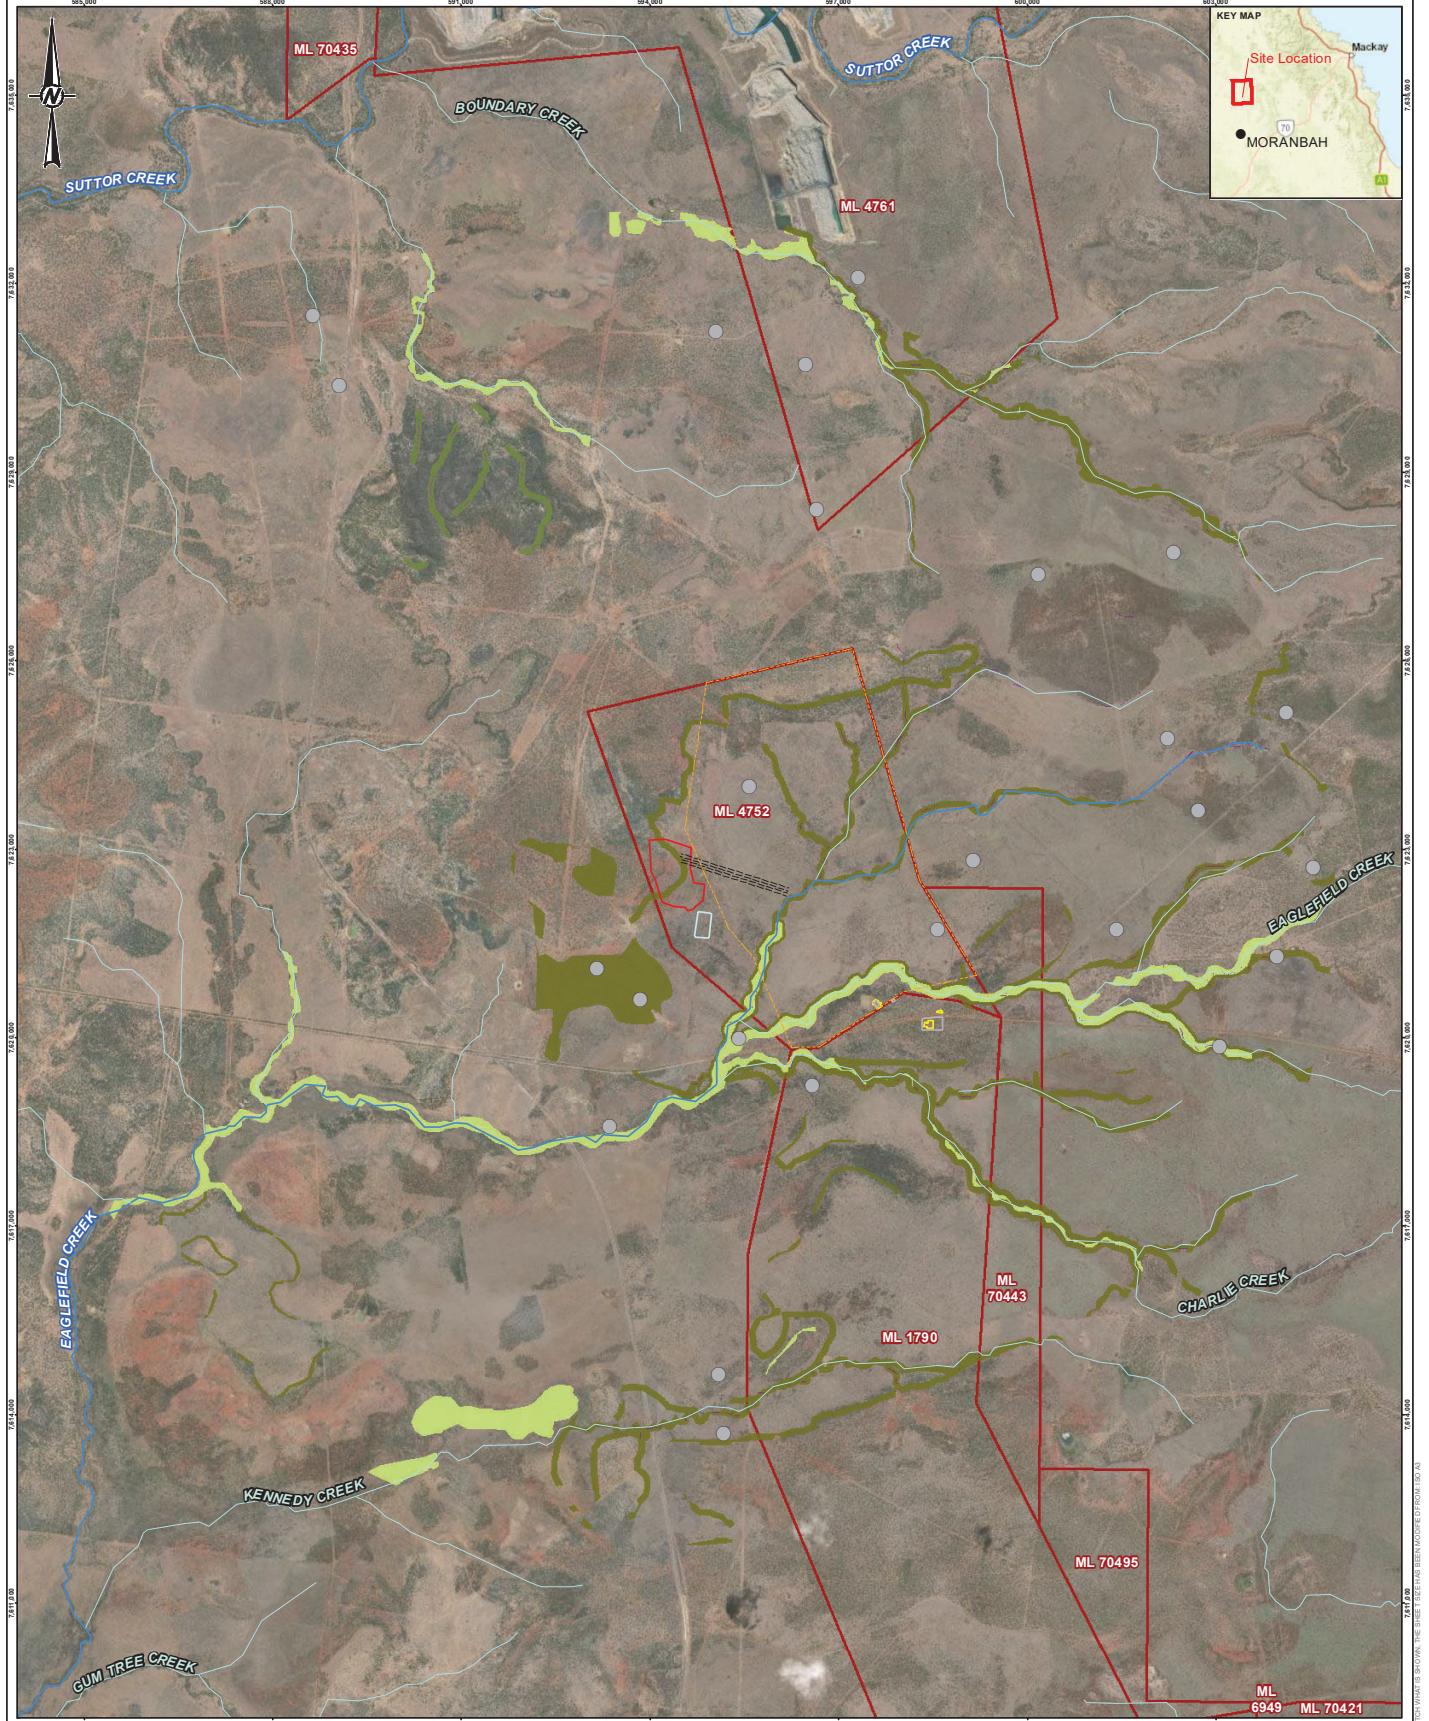
Registered groundwater bores within 10 km of the exploration box cut are displayed in Figure 10.

The distribution of GDEs within 10 km of the exploration box cut is displayed in Figure 10.

There are 16 registered groundwater bores within 10km of the box-cut (both on and off lease), which were listed as existing<sup>13</sup>. Two of the 16 bores were listed for monitoring purposes. The usage for remaining 14 existing bores was not listed, however is expected to be for stock watering or monitoring. Registered bores within 10km of the box-cut are shown on Appendix 4, Figure 10.

A review of the registered groundwater bores within 10km of the box-cut identified a total of 16 bores, which were listed as existing (Appendix 4, Figure 10<sup>11</sup>). Two of the 16 were listed for monitoring purposes. The usage of the remaining 14 existing bores was not listed, however is expected to be for stock watering or monitoring purposes.

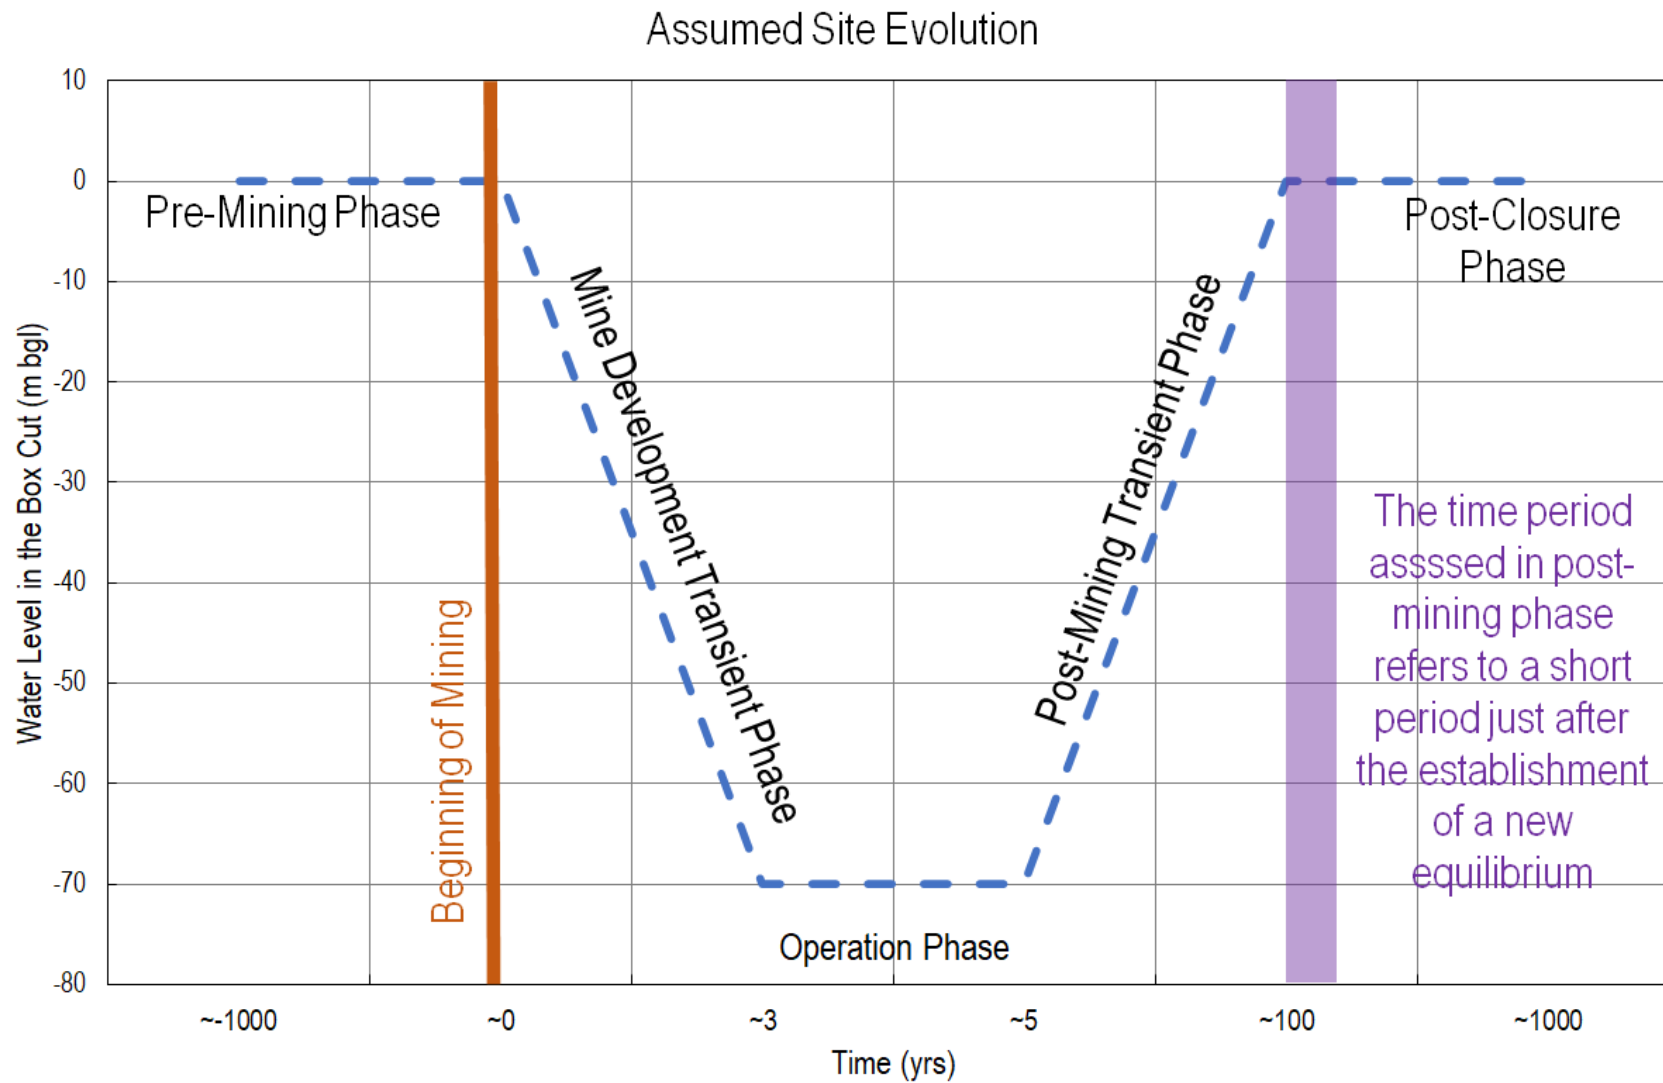
Figure 11: Assumed temporal evolution of the site (time scale is provisional). The purple rectangle shows the time period of the assessment presented in this report.

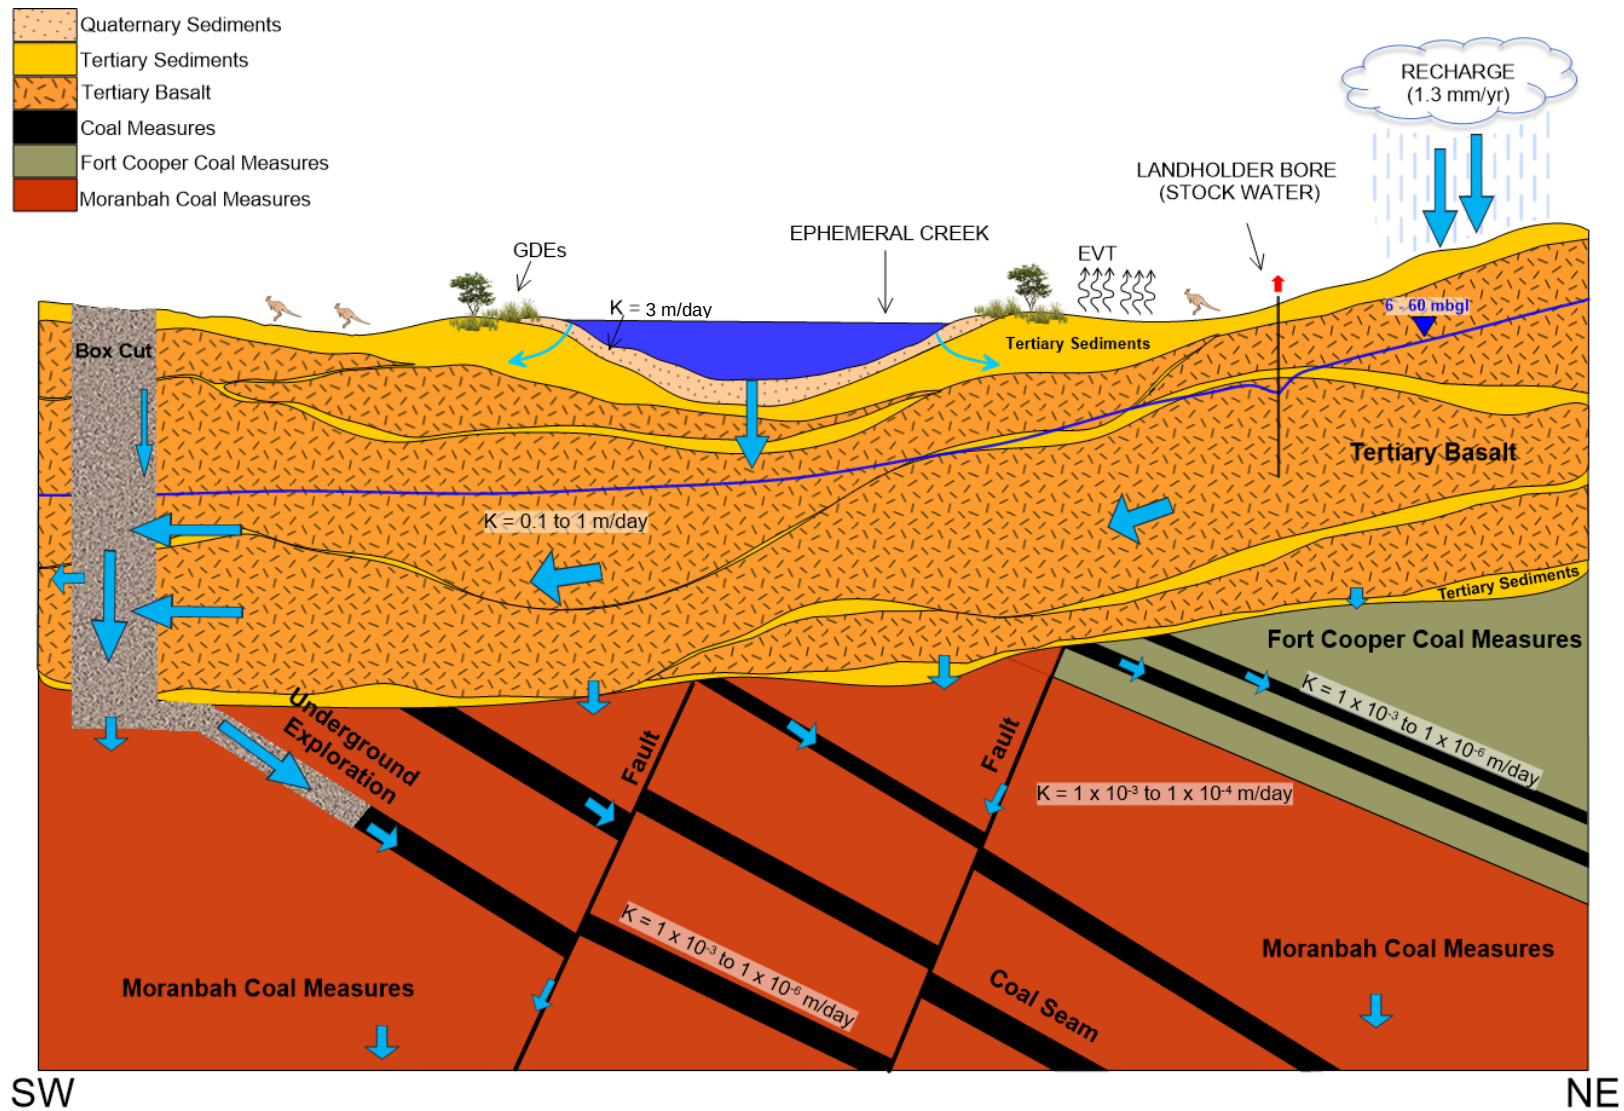
**Figure 12: Qualitative hydrogeological conceptualisation of the post-mining conditions.** Blue arrows show likely groundwater flow directions, with the size of the arrow reflecting the magnitude of groundwater flux.

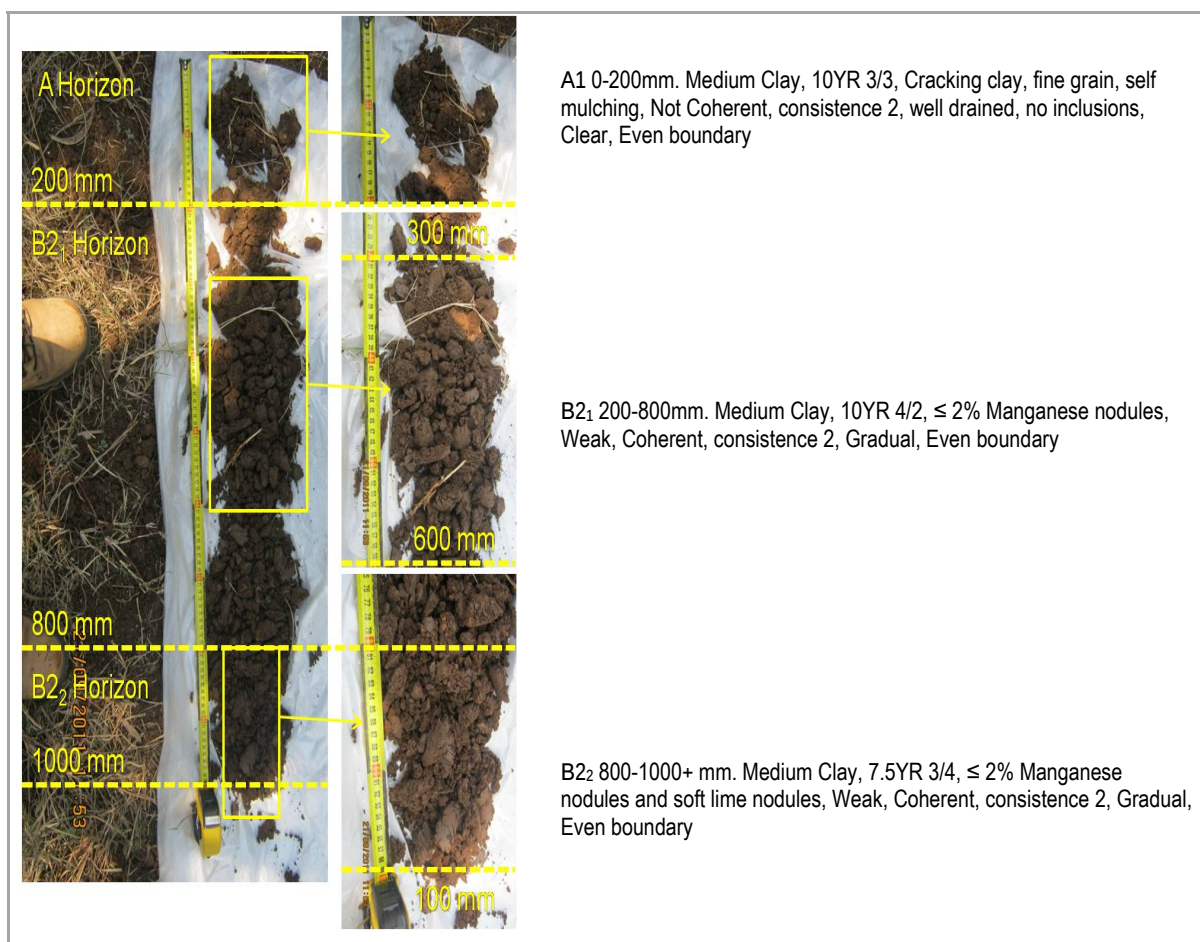
■ **Figure 3-2 3 Vertosol: Profile (Site 6)**

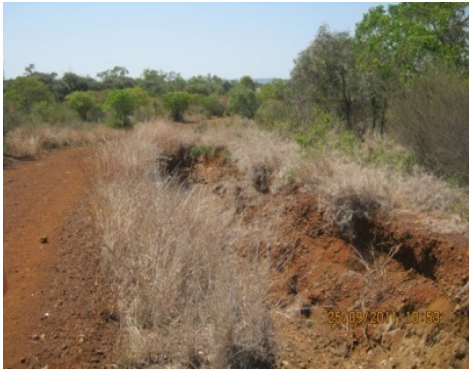
■ **Table 3-5 Sodosol Representative Description and Management (Site 49)**

| Soil | Sodosol | |
| Surface Condition | Gravelly | |
| Land Condition | Extensive erosion ( $\leq 50\%$ of sample area) | |
| Recommended Topsoil Stripping Depth | 200mm if required for rehabilitation | |

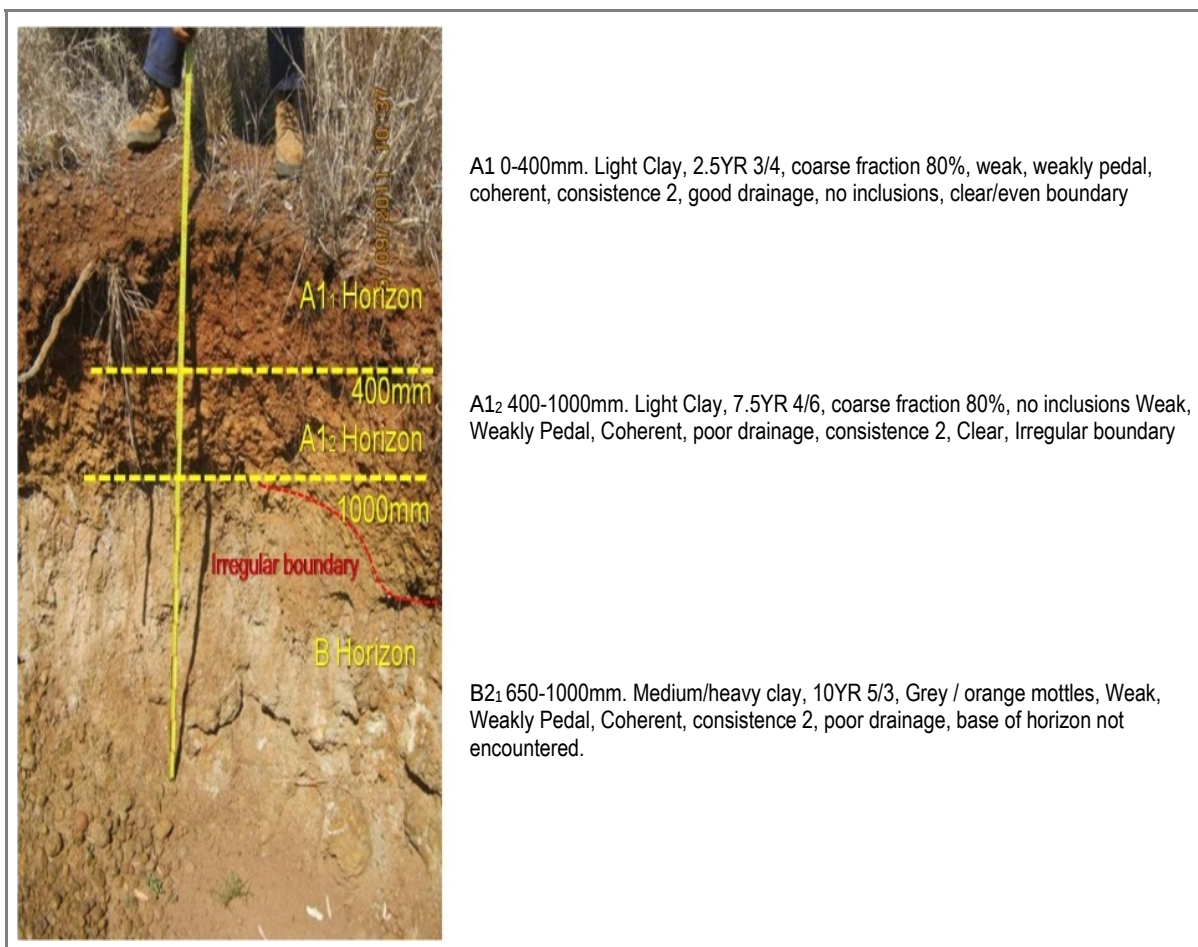
■ **Figure 3-3 Sodosol: Profile (Site 49)**

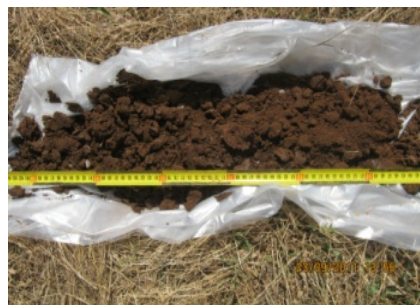
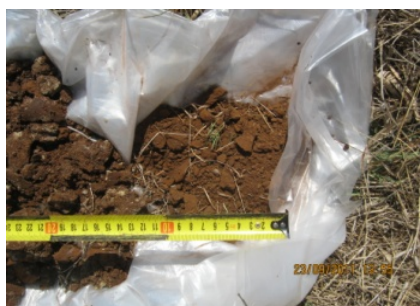
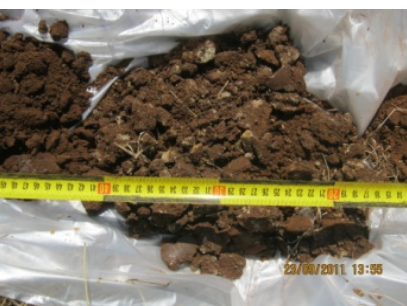
■ **Figure 3-4 Dermosol: Profile (Site 28)**

A1 0-100mm. Light Clay, 7.5YR 4/4, Weak, Weakly Pedal /Apedal, consistence 2, imperfect drainage, no inclusions, clear, even boundary

B21 100-400mm. Medium Clay, 7.5Yr 4/4, ≤ 2% White mottles, Weak, Strongly Pedal, Coherent, poor drainage, consistence 2, clear, even boundary

B22 400+ mm. Medium Clay, 7.5YR 3/3, White / Black mottles, Firm / Very Firm, Strongly Pedal, Coherent, consistence 3/4, poor drainage, base of horizon not encountered.

**Figure 3-4** presents a soil profile description for a Dermosol (Site 28). These Red, Brown Light to Medium Clays are well structured and poorly drained (**Table 3-9**).

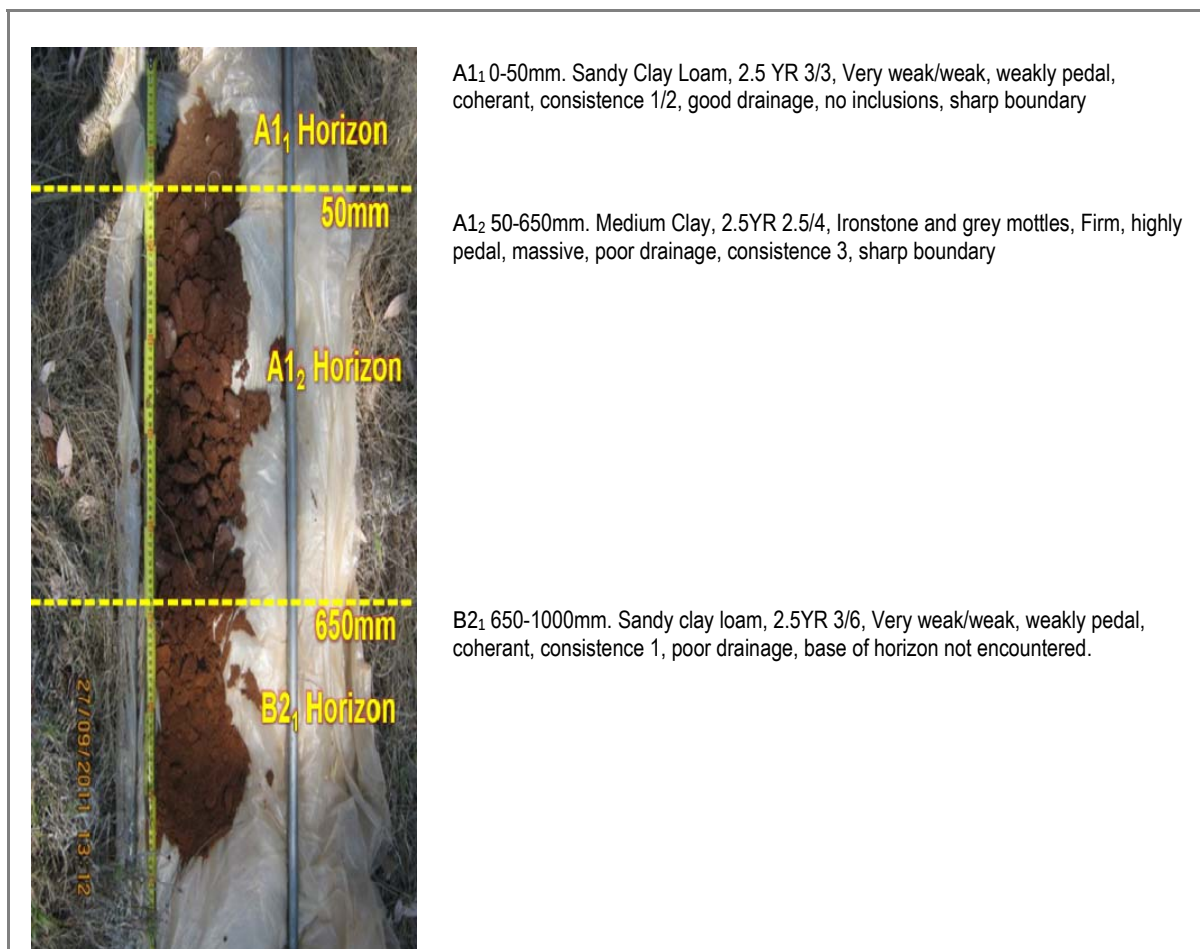
■ **Figure 3-5 Kandosol: Profile (Site 69)**

**Figure 3-5** presents a soil profile description for a Kandosol (Site 69). These Red Sandy Loams are well structured and tend to be poorly drained at depth (**Table 3-12**).

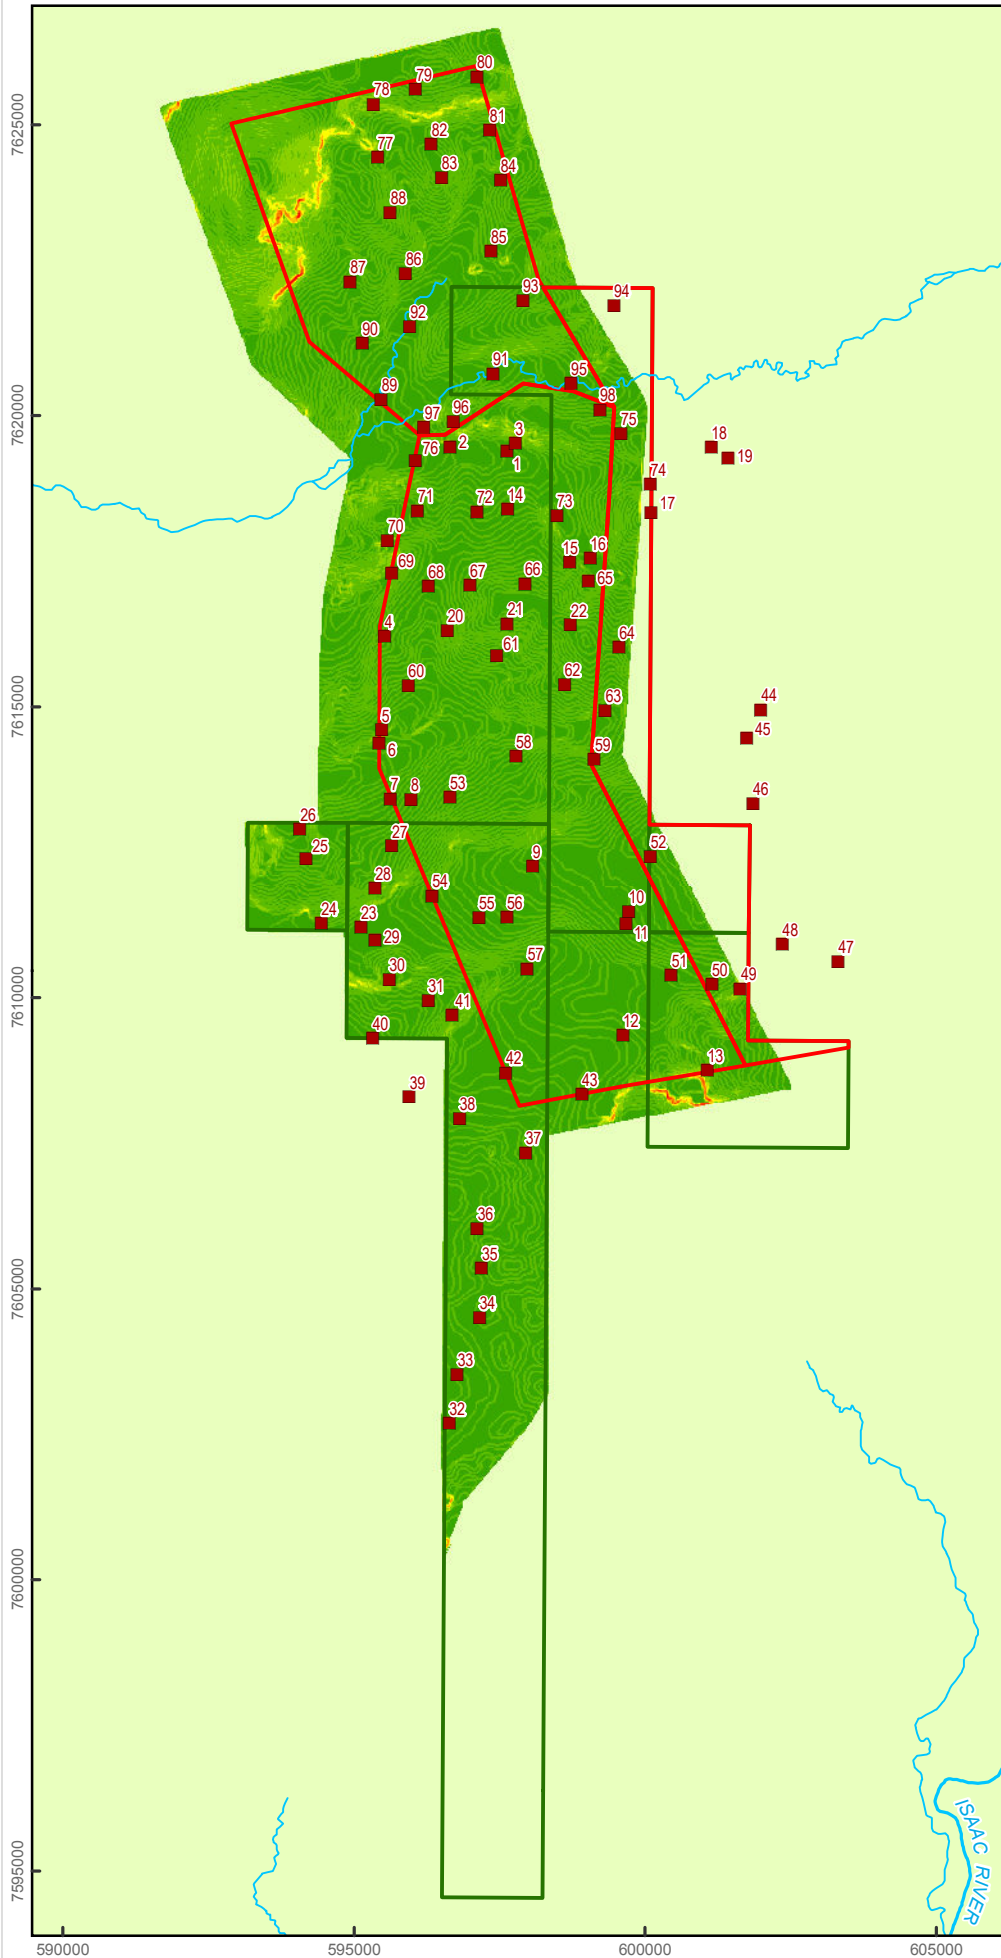
# SLOPE

The site consists of level plains and gently undulating plains and rises with slope across the majority of the site between 1-2%. Steeper slopes up to 11% exist in the far north of the site on Kandosols and on the southeast part of the site on Dermosols. These steeper slopes will present a limitation to cropping in these areas but are suitable for grazing. The map showing slope in the Project area is provided in **Figure 4-1**.

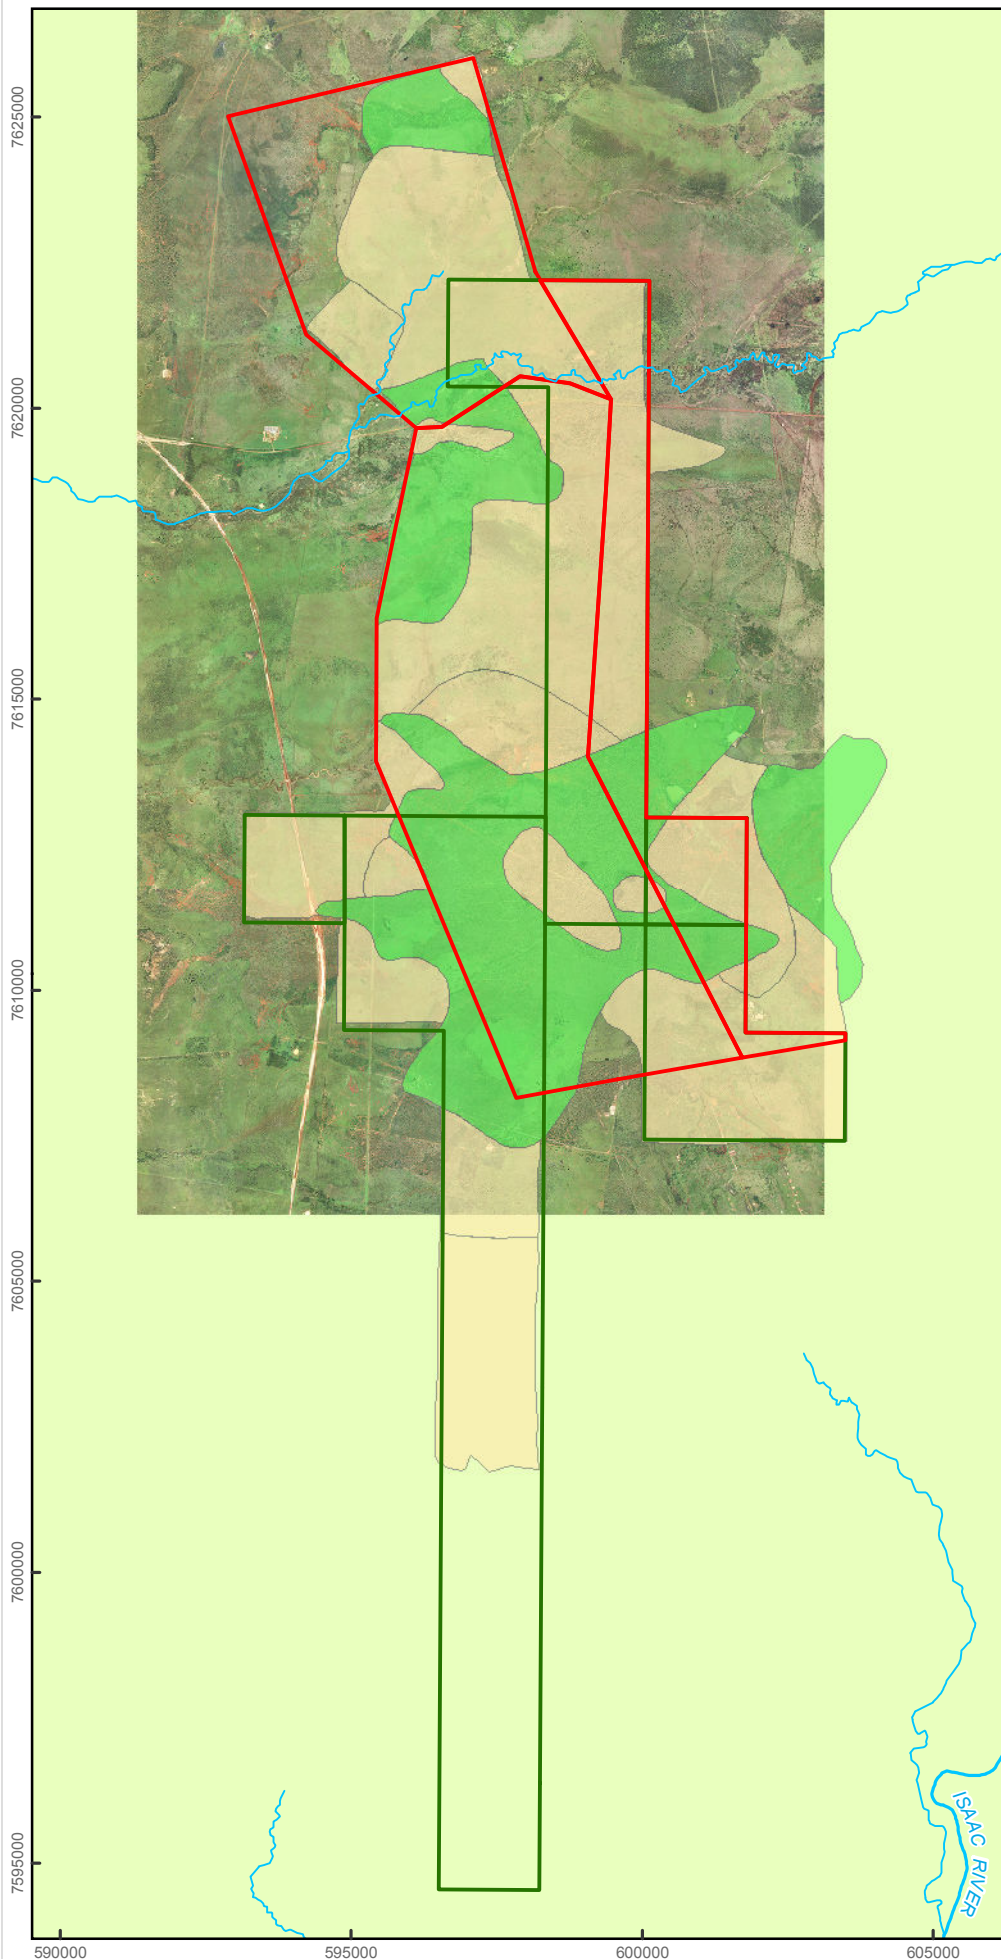
# LAND SUITABLE FOR CROPPING

- Minor Watercourse
- Major Watercourse
- Mining Lease
- Exploration Permit Coal
- Land Suitable for Cropping**
  - 3 - Cropping land with moderate limitations (Kandasols)
  - 4 - Marginal cropping land (Dermosols, Sodosols, Vertosols)

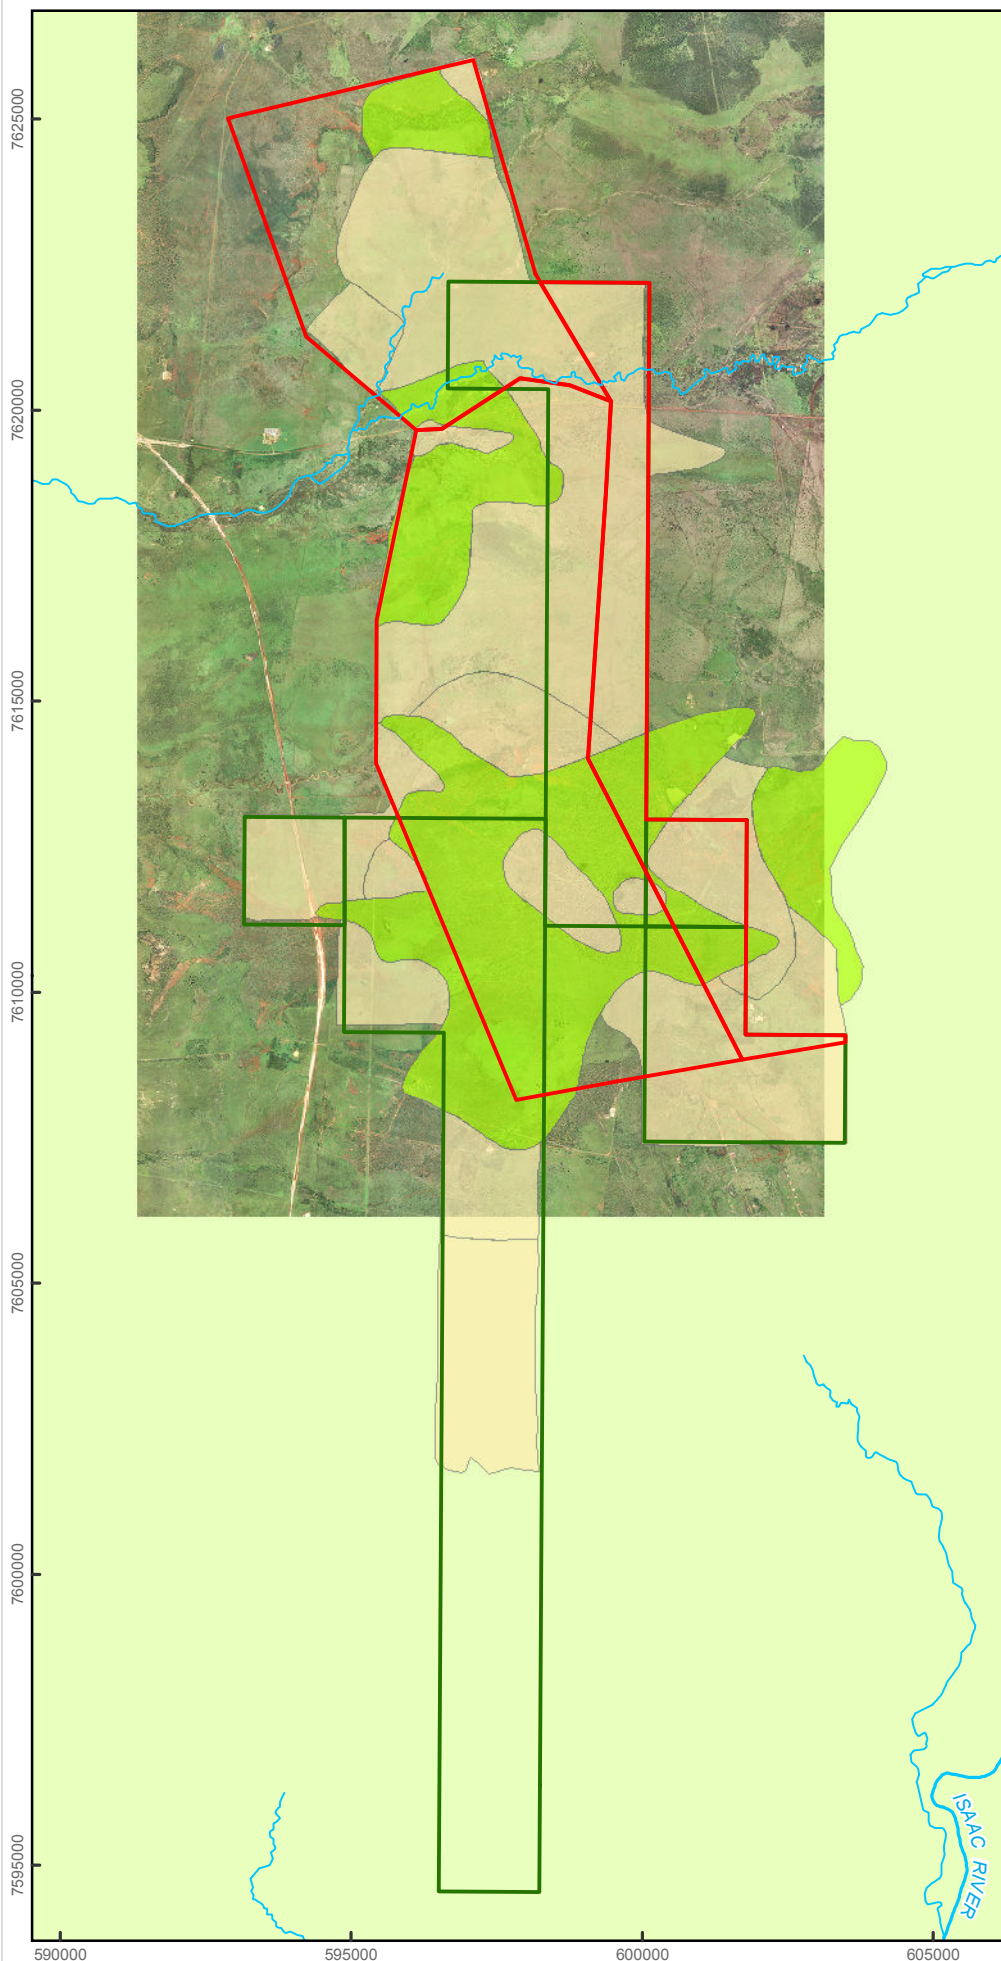
# LAND SUITABLE FOR GRAZING

- Minor Watercourse
- Major Watercourse
- Mining Lease
- Exploration Permit Coal
- Land Suitable for Grazing**
  - 2 - Suitable grazing land with minor limitations (Kandasols)
  - 3 - Suitable grazing land with moderate limitations (Dermosols, Sodosols, Vertosols)

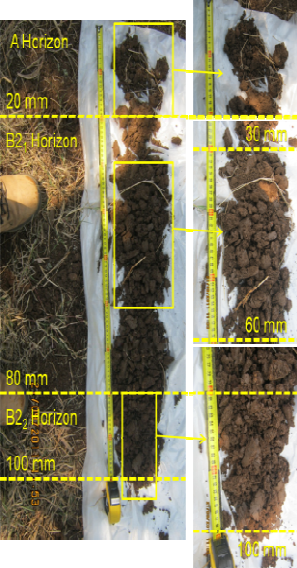
| <b>Project:</b> Wards Well | | <b>Date:</b> 21/9/2011 | | <b>Location:</b> 6 <b>Observation Type:</b> A | | | <b>Coordinates:</b> 0595544, 7614553 | | | | | |
|---|---|---|---|---|---|---|---|---|---|---|---|---|
| 0-200 | MC | Not recorded | 10YR 3/3 | Nil | | Cracking clay, fine grain, self mulching | Not Coherent, Mulch | 2 | Not recorded | Clear, Even | A1 | 0-10 mm |
| 200-800 | MC | Not recorded | 10YR 4/2 | ≤ 2% Manganese nodules | | - | Weak, Coherent | 2 | Not recorded | Gradual, Even | B2 <sub>1</sub> | 20-30 mm |
| 800-1000+ | MC | Not recorded | 7.5YR 3/4 | ≤ 2% Manganese nodules and soft lime nodules | | - | Weak, Coherent | 2 | Not recorded | Gradual, Even | B2 <sub>2</sub> | 80-90 mm |

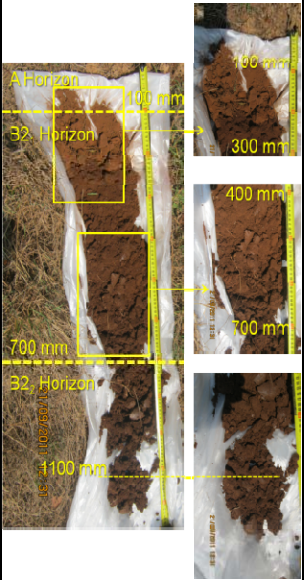
| <b>Project:</b> Wards Well | | <b>Date:</b> 21/9/2011 | | <b>Location:</b> 7 <b>Observation Type:</b> A | | | <b>Coordinates:</b> 595743,7613598 | | | | | |
|---|---|---|---|---|---|---|---|---|---|---|---|---|
| 0-100 | SiC | Not recorded | 5YR 3/4 | Nil | | Firm<br>hardsetting,<br>weak cracking | Very Firm,<br>Coherent,<br>Massive | 4 | Not recorded | Clear, Even | A1 | No sample |
| 100-700 | MC | Not recorded | 2.5YR 4/4 | Nil | | - | Firm, Coherent,<br>Massive | 3 | Not recorded | Gradual,<br>Even | B2 <sub>1</sub> | No sample |
| 700-1000+ | MC | $\leq 5\%$ | 2.5Yr 3/4 | Manganese nodules<br>and trace carbonate | | - | Firm, Coherent,<br>Massive | 3 | Not recorded | Base of<br>horizon not<br>encountered | B2 <sub>2</sub> | No sample |

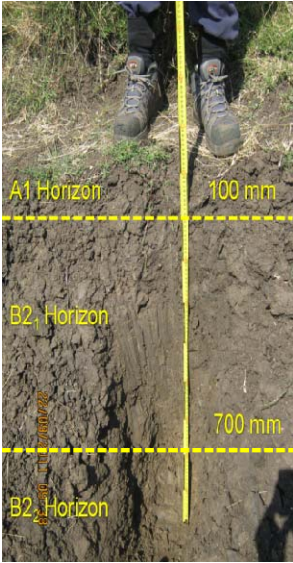
| <b>Project:</b> Wards Well | | <b>Date:</b> 22/9/2011 | | <b>Location:</b> 16 <b>Observation Type:</b> P | | | <b>Coordinates:</b> 599176,7617728 | | | | | |
|---|---|---|---|---|---|---|---|---|---|---|---|---|
| 0-100 | LC | Nil | 7.5YR 2.5/1 | | | No cracking, self-mulching crust | Weak, Weakly Pedal, Coherent | 1 | Not recorded | Gradual, Clear | A1 | No sample |
| 100-700 | MC | ≤ 30% | 7.5YR 2.5/1 | 5-10 mm diameter gravel, some mottles | | - | Weak, Weakly Pedal, Coherent | 1 | Not recorded | Gradual, Clear | B2 <sub>1</sub> | No sample |
| 700-1000+ | MC | ≤ 30% | 7.5YR 3/1 | 5-10 mm diameter gravel, some mottles | | - | Weak, Weakly Pedal, Coherent | 1 | Not recorded | Base of horizon not encountered | B2 <sub>2</sub> | No sample |

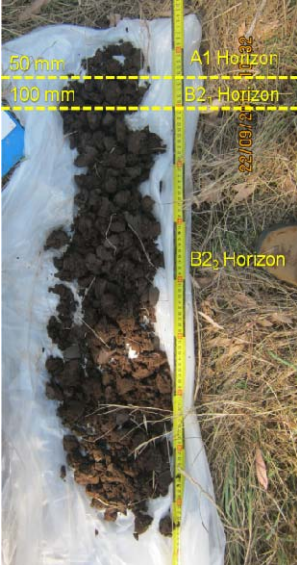
| <b>Project:</b> Wards Well | | <b>Date:</b> 22/9/2011 | | <b>Location:</b> 17 <b>Observation Type:</b> A | | | <b>Coordinates:</b> 600217,7618517 | | | | | |
|---|---|---|---|---|---|---|---|---|---|---|---|---|
| 0-50 | LC | Nil | 5YR 3/2 | Carbonate nodules | | Self mulching | Weak, Highly Pedal, Coherent | 2 | Not recorded | Gradual | A1 | No sample |
| 50-100 | MC | Nil | 5YR 3/2 | Nil | | - | Firm, Highly Pedal, Coherent | 3 | Not recorded | Gradual | B2 <sub>1</sub> | No sample |
| 100-1000 | MC | Nil | 10YR 4/4 | Nil | | - | Very Firm, Highly Pedal, Coherent | 4 | Not recorded | Base of horizon not encountered | B2 <sub>2</sub> | No sample |

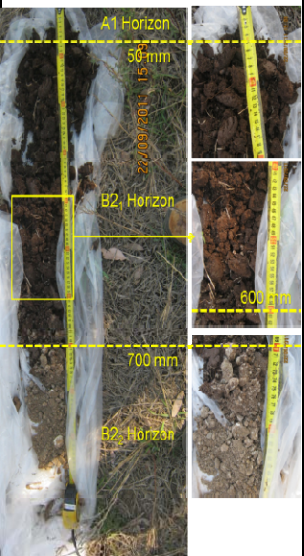
| <b>Project:</b> Wards Well | | <b>Date:</b> 22/9/2011 | | <b>Location:</b> 22 <b>Observation Type:</b> A | | | | <b>Coordinates:</b> 598838, 7616587 | | | | | |
|---|---|---|---|---|---|---|---|---|---|---|---|---|--|
| 0-50 | LC | Nil | 7.5YR 3/3 | Nil | | Self-mulching cracking clay | Very Weak, Weakly pedal / Apedal, | 1 | Restricted | Gradual, Even | A1 | 0-100 mm | |
| 50-700 | MC | Nil | 7.5YR 2.5/2 | Carbonate nodules, White mottling | | - | Weak, Stronger then weakly pedal, Coherent | 2 | Poor | Clear, Even | B2 <sub>1</sub> | 200-400 mm | |
| 700-1000+ | SLC | Nil | 10YR 4/4 | Distinct white / yellow / red mottling | | - | Very Firm, Strongly Pedal, Coherent | 4 | Poor | Clear, Even | B2 <sub>2</sub> | 800-900 mm | |

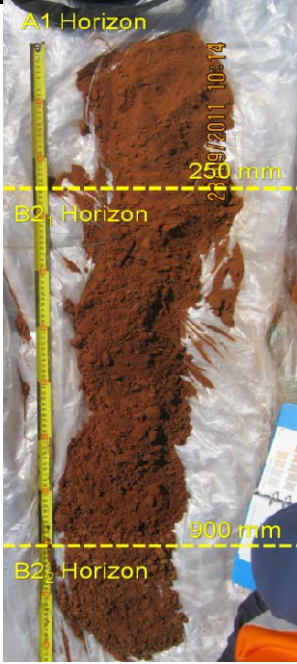
| <b>Project:</b> Wards Well | | <b>Date:</b> 23/9/2011 | | <b>Location:</b> 23 <b>Observation Type:</b> A | | <b>Coordinates:</b> 0595233, 7611393 | | | | | | |
|---|---|---|---|---|---|---|---|---|---|---|---|---|
| 0-250 | SL | Nil | 5YR 4/4 | Nil | | Hard-setting | Very Weak, Apedal | 1 | Not recorded | Clear Even | A1 | 0-100 mm |
| 250-900 | FSCL | ≤ 5% | 5YR 3/4 | Drak gray / black mottles | | - | Very Weak, Apedal / Weakly Coherent | 1 | Not recorded | Gradual Even | B2 <sub>1</sub> | 300-400 mm |
| 900-1000+ | FSCL | ≤ 80% | 5YR 3/4 | Nil | | - | Very Weak, Apedal / Weakly Coherent | 1 | Not recorded | Base of horizon not encountered | B2 <sub>2</sub> | 900-1000 mm |

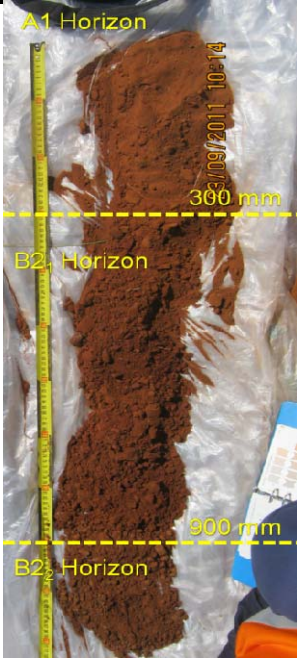
| <b>Project:</b> Wards Well | | <b>Date:</b> 23/9/2011 | | <b>Location:</b> 24 <b>Observation Type:</b> A | | | <b>Coordinates:</b> 594552,7611459 | | | | | |
|---|---|---|---|---|---|---|---|---|---|---|---|---|
| 0-300 | SL | Nil | 2.5YR 4/6 | Nil | | Hard packed, hard-setting | Very Weak, Apedal | 1 | Well | Gradual, Even | A1 <sub>1P</sub> | No sample |
| 300-900 | LC | Nil | 5YR 3/6 | Nil | | - | Very Weak, Apedal / Weakly Coherent | 1 | Poor | Gradual, Even | B2 <sub>1</sub> | No sample |
| 900+ | FSCL | ≤ 5% | 2.5YR 2.5/4 | Some mottling present | | - | Very Weak, Apedal / Weakly Coherent | 1 | Poor | Base of horizon not encountered | B2 <sub>2</sub> | No sample |

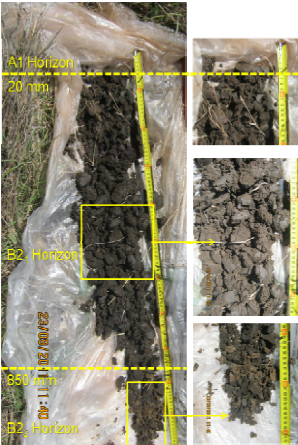
| <b>Project:</b> Wards Well | | <b>Date:</b> 23/9/2011 | | <b>Location:</b> 25 <b>Observation Type:</b> A | | | <b>Coordinates:</b> 594285, 7612574 | | | | | |
|---|---|---|---|---|---|---|---|---|---|---|---|---|
| 0-20 | LC / MC | Nil | 10YR 2/2 | Slight red / yellow mottling | | Self-mulching | Firm, Strongly Pedal, Coherent | 3 | Not recorded | Clear, Even | A1 | No sample |
| 20-80 | MC | Nil | 10YR 3/2 | Red mottles, White and orange nodules | | - | Firm, Strongly Pedal, Coherent | 3 | Not recorded | Clear, Even | B2 <sub>1</sub> | No sample |
| 850-1000 | MC | Nil | 7.5YR 3/2 | Red mottles, White and orange nodules | | - | Weak, Strongly Pedal, Coherent | 2 | Not recorded | Base of horizon not encountered | B2 <sub>2</sub> | No sample |

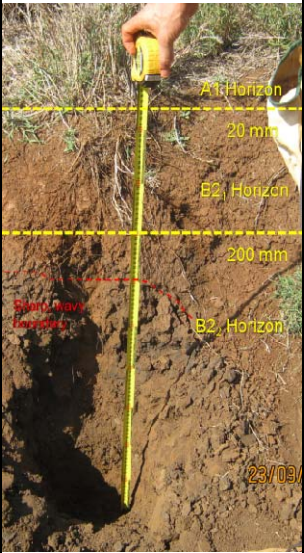
| <b>Project:</b> Wards Well | | <b>Date:</b> 23/9/2011 | | <b>Location:</b> 31 <b>Observation Type:</b> P | | | <b>Coordinates:</b> 0596389, 7610125 | | | | | |
|---|---|---|---|---|---|---|---|---|---|---|---|---|
| 0-20 | SCL | Nil | 10YR 4/4 | Nil | | Hard-setting clay | Weak / Very Weak, Weakly pedal, Coherent | 1 | Well drained | Clear, Even | A1 | No sample |
| 20-200 | LC | Nil | 10YR 3/6 | Nil | | - | Weak, Weakly pedal, Coherent | 2 | Well drained | Sharp, Wavy | B2 <sub>1</sub> | No sample |
| 200-1000+ | HC | Nil | 10YR 3/3 | Ironstone | | - | Very Firm, Weakly Pedal / Massive, Coherent | 4 | Well drained | Base of horizon not encountered | B2 <sub>2</sub> | No sample |

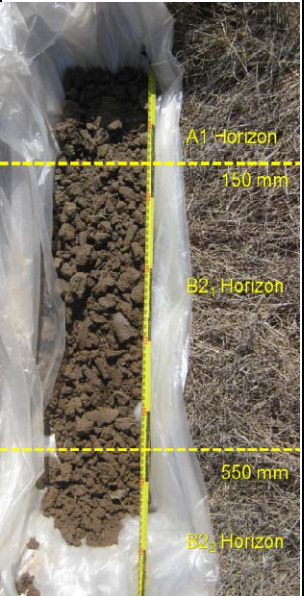
| <b>Project:</b> Wards Well | | <b>Date:</b> 27/9/2011 | | <b>Location:</b> 33 | | <b>Observation Type:</b> A | | <b>Coordinates:</b> 596891, 7603704 | | | | |
|---|---|---|---|---|---|---|---|---|---|---|---|---|
| 0-150 | LC / MC | Nil | 10YR 3/2 | Nil | | Self-mulching cracking clay | Very firm, Highly Pedal, Coherent | 4 | Not recorded | Diffuse, Even | A1 | No sample |
| 150-550 | MC | Nil | 10YR 3/3 | Orange / red mottles | | - | Very firm, Highly Pedal, Coherent | 4 | Not recorded | Diffuse, Even | B2 <sub>1</sub> | No sample |
| 550-1000+ | MC | Nil | 10YR 3/4 | Carbonate nodules, Ironstone. Red / orange mottles | | - | Very firm, Highly Pedal, Coherent | 4 | Not recorded | base of horizon not encountered | B2 <sub>2</sub> | No sample |

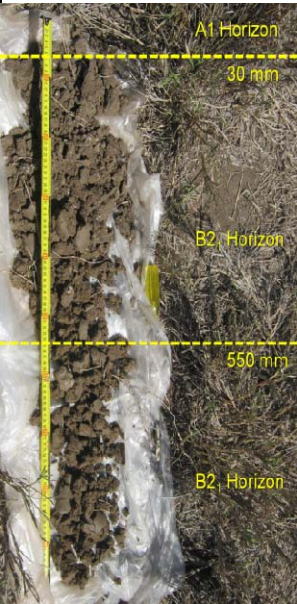
| <b>Project:</b> Wards Well | | <b>Date:</b> 24/9/2011 | | <b>Location:</b> 34 <b>Observation Type:</b> A | | | <b>Coordinates:</b> 597267, 7604679 | | | | | |
|---|---|---|---|---|---|---|---|---|---|---|---|---|
| 0-30 | MC | Nil | 10YR 3/2 | Nil | | Self-mulching cracking clay | Very Firm, Highly Pedal, Coherent | 4 | Not recorded | Diffuse, Even | A1 | No sample |
| 50-550 | MC | Nil | 10YR 4/2 | Carbonate nodules, Red mottles | | - | Firm, Highly Pedal, Coherent | 3 | Not recorded | Diffuse, Even | B2 <sub>1</sub> | No sample |
| 550+ | MC | Nil | 10YR 4/2 | Tree roots intercepted | | - | Weak, Highly Pedal, Coherent | 2 | Not recorded | Base of horizon not encountered | B2 <sub>1</sub> | No sample |

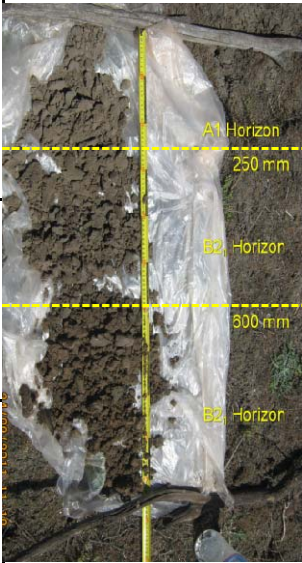
| <b>Project:</b> Wards Well | | <b>Date:</b> 24/9/2011 | | <b>Location:</b> 35 | | <b>Observation Type:</b> A | | <b>Coordinates:</b> 597310, 7605530 | | | | |
|---|---|---|---|---|---|---|---|---|---|---|---|---|
| <b>Remarks:</b> Sample from within melonhole | | | | | <b>ASC Mapped:</b> Vertosol | | | <b>ASC Ground Truth:</b> Vertosol | | | | |
| 0-250 | LC | Nil | 10YR 4/1 | Nil | | self-mulching, craking clay | Firm, Highly Pedal, Coherent | 3 | Imperfect | Gradual, Even | A1 | No sample |
| 250-600 | MC | Nil | 10YR 4/2 | White / Brown / Orange / Red mottles | | | Very Firm, Highly Pedal, Coherent | 4 | Imperfect | Clear, Even | B2 <sub>1</sub> | No sample |
| 600-1000+ | MC | Nil | 10YR 5/2 | Orange / Brown mottles | | | Very Firm, Highly Pedal, Coherent | 4 | Imperfect | Base of horizon not encountered | B2 <sub>2</sub> | No sample |
