# Progressive Rehabilitation and Closure Plan

## Wards Well Mine

| <b>Document title</b> | Progressive Rehabilitation and Closure Plan |
| <b>Version number</b> | V3.0 |

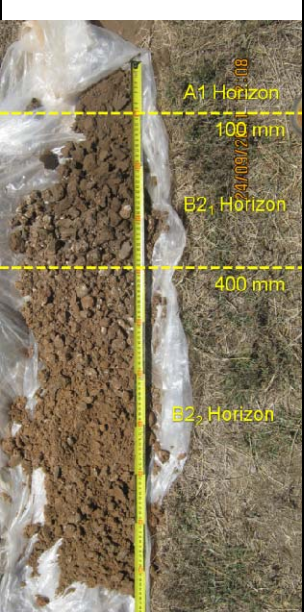
| <b>Project:</b> Wards Well | | <b>Date:</b> 24/9/2011 | | <b>Location:</b> 36 <b>Observation Type:</b> A | | | <b>Coordinates:</b> 0597230, 7606211 | | | | | |
|---|---|---|---|---|---|---|---|---|---|---|---|---|
| <b>Remarks:</b> | | | | | <b>ASC Mapped:</b> Vertosol | | | <b>ASC Ground Truth:</b> Brown Dermosol | | | | |
| 0-100 | SCL | Nil | 7.5YR 3/2 | Nil | | Hard-setting | Firm, Highly Pedal, Coherent | 4 | Not recorded | Diffuse, Even | A1 | 0-100 mm |
| 100-400 | LC / MC | Nil | 7.5Yr 3/2 | Carbonate nodules, Ironstone | | - | Firm, Highly Pedal, Coherent | 4 | Not recorded | Gradual, Even | B2 <sub>1</sub> | 200-300 mm |
| 400-1000+ | MC | Nil | 7.5YR 4/3 | Carbonate nodules | | - | Firm, Highly Pedal, Coherent | 3 | Not recorded | Base of horizon not encountered | B2 <sub>2</sub> | 700-800 mm |

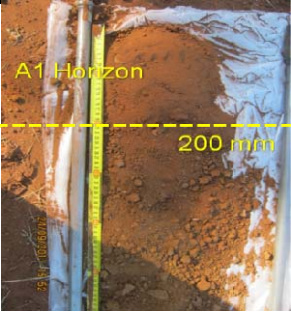
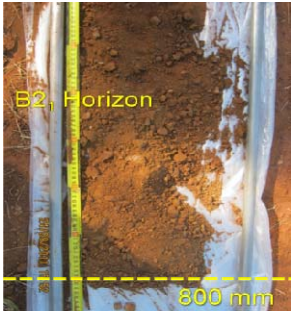
| <b>Project:</b> Wards Well | | <b>Date:</b> 41 | | <b>Location:</b> 41 <b>Observation Type:</b> A | | | | <b>Coordinates:</b> 596794, 7609884 | | | | | |
|---|---|---|---|---|---|---|---|---|---|---|---|---|--|
| 0-200 | SL | ≤ 5% | 2.5YR 4/4 | Small Gravel (1-2 mm), ≤ 5% | | Sandy | Very Weak, Apedal | 1 | Well drained | Diffuse, Even | A1 | No sample | |
| 200-800 | SL | ≤ 5% | 2.5YR 4/6 | Medium Gravel (1-2 mm), ≤ 5% | | - | Weak, Weakly Pedal, Coherent | 2 | Well drained | Sharp, Even | B2 <sub>1</sub> | No sample | |

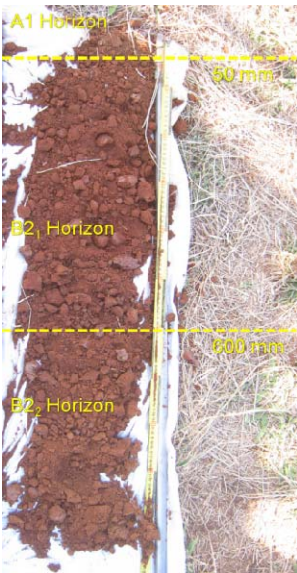
| <b>Project:</b> Wards Well | | <b>Date:</b> 24/9/2011 | | <b>Location:</b> 42 <b>Observation Type:</b> A | | | <b>Coordinates:</b> 0897721, 7608886 | | | | | |
|---|---|---|---|---|---|---|---|---|---|---|---|---|
| 0-50 | SCL | Nil | 5YR 3/4 | Nil | | Firm, hardset sand | Weak, Weakly Pedal, Coherent | 2 | Not recorded | Diffuse, Even | A1 | No sample |
| 50-600 | LC | Nil | 2.5YR 3/4 | Ironstone | | Weak / Firm, Stronger then Weakly Pedal, Coherent | 2 | Not recorded | Diffuse, Even | B2 <sub>1</sub> | No sample | |
| 600+ | MC | Nil | 4YR 3/4 | Black mottles | | Weak / Firm, Stronger then Weakly Pedal, Coherent | 2 | Not recorded | Base of horizon not encountered | B2 <sub>2</sub> | No sample | |

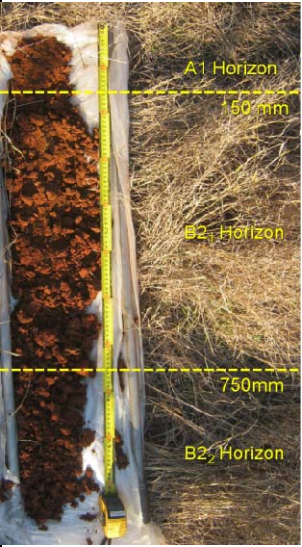
| 0-150 | SL | Nil | 2.5YR 3/3 | Nil | | Firm sand | Very Weak, Weakly Pedal, Coherent | 1 | Well drained | Gradual, Even | A1 | No sample |
| 150-750 | SCL | Nil | 5YR 3/4 | Nil | | - | Weak, Stronger than Weakly Pedal, Coherent | 2 | Imperfect | Diffuse, Even | B2 <sub>1</sub> | No sample |
| 750+ | MC | Nil | 2.5YR 3/4 | Yellow mottles | | - | Weak / Firm, Highly Pedal, Coherent | 2 / 3 | Poor drainage | Base of horizon not encountered | B2 <sub>2</sub> | No sample |

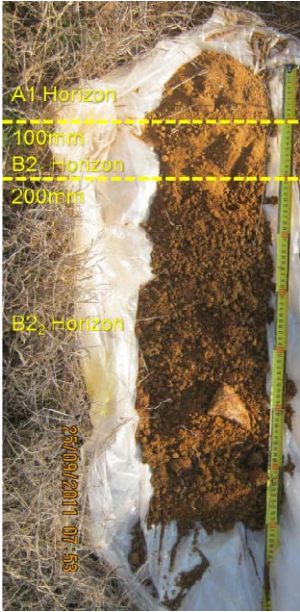
| <b>Project:</b> Wards Well | | <b>Date:</b> 25/9/2011 | | <b>Location:</b> 44 <b>Observation Type:</b> A | | | <b>Coordinates:</b> 0602107, 7615125 | | | | | |
|---|---|---|---|---|---|---|---|---|---|---|---|---|
| 0-100 | SL | 20-30% | 10YR 3/6 | Nil | | Gravely, hard-setting | Loose / Very Weak, Apedal | 0 / 1 | Not recorded | Clear, Even | A1 | 0-100 mm |
| 100-200 | SL | 30% | 10YR 4/4 | Nil | | - | Very Weak, Weakly Pedal | 1 | Not recorded | Clear, Even | B2 <sub>1</sub> | 100-200 mm |
| 200-800 | SCL | 80% | 10YR 4/6 | Yellow mottles | | - | Weak, Highly Pedal, Coherent | 1 / 2 | Not recorded | Base of Horizon not encountered | B2 <sub>2</sub> | 500-600 mm |

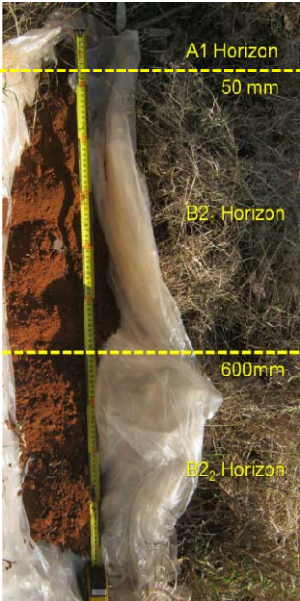
| <b>Project:</b> Wards Well | | <b>Date:</b> 25/9/2011 | | <b>Location:</b> 45 | | <b>Observation Type:</b> A | | <b>Coordinates:</b> 601862, 7614637 | | | | |
|---|---|---|---|---|---|---|---|---|---|---|---|---|
| 0-50 | SCL | ≤ 5% | 7.5YR 3/3 | Nil | | Sandy, Firm, Small gravel (2 - 5 mm) ≤ 5% | Very Weak, Apedal | 1 | Not recorded | Gradual, Even | A1 | No sample |
| 50-600 | LC | ≤ 2% Ironstone | 7.5YR 3/4 | Ironstone | | - | Weak, Weakly Pedal, Coherent | 2 | Not recorded | Gradual, Even | B2 <sub>1</sub> | No sample |
| 600-1000+ | LC | ≤ 5% Gravel | 2.5YR 3/4 | Gravel | | - | Weak, Stronger than Weakly Pedal, Coherent | 2 | Not recorded | Base of horizon not encountered | B2 <sub>2</sub> | No sample |

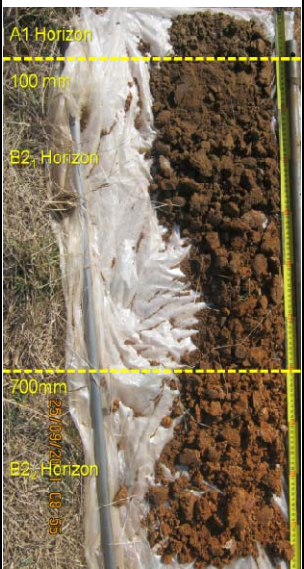
| <b>Project:</b> Wards Well | | <b>Date:</b> 25/9/2011 | | <b>Location:</b> 46 <b>Observation Type:</b> A | | | <b>Coordinates:</b> 0601972, 7613518 | | | | | |
|---|---|---|---|---|---|---|---|---|---|---|---|---|
| 0-100 | LC | ≤ 10% | 10YR 3/2 | Nil | | hard-setting | Firm, Hghly Pedal, Coherent | 3 | Not recorded | Diffuse, Even | A1 | No sample |
| 100-700 | MC | ≤ 5% Ironstone | 10YR 2/2 | Ironstone | | - | Very Firm, Highly Pedal, Coherent | 4 | Not recorded | Gradual, Even | B2 <sub>1</sub> | No sample |
| 700-1000+ | MC | Nil | 7.5YR 6/8 | Orange / red / white mottles, Carbonate nodules | | - | Very Firm, Highly Pedal, Coherent | 4 | Not recorded | Base of horizon not encountered | B2 <sub>2</sub> | No sample |

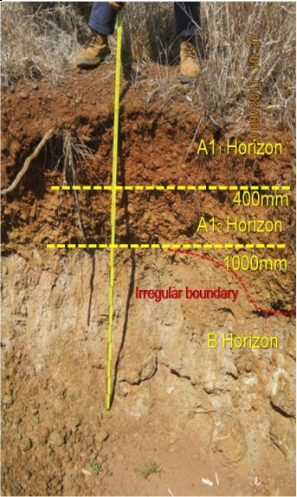
| <b>Remarks:</b> Taken in erosion channel of gravel ridge | <b>ASC Mapped:</b> Kandosol | <b>ASC Ground Truth:</b> Sodosol |

| Depth (mm) | Texture | Coarse Fraction | Munsell Colour | Inclusion | Photograph | Surface Soil Con. | Pedality | Consistence | Drainage | Boundaries | Horizons | Sample |
|---|---|---|---|---|---|---|---|---|---|---|---|---|
| 0-400 | LC | 80% | 2.5YR 3/4 | Nil | | Hard gravel | Weak, Weakly Pedal, Coherent | 2 | Good | Clear, Even | A1 <sub>1</sub> | No sample |
| 400-1000 | LC | 80% | 7.5YR 4/6 | Nil | | - | Weak, Weakly Pedal, Coherent | 2 | Good | Clear, Irregular | A1 <sub>2</sub> | No sample |
| >1000 | MC / HC | Nil | 10YR 5/3 | Grey / orange mottles | | - | Weak, Weakly Pedal, Coherent | 2 | Poor | Base of horizon not encountered | B2 <sub>1</sub> | No sample |

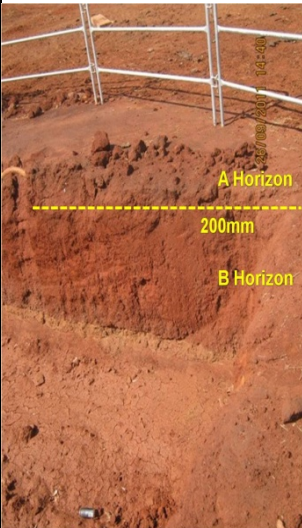
| <b>Project:</b> Wards Well | | <b>Date:</b> 26/9/2011 | | <b>Location:</b> 53 <b>Observation Type:</b> P | | | <b>Coordinates:</b> 596761, 7613627 | | | | | |
|---|---|---|---|---|---|---|---|---|---|---|---|---|
| <b>Remarks:</b> Drill pad | | | | | <b>ASC Mapped:</b> Vertosol | | | <b>ASC Ground Truth:</b> Kandosol | | | | |
| 0-200 | SCL | 0-1% | 2.5YR 3/4 | Ironstone | | Hard packed | Very weak, Weakly pedal, Coherent | 1 | Good | Diffuse | A1 <sub>p</sub> | No sample |
| 200 - >1000 | LC/MC | Nil | 2.5YR 2.5/4 | Ironstone | | Coherent / Massive | Weak, Weakly pedal, Coherent | 2 | Good | Diffuse | B2 <sub>1</sub> | No sample |

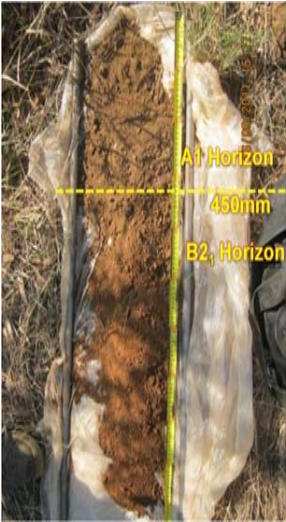
| <b>Project:</b> Wards Well | | <b>Date:</b> 26/9/2011 | | <b>Location:</b> 54 <b>Observation Type:</b> A | | | <b>Coordinates:</b> 596761, 7613627 | | | | | |
|---|---|---|---|---|---|---|---|---|---|---|---|---|
| 0-450 | MC | Nil | 10YR 2/2 | Nil | | Hard packed | Weak, Non-pedal | 2 | Not Recorded | Gradual | A1 | No sample |
| 450-1000+ | SCL | 10-20% | 7.5YR 3/3 | Ironstone | | - | Very weak, weakly pedal | 1 | Not Recorded | Base of horizon not encountered | B2 <sub>1</sub> | No sample |

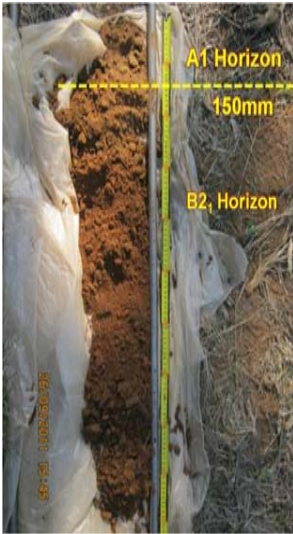
| <b>Project:</b> Wards Well | | <b>Date:</b> 26/9/2011 | | <b>Location:</b> 55 <b>Observation Type:</b> A | | | <b>Coordinates:</b> 597258, 7611552 | | | | | |
|---|---|---|---|---|---|---|---|---|---|---|---|---|
| 0-150 | SL | Nil | 7.5YR 3/4 | Nil | | Sandy Firm | Very weak, Apedal, Coherent | 1 | Good | Gradual | A1 | No sample |
| 150 - >1000 | SCL | Nil | 7.5YR 3/4 | Black / orange mottles at 950mm | | - | Weak, Weakly pedal, Coherent | 1 / 2 | Not Recorded | Base of horizon not encountered | B2 <sub>1</sub> | No sample |

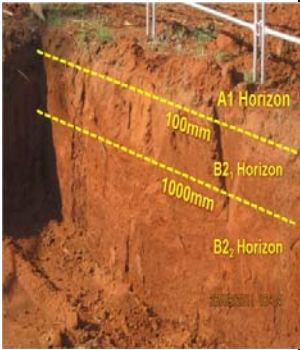
| <b>Project:</b> Wards Well | | <b>Date:</b> 26/9/2011 | | <b>Location:</b> 56 <b>Observation Type:</b> P | | | <b>Coordinates:</b> 0597741, 7611566 | | | | | |
|---|---|---|---|---|---|---|---|---|---|---|---|---|
| 0-100 | SCL | Nil | 5YR 3/3 | Nil | | Hard packed | Very weak, Apedal, Coherent | 1 | Poor | Gradual | A1 <sub>p</sub> | No sample |
| 100 - >1000 | LC | Nil | 2.5YR 3/4 | Some Ironstone | | - | Very weak, Highly pedal | 1 | Poor | Base of horizon not encountered | B2 <sub>1</sub> | No sample |
| >1000 | LC | 20% | | | | | | | | | B2 <sub>2</sub> | No sample |

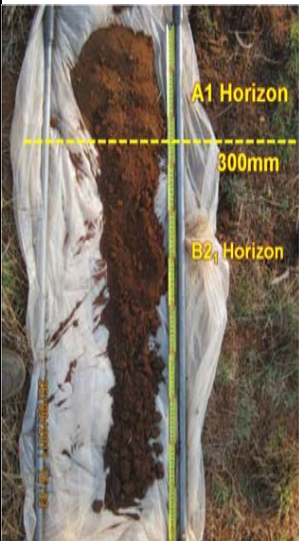
| <b>Project:</b> Wards Well | | <b>Date:</b> 26/9/2011 | | <b>Location:</b> 57 <b>Observation Type:</b> A | | | <b>Coordinates:</b> 0598090, 7610680 | | | | | |
|---|---|---|---|---|---|---|---|---|---|---|---|---|
| 0-300 | LC | Nil | 5YR 3/3 | Nil | | Hard packed | Very weak, Weakly pedal | 1 | Not recorded | Gradual | A1 | No sample |
| 300-1000 | LC/MC | Nil | 5YR 3/4 | Ironstone | | - | Very weak, Weakly pedal | 1 | Not recorded | Base of horizon not encountered | B2 <sub>1</sub> | No sample |

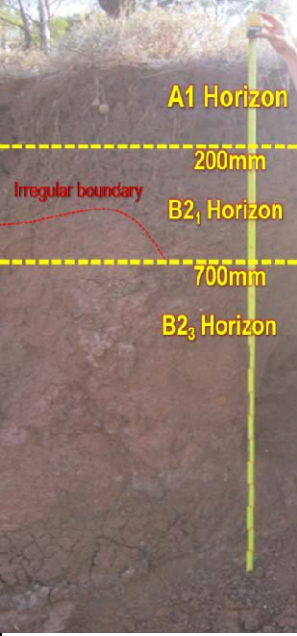
| <b>Project:</b> Wards Well | | <b>Date:</b> 26/9/2011 | | <b>Location:</b> 58 <b>Observation Type:</b> A | | | <b>Coordinates:</b> 597898, 7614327 | | | | | |
|---|---|---|---|---|---|---|---|---|---|---|---|---|
| <b>Remarks:</b> Location is in creekbank, dry and heavily eroded (at 180cm surface is brittle/rocky | | | | <b>ASC Mapped:</b> Vertosol | | | | <b>ASC Ground Truth:</b> Demosol | | | | |
| 0-200 | LC/MC | Nil | 7.5YR 2.5/3 | Nil | | Non cracking | Very weak, Weakly pedal, Coherent | 1 | Not recorded | Gradual, Clear | A1 <sub>p</sub> | No sample |
| 200-700 | MC | <5% | 5YR 3/3 | Ironstone | | - | Very firm, Highly pedal, Coherent | 4 | Not recorded | Not recorded | B2 <sub>1</sub> | No sample |
| 700 - >1000 | MC | 50% is 5-15mm | 7.5YR 2.5/3 | Ironstone | | | Very firm, Highly pedal. Transition layer from B to C. Profile predominately B | 4 | Not recorded | Base of horizon not encountered | B2 <sub>3</sub> | No sample |

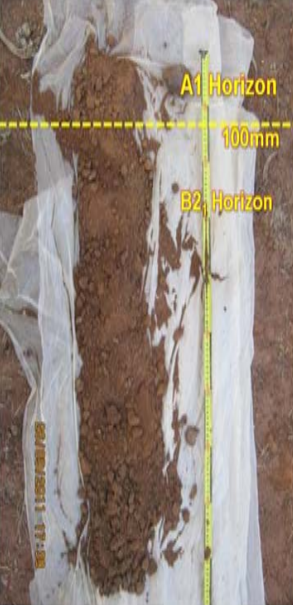
| <b>Project:</b> Wards Well | | <b>Date:</b> 26/9/2011 | | | <b>Location:</b> 59 <b>Observation Type:</b> A | | | <b>Coordinates:</b> 599246, 7614274 | | | | |
|---|---|---|---|---|---|---|---|---|---|---|---|---|
| 0-100 | SCL | 1-5% | 5YR 4/4 | Nil | | Not recorded | Very weak, Weakly pedal, Coherent | 1 | Good | Gradual | A1 | No sample |
| 100- >1000 | LC | Nil | 7.5YR 4/4 | White mottles | | - | Weak, Weakly pedal, Coherent | 2 | Poor | Gradual | B2 <sub>1</sub> | No sample |

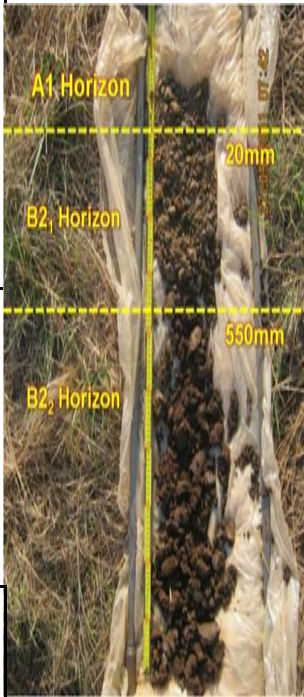
| <b>Project:</b> Wards Well | | <b>Date:</b> 27/9/2011 | | <b>Location:</b> 60 | | | | <b>Observation Type:</b> A | | | | <b>Coordinates:</b> 0596050, 7615539 | | | |
|---|---|---|---|---|---|---|---|---|---|---|---|---|--|--|--|
| 0-20 | LC | Nil | 7.5YR | Nil | | Self Mulching | Very firm, Highly pedal | 4 | Not recorded | Sharp | A1 | 0-20 mm | | | |
| 20-550 | MC | Nil | 7.5YR 3/4 | Nil | | - | Firm, Highly pedal | 3 | Poor | Sharp | B2 <sub>1</sub> | 20-300 mm | | | |
| 550-1000 | SiC | 40% | 7.5YR 3/3 | White/grey mottles and some yellow mottles | | - | Very weak, Highly pedal | 1 | Good | Base of horizon not encountered | B2 <sub>2</sub> | 700-800 mm | | | |

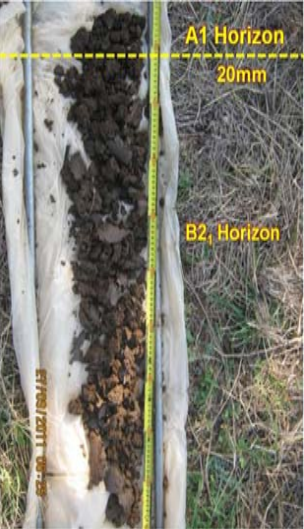
| <b>Project:</b> Wards Well | | <b>Date:</b> 27/9/2011 | | <b>Location:</b> 61 | | | <b>Observation Type:</b> A | | | <b>Coordinates:</b> 597565, 7616055 | | |
|---|---|---|---|---|---|---|---|---|---|---|---|---|
| <b>Remarks:</b> Alluvial floodplain, wet clay at 20mm | | | | <b>ASC Mapped:</b> Vertosol | | | <b>ASC Ground Truth:</b> Vertosol | | | | | |
| 0-20 | LC | Nil | 7.5YR 4/4 | Nil | | Self Mulching | Firm, Highly pedal | 1 / 2 | Good | Gradual | A1 | No sample |
| 20- >1000 | MC | 1-2% 15mm | 7.5YR 3/4 | Orange / white mottles | | - | Firm, Highly pedal | 2 | Poor | Base of horizon not encountered | B2 <sub>1</sub> | No sample |

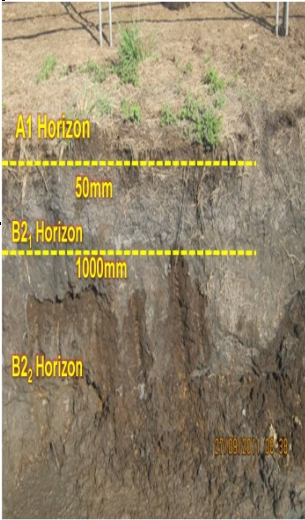
| <b>Project:</b> Wards Well | | <b>Date:</b> 27/9/2011 | | | <b>Location:</b> 62 | | | <b>Observation Type:</b> A | | | <b>Coordinates:</b> 0598732, 7615564 | | |
|---|---|---|---|---|---|---|---|---|---|---|---|---|--|
| 0-50 | LC | Nil | 7.5YR 4/4 | Nil | | Self Mulching | Very weak, Weakly pedal | 1 | Good | Not recorded | A1 <sub>p</sub> | No sample | |
| 50-1000 | MC | ≤ 5% | 7.5YR 3/3 | Black / orange mottling | | - | Weak / firm, Weakly pedal | 2 / 3 | Poor | Sharp | B2 <sub>1</sub> | No sample | |
| >1000 | SCL | ≤ 40% | 10YR 5/4 | Yellow /orange mottles | - | Very weak / Weak, Weakly pedal | 1 / 2 | Not recorded | Base of horizon not encountered | B2 <sub>2</sub> | No sample | | |

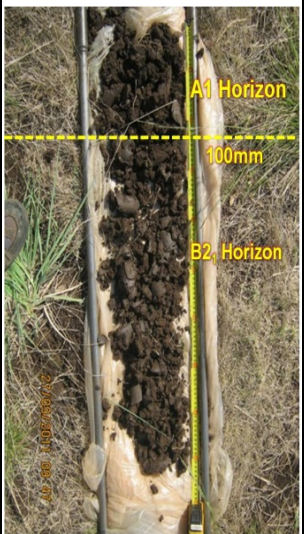
| <b>Project:</b> Wards Well | | <b>Date:</b> 27/9/2011 | | <b>Location:</b> 64 | | | <b>Observation Type:</b> A | | | <b>Coordinates:</b> 0599669, 7616198 | | |
|---|---|---|---|---|---|---|---|---|---|---|---|---|
| 0-100 | MC | Nil | 10YR 3/4 | Nil | | Self Mulching | Very firm, highly pedal | 4 | Poor | Gradual, Even | A1 | No sample |
| 100 - >1000 | MC / HC | Nil | 10YR 3/3 | Orange/brown and white mottling | | - | Very firm, highly pedal | 4 | Poor | Base of horizon not encountered | B2 <sub>1</sub> | No sample |

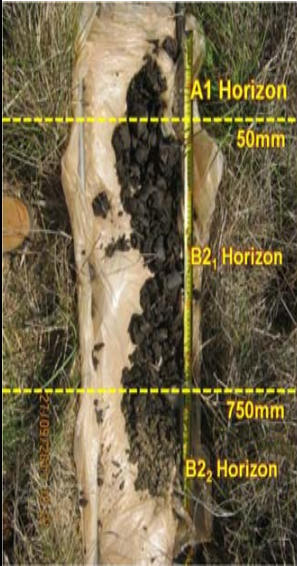
| <b>Project:</b> Wards Well | | <b>Date:</b> 27/9/2011 | | | <b>Location:</b> 65 <b>Observation Type:</b> A | | | <b>Coordinates:</b> 599143, 7617345 | | | | |
|---|---|---|---|---|---|---|---|---|---|---|---|---|
| <b>Remarks:</b> Stiff Clay, auger difficult to advance, tree roots to 500mm | | | | | <b>ASC Mapped:</b> Vertosol | | | <b>ASC Ground Truth:</b> Vertosol | | | | |
| 0-50 | MC | Nil | 7.5 YR 3/2 | Nil | | Self Mulching | Firm, Highly pedal, Coherent | 3 | Poor | Gradual | A1 | No sample |
| 50-750 | MC / HC | Nil | 10YR 3/2 | Fine Ironstone (≥ 2 mm) | | - | Firm/Very firm, Highly pedal, Coherent | 3 / 4 | Poor | Gradual | B2 <sub>1</sub> | No sample |
| 750- >1000 | SiC | 40 -50% | 7.5YR 3/3 | White/grey mottling at 750 | | | Very Weak, Stronger then Weakly Pedal, Coherent | 1 | | sharp | B2 <sub>2</sub> | |

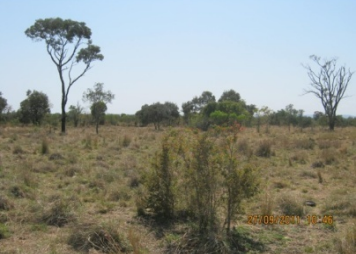
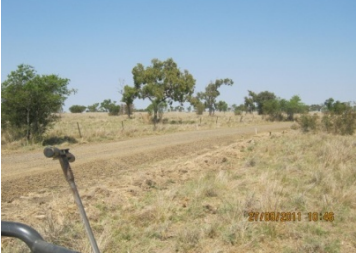
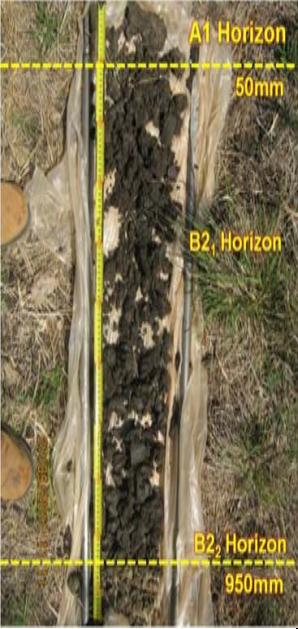
| <b>Project:</b> Wards Well | | <b>Date:</b> 27/9/2011 | | <b>Location:</b> 66 | | | <b>Observation Type:</b> A | | | <b>Coordinates:</b> 0598053, 7617293 | | | |
|---|---|---|---|---|---|---|---|---|---|---|---|---|--|
| <b>Remarks:</b> | | | | <b>ASC Mapped:</b> Vertosol | | | | <b>ASC Ground Truth:</b> Vertosol | | | | | |
| 0-50 | MC | Nil | 10 YR 3/2 | Nil | | Self Mulching, cracking | Very firm, highly pedal | 4 | Not recorded | Sharp | A1 | No sample | |
| 50-950 | MC | Nil | 10YR 3/2 | Fine Ironstone gravel ( $\geq 2$ mm) | | - | Very firm, highly pedal | 4 | Not recorded | Sharp | B2 <sub>1</sub> | No sample | |
| 950- >1000 | SiC | 50% | 10YR 4/3 | White/grey mottling | | - | Very weak, weakly pedal | 1 | Not recorded | Base of horizon not encountered | B2 <sub>2</sub> | No sample | |

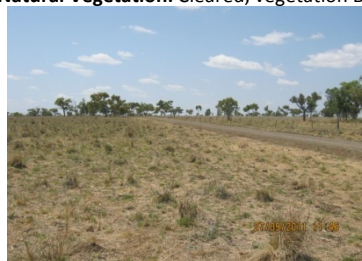
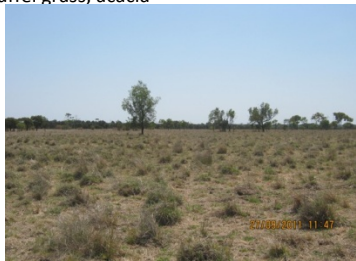
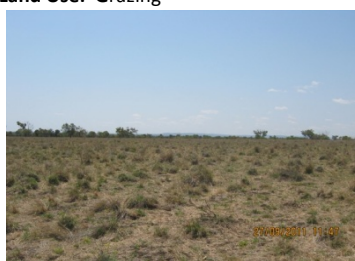
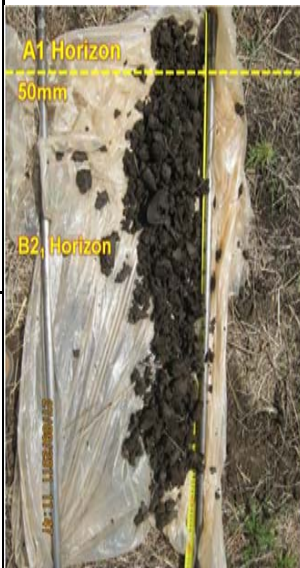
| <b>Project:</b> Wards Well | | <b>Date:</b> 27/9/2011 | | <b>Location:</b> 67 <b>Observation Type:</b> A | | | <b>Coordinates:</b> 0598053, 7617293 | | | | | |
|---|---|---|---|---|---|---|---|---|---|---|---|---|
| <b>Remarks:</b> Large cracks in surface layer | | | | <b>ASC Mapped:</b> Vertosol | | | | <b>ASC Ground Truth:</b> Vertosol | | | | |
| 0-50 | MC | Nil | 10YR 3/3 | Nil | | Self Mulching, cracking | Very firm, highly pedal, massive | 4 | Poor | Gradual | A1 | No sample |
| 50-1000 | MC | Nil | 10YR 3/3 | Orange/black mottles | | - | Very firm, highly pedal, massive | 4 | Poor | Base of horizon not encountered | B2 <sub>1</sub> | No sample |

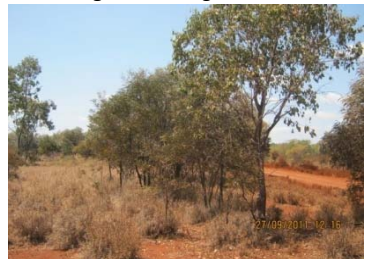
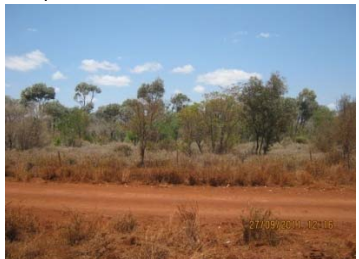
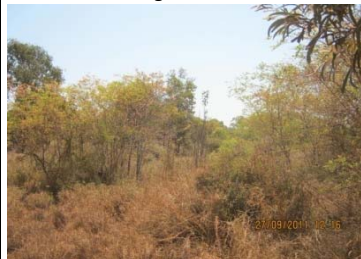
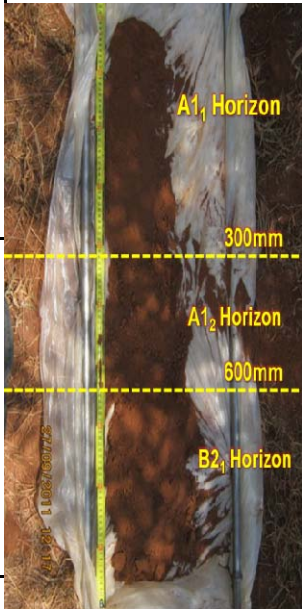
| <b>Project:</b> Wards Well | | <b>Date:</b> 27/9/2011 | | | <b>Location:</b> 68 | | | <b>Observation Type:</b> A | | | <b>Coordinates:</b> 0596388, 7617258 | | |
|---|---|---|---|---|---|---|---|---|---|---|---|---|--|
| <b>Remarks:</b> 600-1000 is hard digging | | | | | <b>ASC Mapped:</b> Vertosol | | | <b>ASC Ground Truth:</b> Kandosol | | | | | |
| 0-300 | SCL | Nil | 2.5 YR 2.5/4 | Nil | | Hard packed | Firm, weakly pedal | 3 | Not recorded | Gradual | A1 <sub>1</sub> | No sample | |
| 300-600 | SCL | 5% | 2.5YR 3/4 | Nil | | - | Weak, weakly pedal | 2 | Not recorded | Dradual | A1 <sub>2</sub> | No sample | |
| 600-1000 | SCL | Nil | 2.5YR 2.5/4 | Nil | | - | Weak, weakly pedal | 2 | Not recorded | Base of horizon not encountered | B2 <sub>1</sub> | No sample | |

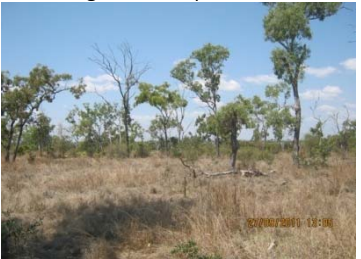
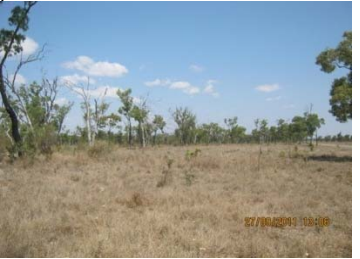
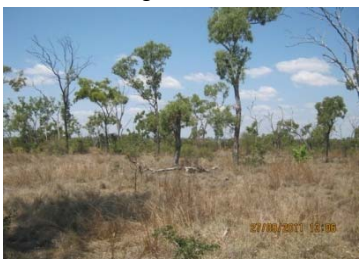
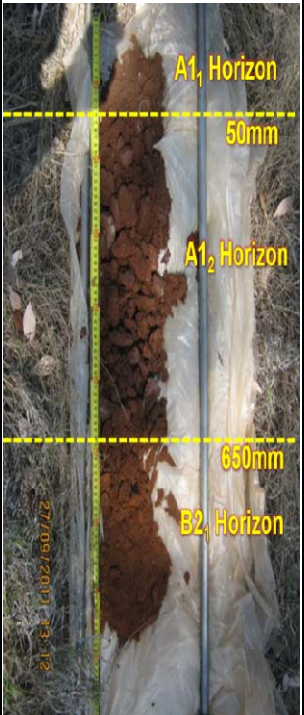
| <b>Project:</b> Wards Well | | <b>Date:</b> 27/9/2011 | | <b>Location:</b> 69 | | | <b>Observation Type:</b> A | | | <b>Coordinates:</b> 0595767, 7617473 | | | |
|---|---|---|---|---|---|---|---|---|---|---|---|---|--|
| <b>Remarks:</b> 600-1000 is hard digging | | | | <b>ASC Mapped:</b> Vertosol | | | <b>ASC Ground Truth:</b> Kandosol | | | | | | |
| 0-50 | SCL | Nil | 2.5 YR 3/3 | Nil | | Hard packed | Very weak/weak, weakly pedal, coherent | 1 / 2 | Good | Sharp | A1 <sub>1</sub> | 0-50 mm | |
| 50-650 | MC | Nil | 2.5YR 2.5/4 | Ironstone and grey mottles | | - | Firm, highly pedal, massive | 3 | Poor | Sharp | A1 <sub>2</sub> | 200-300 mm | |
| 650-100 | SCL | Nil | 2.5YR 3/6 | Nil | | - | Very weak/weak, weakly pedal, coherent | 1 | Not recorded | Base of horizon not encountered | B1 <sub>1</sub> | 800-900 mm | |

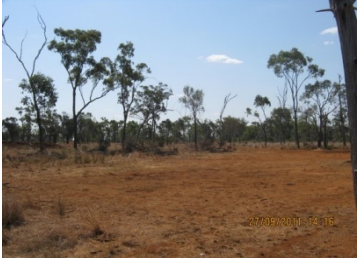
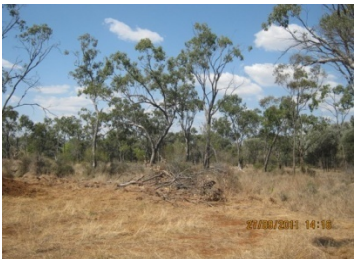
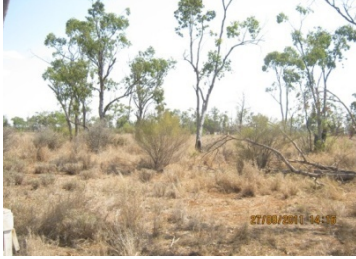
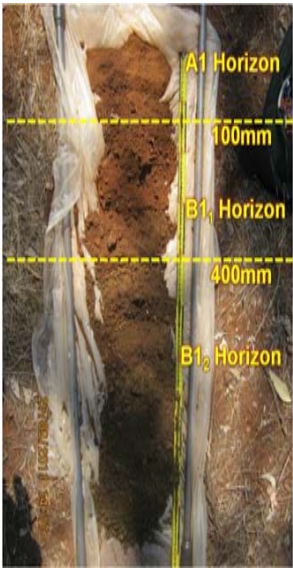
| <b>Project:</b> Wards Well | | <b>Date:</b> 27/9/2011 | | | <b>Location:</b> 71 Observation Type: A | | | <b>Coordinates:</b> 0596210, 7618561 | | | | |
|---|---|---|---|---|---|---|---|---|---|---|---|---|
| 0-100 | LC | Nil | 2.5 YR 3/3 | Nil | | Self mulching | Weak, Apedal | 2 | Not recorded | Gradual | A1 <sub>1</sub> | No sample |
| 100-400 | SC | 5% | 5YR 3/3 | Ironstone | | - | Very weak, weakly pedal | 1 | Not recorded | Sharp | B1 <sub>1</sub> | No sample |
| 400-1000 | SCL | 50% | 7.5YR 2.5/2 | Many ironstone gravels | | - | Very weak, weakly pedal | 1 | Not recorded | Base of horizon not encountered | B2 <sub>1</sub> | No sample |

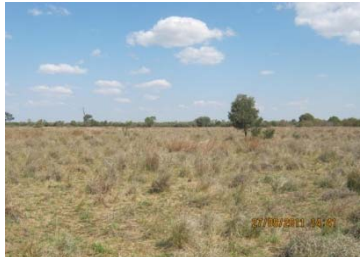
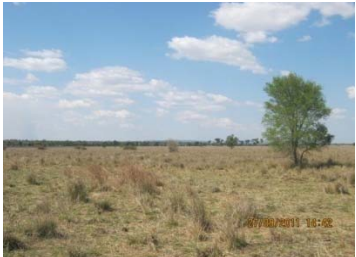
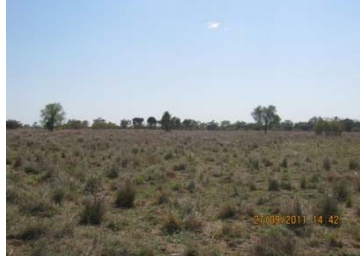
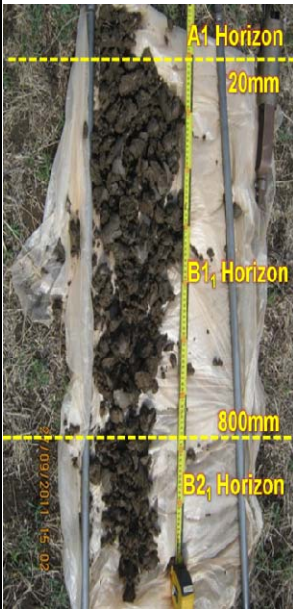
| <b>Project:</b> Wards Well | | <b>Date:</b> 27/9/2011 | | <b>Location:</b> 72 Observation Type: A | | | <b>Coordinates:</b> 0597226, 7618527 | | | | | |
|---|---|---|---|---|---|---|---|---|---|---|---|---|
| <b>Remarks:</b> Hard digging | | | | <b>ASC Mapped:</b> Vertosol | | | | <b>ASC Ground Truth:</b> Vertosol | | | | |
| 0-20 | LC | Nil | 10 YR 3/3 | Nil | | Hard cracking clay, self mulching | Weak, weakly pedal | 2 | Good | Gradual | A1 <sub>1</sub> | No sample |
| 20-800 | MC / HC | 1% | 10YR 3/3 | Black and white mottles (ironstone) | | - | Very firm, strongly pedal | 4 | Poor | Gradual | B2 <sub>1</sub> | No sample |
| 800- >1000 | MC / HC | Nil | 10YR 3/6 | Yellow/orange mottles and ironstone | | - | Very firm, strongly pedal | 4 | Poor | Base of horizon not encountered | B2 <sub>1</sub> | No sample |

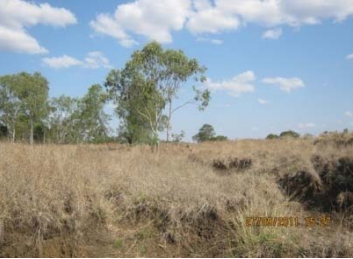
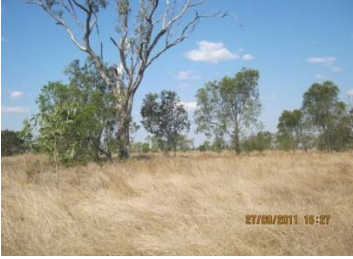
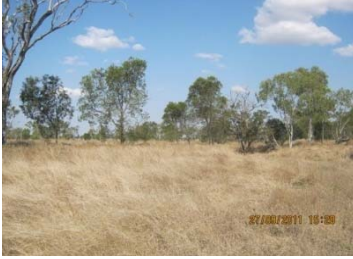
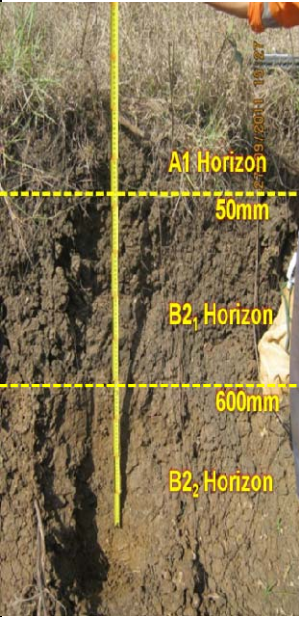
| <b>Project:</b> Wards Well | | <b>Date:</b> 27/9/2011 | | | <b>Location:</b> 73 | | | <b>Observation Type:</b> A | | | <b>Coordinates:</b> 0598601, 7618470 | | |
|---|---|---|---|---|---|---|---|---|---|---|---|---|--|
| <b>Remarks:</b> Creek bank | | | | | <b>ASC Mapped:</b> Vertosol | | | <b>ASC Ground Truth:</b> Vertosol | | | | | |
| 0-50 | LC | Nil | 10YR 3/1 | Nil | | Self mulching | Loose | 0 | Not recorded | Gradual | A1 <sub>1p</sub> | No sample | |
| 50-600 | LC / MC | 5% | 10YR 3/2 | White mottles between 150-200mm | | | Very Firm, Strongly Pedal, Coherent | 4 | Not recorded | Abrupt | B2 <sub>1</sub> | No sample | |
| 600- >1000 | LC / MC | 5% | 10YR 4/3 | Ironstone | | | Weak, weakly pedal, massive | 2 | Poor | Base of horizon not encountered | B2 <sub>2</sub> | No sample | |

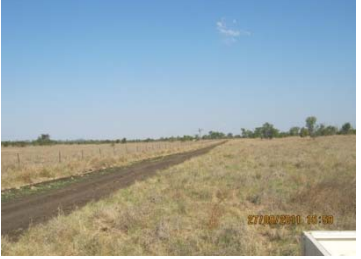
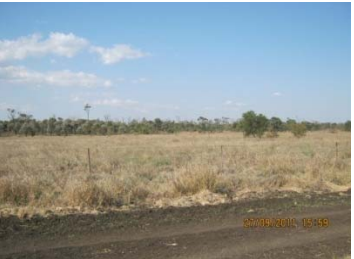
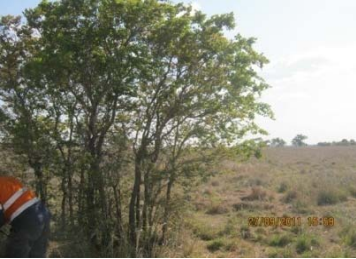
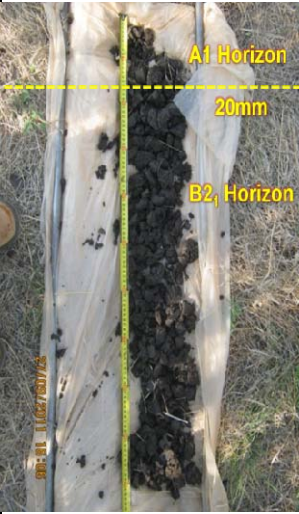
| <b>Project:</b> Wards Well | | <b>Date:</b> 27/9/2011 | | <b>Location:</b> 74 Observation Type: A | | | <b>Coordinates:</b> 0600207, 7619004 | | | | | |
|---|---|---|---|---|---|---|---|---|---|---|---|---|
| <b>Remarks:</b> Hard digging | | | | | <b>ASC Mapped:</b> Vertosol | | | <b>ASC Ground Truth:</b> Vertosol | | | | |
| 0-20 | LC | Nil | 10YR 3/3 | Nil | | Self mulching, hard cracking clays | Weak, Weakly pedal, Massive | 2 | Good | Gradual | A <sub>1</sub> | No sample |
| 20-1000 | MC | 1% | 10YR 3/3 | Black and white mottles | | | Very firm, strongly pedal, Massive | 4 | Poor | Abrupt | B <sub>2</sub> <sub>1</sub> | No sample |

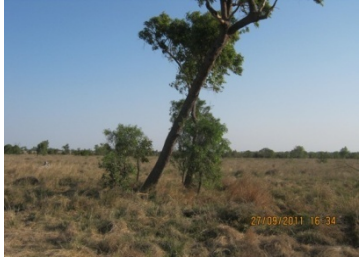
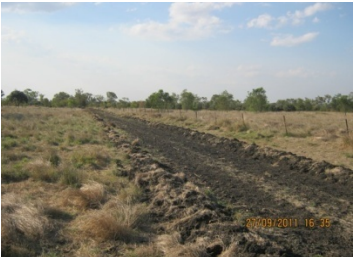
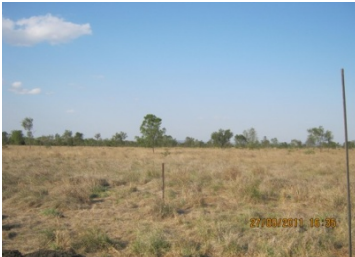
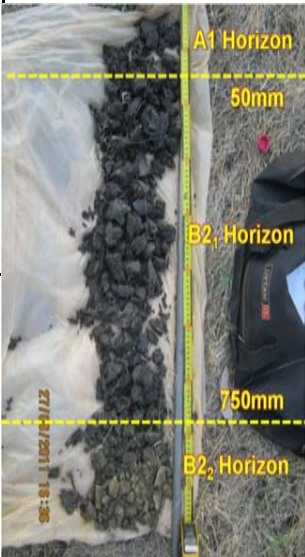
| <b>Project:</b> Wards Well | | <b>Date:</b> 27/9/2011 | | | <b>Location:</b> 75 <b>Observation Type:</b> A | | | <b>Coordinates:</b> 0599700, 7619872 | | | | |
|---|---|---|---|---|---|---|---|---|---|---|---|---|
| <b>Remarks:</b> Hard digging | | | | | <b>ASC Mapped:</b> Vertosol | | | <b>ASC Ground Truth:</b> Vertosol | | | | |
| 0-50 | LC | Nil | 10YR 4/1 | Nil | | Self mulching, hard cracking clay | Weak / firm, highly pedal, massive | 2-3 | Poor | Gradual | A <sub>1</sub> | 0-50 mm |
| 50-750 | MC | Nil | 10YR 4/1 | white mottles | | Very firm, highly pedal, massive | 4 | Poor | Sharp | B <sub>2</sub> <sub>1</sub> | 400-500 mm | |
| 750 - >1000 | LC/MC | Nil | Not recorded | white/grey mottles | - | Fine, sub-angular, r3 | No recorded | No recorded | Base of horizon not encountered | B <sub>2</sub> <sub>2</sub> | 900-1000 mm | |

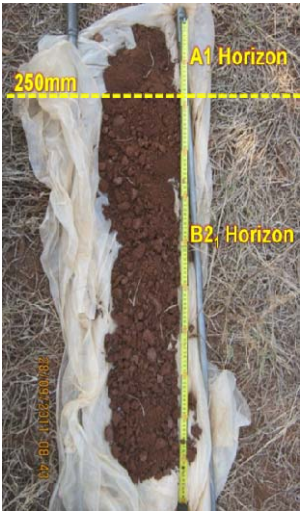
| <b>Project:</b> Wards Well | | <b>Date:</b> 28/9/2011 | | | <b>Location:</b> 77 Observation Type: A | | | <b>Coordinates:</b> 0595518, 7624627 | | | | |
|---|---|---|---|---|---|---|---|---|---|---|---|---|
| 0-250 | SL | 10% | 5YR 3/4 | Nil | | Sandy, firm, non-cracking | Very weak, weakly pedal, massive | 1 | Good | Sharp | A1 <sub>1</sub> | No sample |
| 250- >1000 | SCL | Nil | 5YR 3/4 | White/black mottles, yellow mottles at 300mm | | - | Very weak, weakly pedal, massive | 1 | Good | Gradual | B2 <sub>1</sub> | No sample |

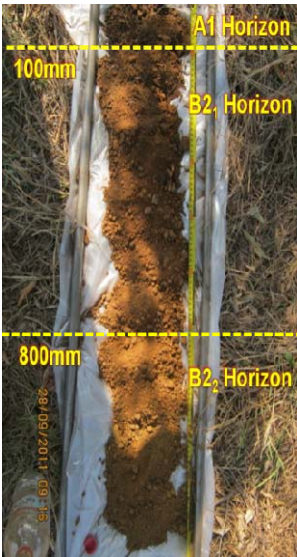
| <b>Project:</b> Wards Well | | <b>Date:</b> 28/9/2011 | | <b>Location:</b> 78 | | | <b>Observation Type:</b> A | | | <b>Coordinates:</b> 0595448, 7625536 | | | |
|---|---|---|---|---|---|---|---|---|---|---|---|---|--|
| 0-100 | SCL | 20% | 7.5YR 3/3 | Nil | | Self mulching | Very weak, weakly pedal | 1 | Not recorded | Gradual | A <sub>1</sub> | No sample | |
| 100-800 | SCL | 50% | 7.5YR 4/4 | Nil | | - | Very weak, weakly pedal | 1 | Good | Gradual | B <sub>2</sub> <sub>1</sub> | No sample | |
| 800 - >1000 | SCL | 60% | 10YR 4/6 | Nil | | - | Very weak, weakly pedal | 1 | Not recorded | Base of horizon not encountered | B <sub>2</sub> <sub>2</sub> | No sample | |

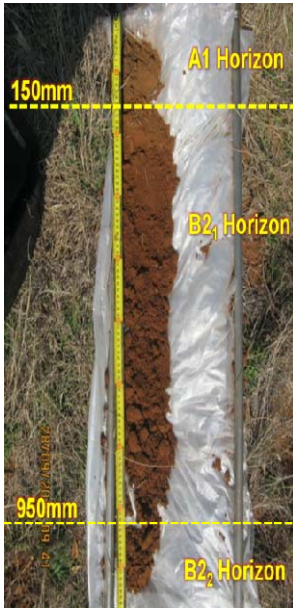
| <b>Project:</b> Wards Well | | <b>Date:</b> 28/9/2011 | | <b>Location:</b> 79 Observation Type: A | | | <b>Coordinates:</b> 0596176, 7625794 | | | | | |
|---|---|---|---|---|---|---|---|---|---|---|---|---|
| 0-150 | SL | Nil | 5YR 3/3 | Nil | | Hard packed sandy | Very weak, non-pedal | 1 | Good | Gradual | A1 <sub>1</sub> | No sample |
| 150-950 | SCL | Nil | 2.5YR 4/4 | Nil | | - | Very weak, weakly pedal, massive | 1 | Good | Sharp | B2 <sub>1</sub> | No sample |
| 950- >1000 | SCL | Nil | 5YR 4/4 | Ironstone | | - | Very weak, weakly pedal, massive | 1 | Poor | Base of horizon not encountered | B2 <sub>2</sub> | No sample |

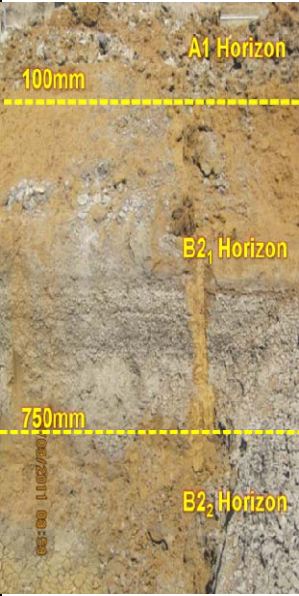
| <b>Project:</b> Wards Well | | <b>Date:</b> 28/9/2011 | | <b>Location:</b> 80 | | | <b>Observation Type:</b> P | | | <b>Coordinates:</b> 0597227, 7626006 | | |
|---|---|---|---|---|---|---|---|---|---|---|---|---|
| 0-100 | SL | Nil | 10YR 3/3 | Nil | | Hard packed fine gravel | Very weak, non pedal, massive | 2 | Good | Gradual | A1 <sub>1p</sub> | No sample |
| 100-750 | SCL | Nil | 10YR 4/6 | Ironstone | | - | Weak, weakly pedal, massive | 2 | Poor | Sharp, Irregular | B2 <sub>1</sub> | No sample |
| 750 - >1000 | MC/HC | Nil | 10YR 5/4 | Grey mottles | | - | Very firm, weakly pedal, massive | 4 | Poor | Base of horizon not encountered | B2 <sub>2</sub> | No sample |

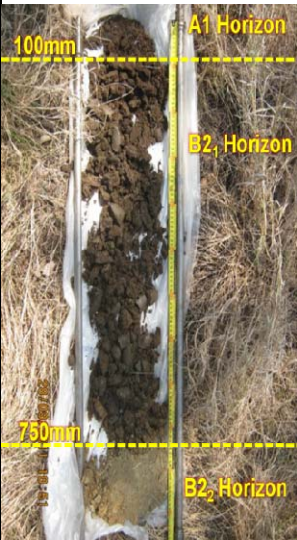
| <b>Project:</b> Wards Well | | <b>Date:</b> 28/9/2011 | | <b>Location:</b> 81 Observation Type: P | | | <b>Coordinates:</b> 0597444, 7625089 | | | | | |
|---|---|---|---|---|---|---|---|---|---|---|---|---|
| 0-50 | MC | Nil | 10YR 3/3 | Nil | | Hard cracking | Firm, Weakly pedal, Massive | 3 | Good | Gradual | A1 <sub>1</sub> | No sample |
| 50-700 | MC | Nil | 10YR 3/2 | Ironstone | | - | Firm, Weakly pedal, Massive | 3 | Poor | Sharp | B2 <sub>1</sub> | No sample |
| 700- >1000 | SL | Nil | 10YR 4/3 | White, grey, orange mottles | | - | Very weak, Apedal | 1 | Good | Base of horizon not encountered | B2 <sub>2</sub> | No sample |

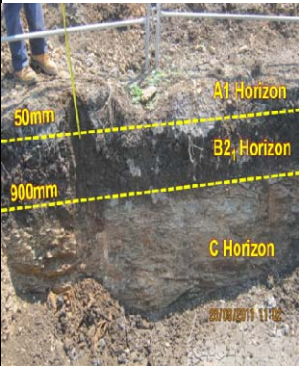
| <b>Project:</b> Wards Well | | <b>Date:</b> 28/9/2011 | | <b>Location:</b> 82 | | | <b>Observation Type:</b> P | | | <b>Coordinates:</b> 0596439, 7624851 | | |
|---|---|---|---|---|---|---|---|---|---|---|---|---|
| 0-50 | LC/MC | Nil | 10YR 2/2 | Nil | | Self mulching | Weak | 2 | Good | Gradual | A1 <sub>1p</sub> | No sample |
| 50-900 | MC | Nil | 10YR 3/3 | Ironstone | | - | Weak | 2 | Poor | Sharp | B2 <sub>1</sub> | No sample |
| 900-1000 | SC | Massive | 10YR 4/3 | White, grey, orange mottles | | - | Massive, Rock | 1 | Poor | Base of horizon not encountered | C | No sample |

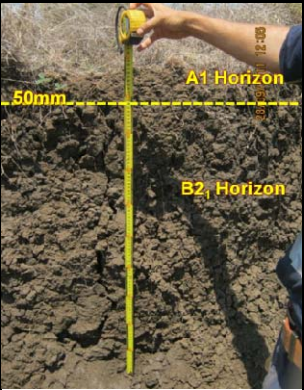
| <b>Project:</b> Wards Well | | <b>Date:</b> 28/9/2011 | | <b>Location:</b> 84 <b>Observation Type:</b> E | | | <b>Coordinates:</b> | | | | | |
|---|---|---|---|---|---|---|---|---|---|---|---|---|
| 0-50 | SC | 10% | 10YR 3/2 | Nil | | Self mulching | Weak, highly pedal, massive | 2 | Good | Sharp | A1 <sub>1p</sub> | No sample |
| 50 - >1000 | MC | Nil | 10YR 3/3 | Ironstone | | - | Very firm, highly pedal, massive | 4 | Poor | Base of horizon not encountered | B2 <sub>1</sub> | No sample |

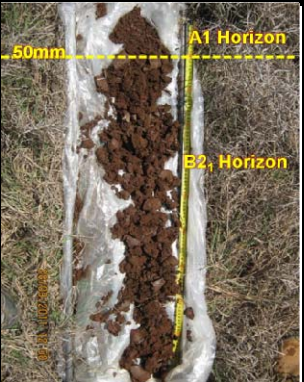
| <b>Project:</b> Wards Well | | <b>Date:</b> 28/9/2011 | | <b>Location:</b> 85 | | <b>Observation Type:</b> A | | <b>Coordinates:</b> 0597468, 7623012 | | | | |
|---|---|---|---|---|---|---|---|---|---|---|---|---|
| 0-50 | LC | Nil | 5YR 3/4 | Nil | | Self mulching | Firm, weakly pedal | 3 | Not recorded | Gradual | A1 <sub>1</sub> | No sample |
| 50 - >1000 | MC | Nil | 5YR 3/4 | Ironstone | | - | Weak, highly pedal | 2 | Not recorded | Base of horizon not encountered | B2 <sub>1</sub> | No sample |

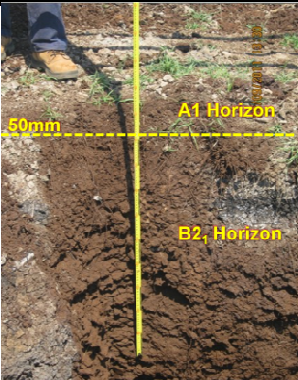
| <b>Project:</b> Wards Well | | <b>Date:</b> 28/9/2011 | | <b>Location:</b> 86 <b>Observation Type:</b> P | | <b>Coordinates:</b> 0595998, 7622629 | | | | | | |
|---|---|---|---|---|---|---|---|---|---|---|---|---|
| 0-50 | LC | Nil | 7.5YR 3/3 | Nil | | Hard cracking clay | Weak, strongly pedal | 2 | Not recorded | Gradual | A1 <sub>1p</sub> | No sample |
| 50 - >1000 | MC | 5-10% | 7.5YR 3/4 | Ironstone and orange/brown mottles | | - | Very firm, highly pedal | 4 | Not recorded | | B2 <sub>1</sub> | No sample |

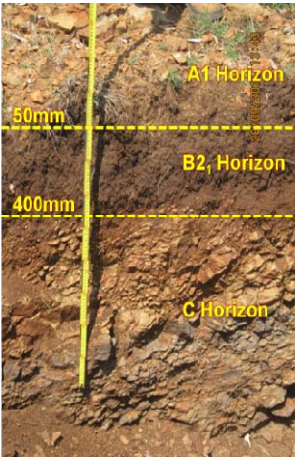
| <b>Project:</b> Wards Well | | <b>Date:</b> 28/9/2011 | | <b>Location:</b> 87 | | | <b>Observation Type:</b> P | | | <b>Coordinates:</b> 0595048, 7622481 | | | |
|---|---|---|---|---|---|---|---|---|---|---|---|---|--|
| <b>Remarks:</b> Dead trees | | | | <b>ASC Mapped:</b> Vertosol | | | <b>ASC Ground Truth:</b> Dermosol | | | | | | |
| 0-20 | SC | 1% | 7.5YR 2.5/3 | White mottles | | Non-cracking clay | Very firm, massive | 4 | Good | Sharp | A <sub>1p</sub> | No sample | |
| 20-400 | LC/MC | 0% | 7.5YR 3/3 | Ironstone | | - | Weak/firm | 2-3 | Poor | Sharp | B <sub>2</sub> <sub>1</sub> | No sample | |
| 400 - >1000 | Rock | 100% | | Massive Rock | | - | Massive | 4 | Poor | Base of horizon not encountered | C | No sample | |

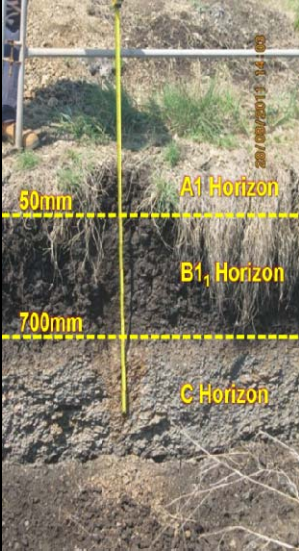
| <b>Project:</b> Wards Well | | <b>Date:</b> 28/9/2011 | | <b>Location:</b> 88 <b>Observation Type:</b> P | | <b>Coordinates:</b> 0595737, 7623676 | | | | | | |
|---|---|---|---|---|---|---|---|---|---|---|---|---|
| <b>Remarks:</b> | | | | <b>ASC Mapped:</b> Vertosol | | <b>ASC Ground Truth:</b> Dermosol | | | | | | |
| 0-50 | HC | 1% | 10YR 4/2 | Nil | | Very hard cracking clay | Very firm, highly pedal, massive | 4 | Good | Sharp | A1 <sub>1p</sub> | No sample |
| 50-700 | MC | 0% | 10YR 3/2 | White mottles | | | firm, highly pedal, massive | 3 | Poor | Sharp | B2 <sub>1</sub> | No sample |
| 700 - >1000 | Hard rock layer | 100% | Not recorded | Yellow/grey | | | Massive | 4 | Poor | Base of horizon not encountered | C | No sample |

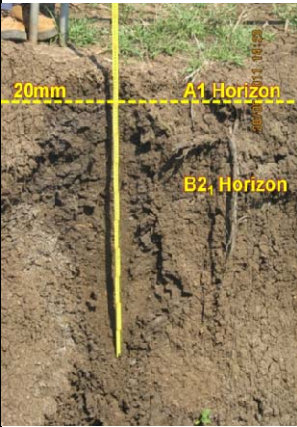
| <b>Project:</b> Wards Well | | <b>Date:</b> 28/9/2011 | | <b>Location:</b> 89 <b>Observation Type:</b> P | | | <b>Coordinates:</b> 0595582, 7620461 | | | | | |
|---|---|---|---|---|---|---|---|---|---|---|---|---|
| <b>Remarks:</b> Between creeks | | | | <b>ASC Mapped:</b> Vertosol | | | | <b>ASC Ground Truth:</b> Vertosol | | | | |
| 0-20 | LC/MC | 1% | 10YR 3/3 | Nil | | Self mulching, roots | Firm/very firm, strongly pedal, massive | 3-4 | Good | Gradual | A1 <sub>1p</sub> | No sample |
| 20- >1000 | LC/MC | Nil | 10YR 4/3 | Grey mottles with roots and Ironstone | | - | Firm, strongly pedal, massive | 3 | Poor | Base of horizon not encountered | B2 <sub>1</sub> | No sample |

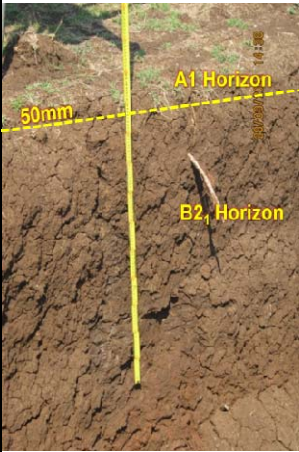
| <b>Project:</b> Wards Well | | <b>Date:</b> 28/9/2011 | | <b>Location:</b> 90 | | <b>Observation Type:</b> P | | <b>Coordinates:</b> 0595253, 7621429 | | | | |
|---|---|---|---|---|---|---|---|---|---|---|---|---|
| <b>Remarks:</b> Good grass cover | | | | <b>ASC Mapped:</b> Vertosol | | | | <b>ASC Ground Truth:</b> Dermosol | | | | |
| 0-50 | MC | Nil | 10YR 3/3 | Nil | | Cracking clay, sel-mulching | Firm / very firm, strongly pedal | 3-4 | Good | Gradual | A1 <sub>1p</sub> | No sample |
| 50-1050 | LC | Nil | 10YR 3/4 | Red mottles and Ironstone | | - | Firm, strongly pedal | 3 | Poor | Base of horizon not encountered | B2 <sub>1</sub> | No sample |

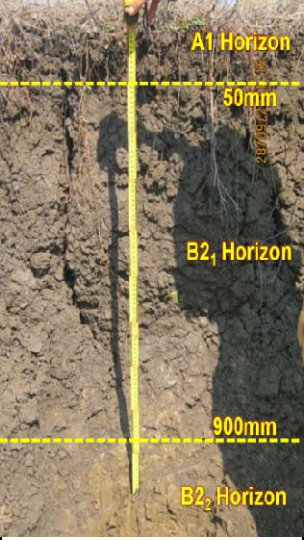
| <b>Project:</b> Wards Well | | <b>Date:</b> 28/9/2011 | | | <b>Location:</b> 91 | | | <b>Observation Type:</b> P | | | <b>Coordinates:</b> 0597501, 7620905 | | |
|---|---|---|---|---|---|---|---|---|---|---|---|---|---|
| <b>Remarks:</b> Dry creekbed | | | | | <b>ASC Mapped:</b> Vertosol | | | <b>ASC Ground Truth:</b> Vertosol | | | | | |
| 0-50 | LC | Nil | 10YR 4/2 | Nil | | Hard cracking clay | Firm, strongly pedal, massive | 3 | Well | Sharp | A <sub>1p</sub> | No sample | |
| 50-900 | LC/MC | Nil | 10YR 4/2 | Carbonate, Ironstone, brown maroon gravel | | | | Weak, strongly pedal, massive | 2 | Poor | Sharp | B <sub>2</sub> <sub>1</sub> | No sample |
| 900 - >1000 | MC | Nil | 10YR 4/3 | Grey gravel, carbonate | | | | Very weak/weak, strongly pedal, massive | 1-2 | | Base of horizon not encountered | B <sub>2</sub> <sub>1</sub> | No sample |

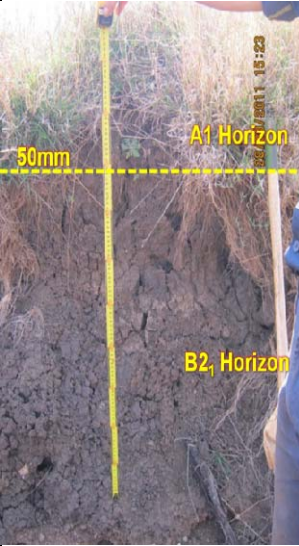
| <b>Project:</b> Wards Well | | <b>Date:</b> 28/9/2011 | | <b>Location:</b> 92 Observation Type: P | | | <b>Coordinates:</b> 0596076, 7621714 | | | | | |
|---|---|---|---|---|---|---|---|---|---|---|---|---|
| <b>Remarks:</b> Dry creekbed | | | | | <b>ASC Mapped:</b> Vertosol | | | <b>ASC Ground Truth:</b> Dermosol | | | | |
| 0-50 | MC | Nil | 10YR 4/3 | Ironstone | | Self mulching | Very firm, strongly pedal, massive | 4 | Well | Sharp | A <sub>1</sub> | No sample |
| 50-1000 | MC | Nil | 10YR 3/3 | Carbonate | | - | Weak/firm, strongly pedal, massive | 2-3 | Poor | Sharp | B <sub>2</sub> | No sample |
| 1000-1050 | White rocks | 60/70% | 10YR 4/3 | Grey gravel, carbonate | | - | Weak, Massive | 3-4 | Not recorded | Base of horizon not encountered | C | No sample |

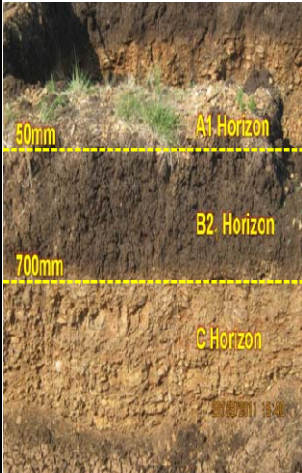
| <b>Project:</b> Wards Well | | <b>Date:</b> 28/9/2011 | | <b>Location:</b> 93 | | | <b>Observation Type:</b> | | | <b>Coordinates:</b> 598022, 7622167 | | |
|---|---|---|---|---|---|---|---|---|---|---|---|---|
| <b>Remarks:</b> Dry creekbed | | | | <b>ASC Mapped:</b> Vertosol | | | <b>ASC Ground Truth:</b> Vertosol | | | | | |
| 0-50 | LC | Nil | 10YR 3/4 | Nil | | Self mulching | Weak/firm, strongly pedal, massive | 2 / 3 | Well | Sharp | A1 <sub>1p</sub> | No sample |
| 50-700 | MC | Nil | 10YR 3/3 | Orange gravel | | - | Weak, strongly pedal, massive | 2 | Poor | Sharp | B2 <sub>1</sub> | No sample |
| 700- >1000 | Rocks | 60/70% | 10YR 4/3 | | | - | Weak, Massive | 3 / 4 | None | Base of horizon not encountered | C | No sample |

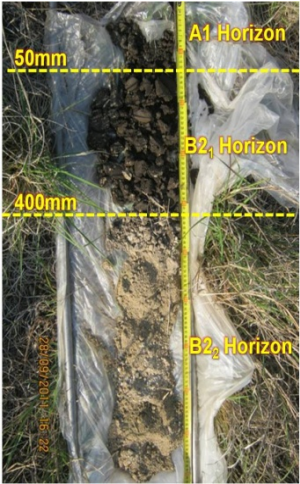
| <b>Project:</b> Wards Well | | <b>Date:</b> 28/9/2011 | | <b>Location:</b> 94 | | | <b>Observation Type:</b> A | | | <b>Coordinates:</b> 0599580, 7622074 | | | |
|---|---|---|---|---|---|---|---|---|---|---|---|---|---|
| <b>Remarks:</b> Long grass up to 1.2m | | | | | <b>ASC Mapped:</b> Vertosol | | | | <b>ASC Ground Truth:</b> Vertosol | | | | |
| 0-50 | LC | Nil | 10YR 3/2 | Nil | | Self mulching | Weak, strongly pedal | 2 | Good | Sharp | A <sub>1</sub> | 0-50 mm | |
| 50-400 | MC | Nil | 10YR 3/1 | Carbonate | | | | Very firm, strongly pedal | 4 | Poor | Sharp | B <sub>2</sub> <sub>1</sub> | 200-300 mm |
| 400->1000 | SL | Nil | 10YR 4/1 | Carbonate at 400mm | | | | Very weak, non pedal | 1 | Good | Base of horizon not encountered | B <sub>2</sub> <sub>2</sub> | 600-700 mm |

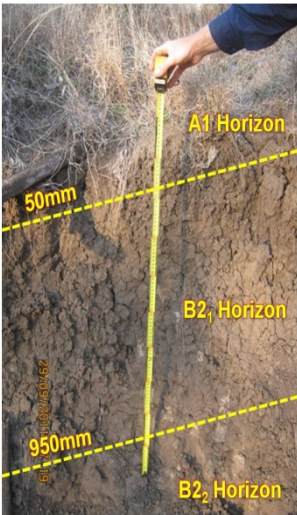
| <b>Project:</b> Wards Well | | <b>Date:</b> 29/9/2011 | | <b>Location:</b> 95 <b>Observation Type:</b> E | | | <b>Coordinates:</b> 0598841, 7620747 | | | | | |
|---|---|---|---|---|---|---|---|---|---|---|---|---|
| <b>Remarks:</b> In creek bed | | | | | <b>ASC Mapped:</b> Vertosol | | | <b>ASC Ground Truth:</b> Vertosol | | | | |
| 0-50 | LC | Nil | 10YR 3/2 | Carbonate gravels | | Self mulching crust | Very firm, strongly pedal | 4 | Not recorded | Sharp | A <sub>1</sub> | No sample |
| 50-950 | LC | Nil | 10YR 3/3 | Carbonate gravels | | - | Very firm, strongly pedal | 4 | Not recorded | Gradual | B <sub>2</sub> <sub>1</sub> | No sample |
| 950- >1000 | MC | Nil | 10YR 4/2 | Ironstone gravels | | - | Firm, strongly pedal | 3 | Not recorded | Base of horizon not encountered | B <sub>2</sub> <sub>2</sub> | No sample |

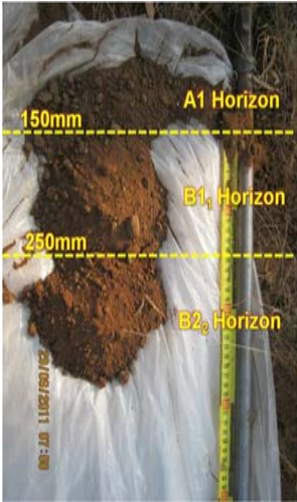
| <b>Project:</b> Wards Well | | <b>Date:</b> 29/9/2011 | | <b>Location:</b> 96 | | | <b>Observation Type:</b> E | | | <b>Coordinates:</b> 0596817, 7620084 | | | |
|---|---|---|---|---|---|---|---|---|---|---|---|---|---|
| <b>Remarks:</b> Located on rocky ridge, auger hit hard rock twice | | | | | <b>ASC Mapped:</b> Vertosol | | | | <b>ASC Ground Truth:</b> Kandosol | | | | |
| 0-150 | SL | 50% | 7.5YR 3/4 | Black and yellow gravels | | Hard packed gravel | Very weak, non pedal | 1 | Good | Sharp | A <sub>1</sub> | No sample | |
| 150-250 | SI | 50% | 5YR 4/4 | Ironstone gravel | | | Very weak, non pedal | 1 | Good | Sharp | B <sub>2</sub> | No sample | |
| 250+ | Rock | | | | | | | | | Poor | | B <sub>2</sub> | No sample |

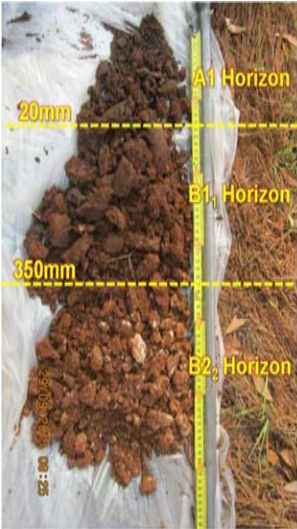
| <b>Project:</b> Wards Well | | <b>Date:</b> 29/9/2011 | | <b>Location:</b> 97 <b>Observation Type:</b> A | | | <b>Coordinates:</b> 0596317, 7619984 | | | | | |
|---|---|---|---|---|---|---|---|---|---|---|---|---|
| 0-20 | LC-MC | Nil | 5YR 3/4 | Nil | | Firm cracking surface | Very firm, strongly pedal, massive | 4 | Good | Sharp | A <sub>1</sub> | No sample |
| 20-350 | MC | Nil | 5YR 4/6 | Ironstone & carbonate gravels | | - | Weak/firm, strongly pedal | 2-3 | Poor | Sharp | B <sub>2</sub> <sub>1</sub> | No sample |
| 350-600 | Sandy clay | 70% | 5YR 4/6 | Carbonate | | - | Very weak, weakly pedal | 1 | Good | Base of horizon not encountered | B <sub>2</sub> <sub>2</sub> | No sample |

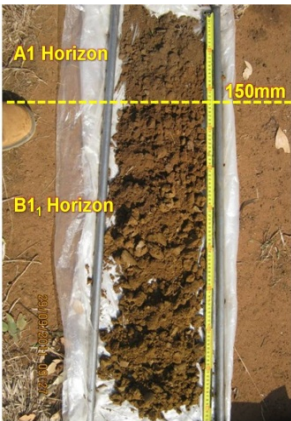
| <b>Project:</b> Wards Well | | <b>Date:</b> 29/9/2011 | | <b>Location:</b> 98 | | | <b>Observation Type:</b> A | | | <b>Coordinates:</b> 0599337, 7620288 | | |
|---|---|---|---|---|---|---|---|---|---|---|---|---|
| 0-150 | SL | Nil | 10YR 4/3 | Nil | | Sandy firm | Very weak, weakly pedal | 1 | Good | Sharp | A1 <sub>1</sub> | No sample |
| 150- >1000 | LC | Nil | 7.5YR 5/6 | Ironstone & orange gravels | | - | Fine, strongly pedal, massive | 3 | Poor | Base of horizon not encountered | B2 <sub>1</sub> | No sample |

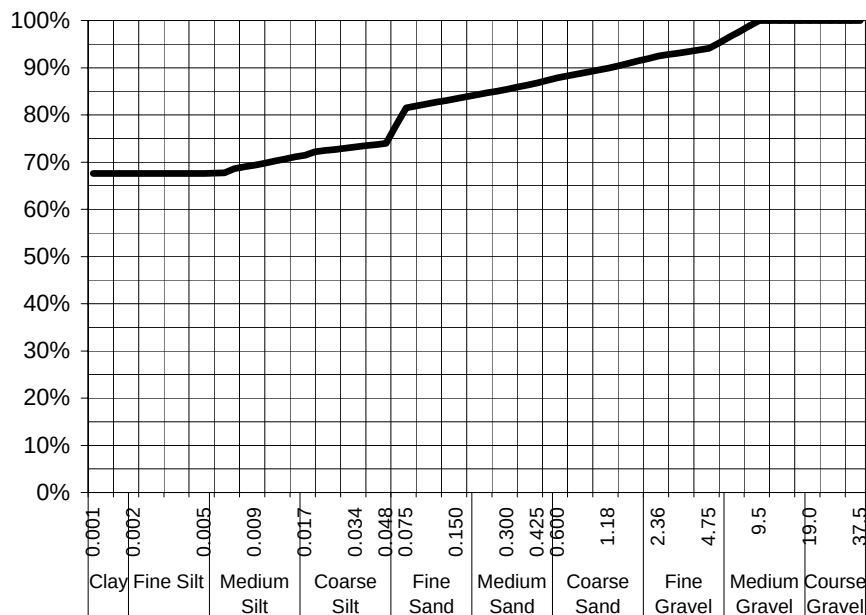
**CLIENT:** Timothy Rohde **DATE REPORTED:** 26-Oct-2011  
**COMPANY:** Sinclair Knight Merz **DATE RECEIVED:** 17-Oct-2011  
**ADDRESS:** P O Box 312 Flinders Lane **REPORT NO:** EB1121537-002 / PSD  
Melbourne, Vic Australia 8009  
**PROJECT:** QEO9811 400 Wards Well - **SAMPLE ID:** WW6 20-30  
Land Resources

## Particle Size Distribution

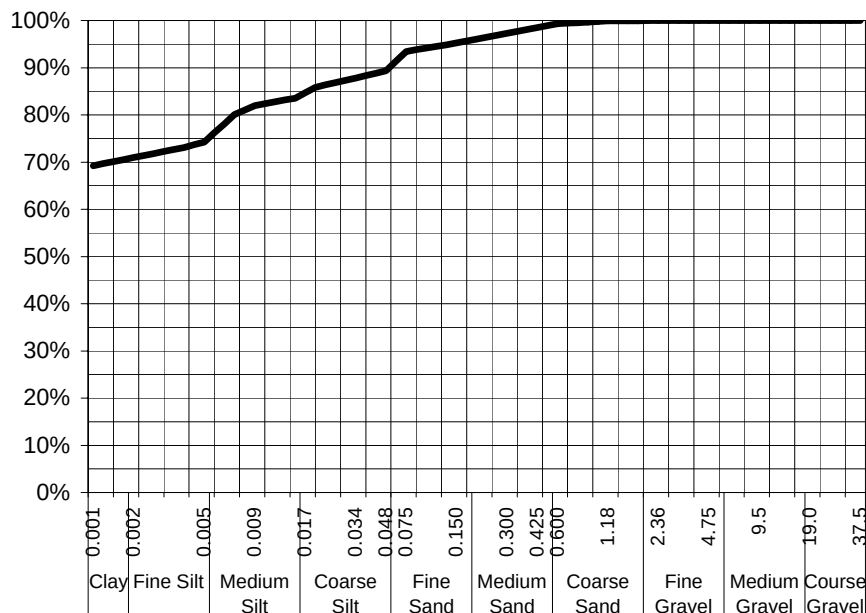
**CLIENT:** Timothy Rohde **DATE REPORTED:** 26-Oct-2011  
**COMPANY:** Sinclair Knight Merz **DATE RECEIVED:** 17-Oct-2011  
**ADDRESS:** P O Box 312 Flinders Lane **REPORT NO:** EB1121537-006 / PSD  
Melbourne, Vic Australia 8009  
**PROJECT:** QEO9811 400 Wards Well - **SAMPLE ID:** WW9 800-900  
Land Resources

## Particle Size Distribution

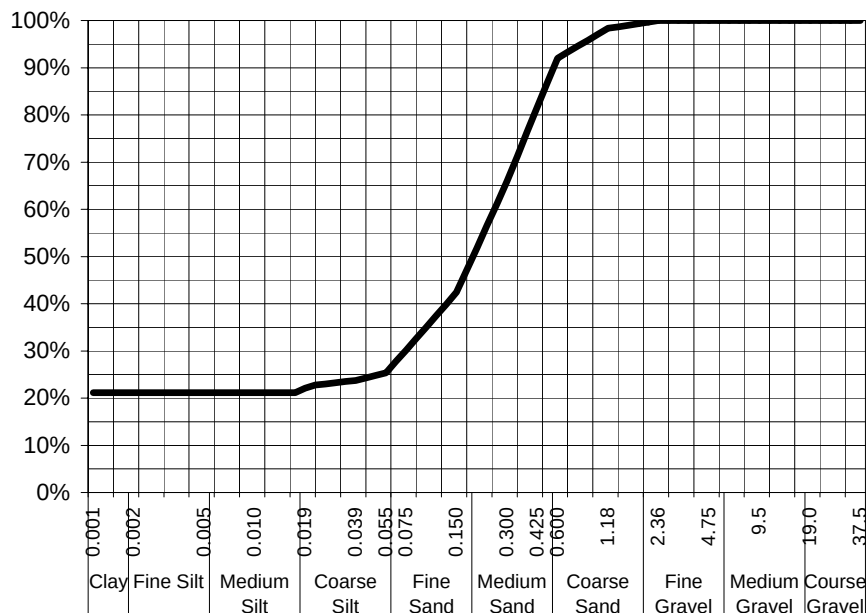
**CLIENT:** Timothy Rohde **DATE REPORTED:** 26-Oct-2011  
**COMPANY:** Sinclair Knight Merz **DATE RECEIVED:** 17-Oct-2011  
**ADDRESS:** P O Box 312 Flinders Lane **REPORT NO:** EB1121537-007 / PSD  
Melbourne, Vic Australia 8009  
**PROJECT:** QEO9811 400 Wards Well - **SAMPLE ID:** WW10 0-100  
Land Resources

## Particle Size Distribution
