# Progressive Rehabilitation and Closure Plan

## Wards Well Mine

| <b>Document title</b> | Progressive Rehabilitation and Closure Plan |
| <b>Version number</b> | V3.0 |

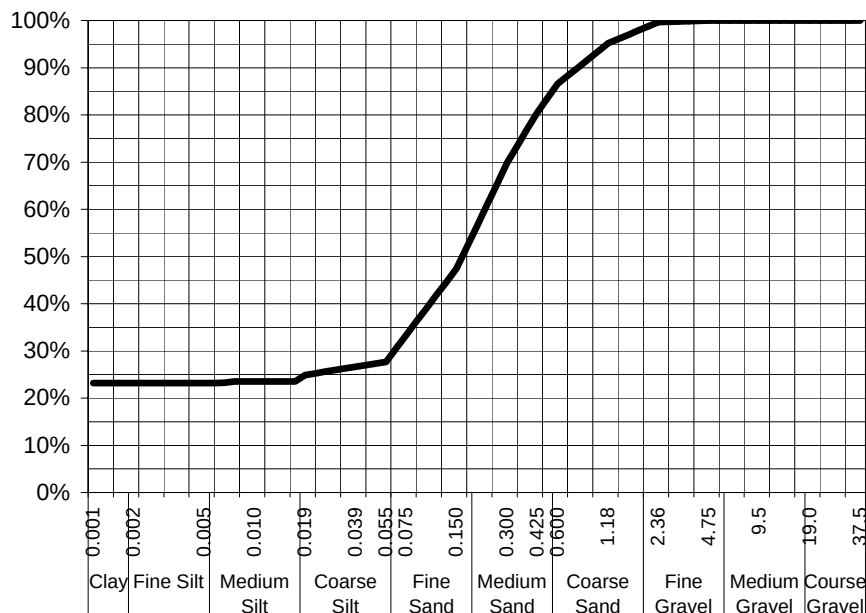
**CLIENT:** Timothy Rohde **DATE REPORTED:** 26-Oct-2011  
**COMPANY:** Sinclair Knight Merz **DATE RECEIVED:** 17-Oct-2011  
**ADDRESS:** P O Box 312 Flinders Lane **REPORT NO:** EB1121537-009 / PSD  
Melbourne, Vic Australia 8009  
**PROJECT:** QEO9811 400 Wards Well - **SAMPLE ID:** WW13 1000-1100  
Land Resources

## Particle Size Distribution

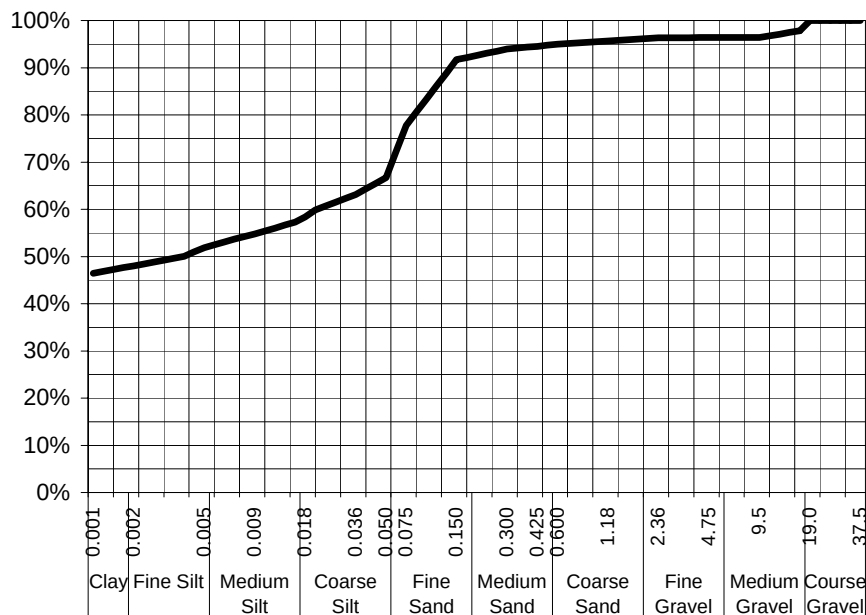
**CLIENT:** Timothy Rohde **DATE REPORTED:** 26-Oct-2011  
**COMPANY:** Sinclair Knight Merz **DATE RECEIVED:** 17-Oct-2011  
**ADDRESS:** P O Box 312 Flinders Lane **REPORT NO:** EB1121537-010 / PSD  
Melbourne, Vic Australia 8009  
**PROJECT:** QEO9811 400 Wards Well - **SAMPLE ID:** WW13 0-50  
Land Resources

## Particle Size Distribution

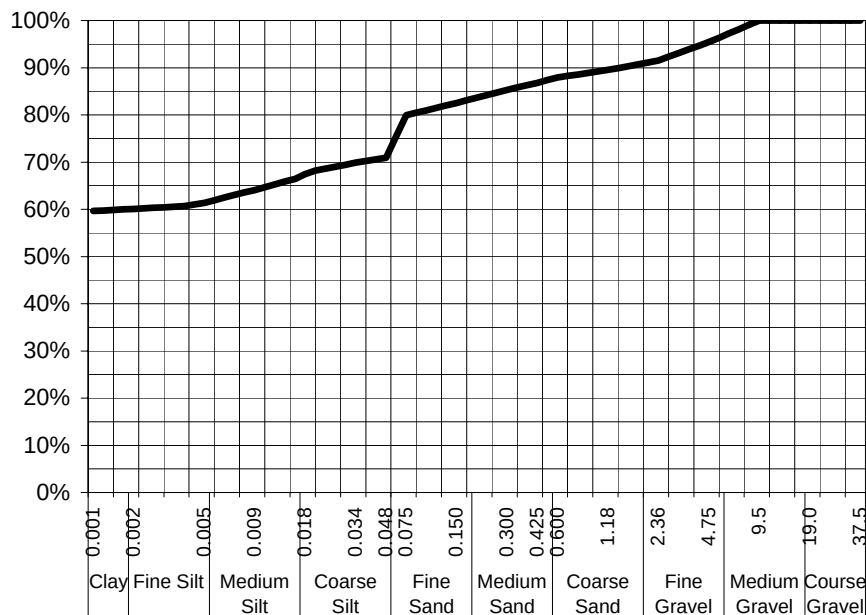
**CLIENT:** Timothy Rohde **DATE REPORTED:** 26-Oct-2011  
**COMPANY:** Sinclair Knight Merz **DATE RECEIVED:** 17-Oct-2011  
**ADDRESS:** P O Box 312 Flinders Lane **REPORT NO:** EB1121537-012 / PSD  
Melbourne, Vic Australia 8009  
**PROJECT:** QEO9811 400 Wards Well - **SAMPLE ID:** WW13 70-80  
Land Resources

## Particle Size Distribution

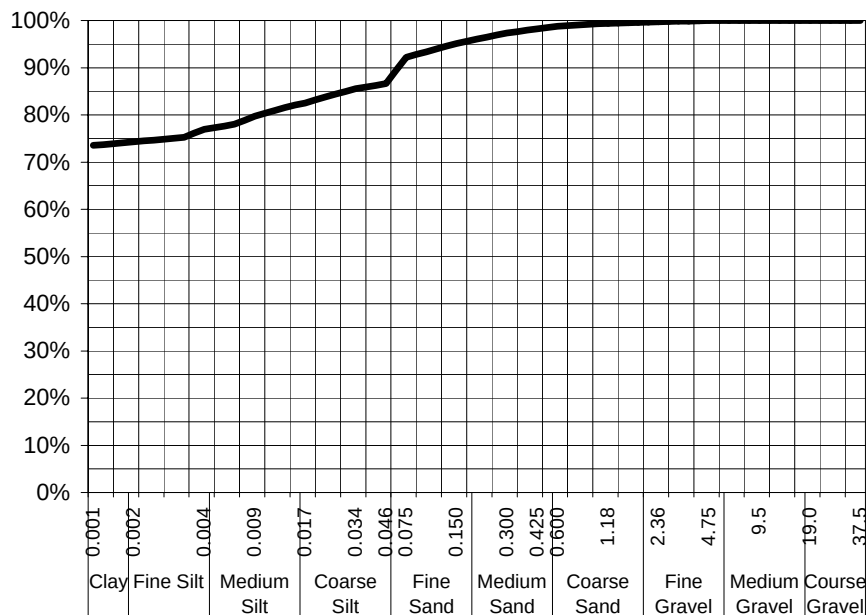
**CLIENT:** Timothy Rohde **DATE REPORTED:** 26-Oct-2011  
**COMPANY:** Sinclair Knight Merz **DATE RECEIVED:** 17-Oct-2011  
**ADDRESS:** P O Box 312 Flinders Lane **REPORT NO:** EB1121537-013 / PSD  
Melbourne, Vic Australia 8009  
**PROJECT:** QEO9811 400 Wards Well - **SAMPLE ID:** WW15 0-10  
Land Resources

## Particle Size Distribution

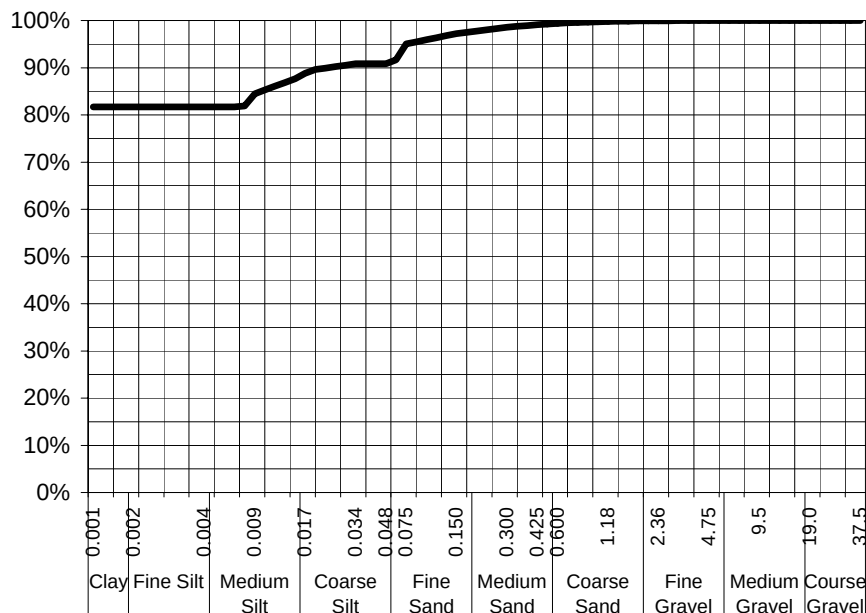
**CLIENT:** Timothy Rohde **DATE REPORTED:** 26-Oct-2011  
**COMPANY:** Sinclair Knight Merz **DATE RECEIVED:** 17-Oct-2011  
**ADDRESS:** P O Box 312 Flinders Lane **REPORT NO:** EB1121537-015 / PSD  
Melbourne, Vic Australia 8009  
**PROJECT:** QEO9811 400 Wards Well - **SAMPLE ID:** WW15 90-100  
Land Resources

## Particle Size Distribution

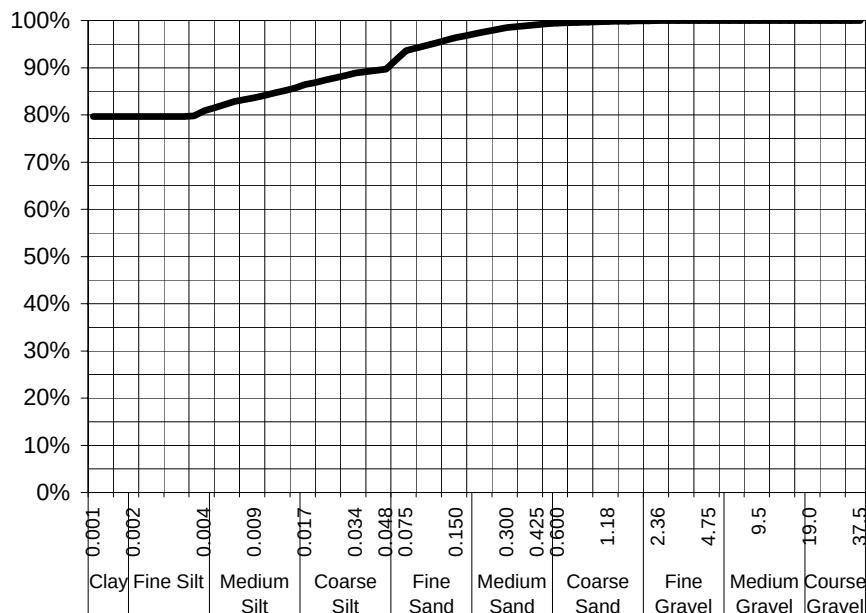
**CLIENT:** Timothy Rohde **DATE REPORTED:** 26-Oct-2011  
**COMPANY:** Sinclair Knight Merz **DATE RECEIVED:** 17-Oct-2011  
**ADDRESS:** P O Box 312 Flinders Lane **REPORT NO:** EB1121537-016 / PSD  
Melbourne, Vic Australia 8009  
**PROJECT:** QEO9811 400 Wards Well - **SAMPLE ID:** WW22 0-100  
Land Resources

## Particle Size Distribution

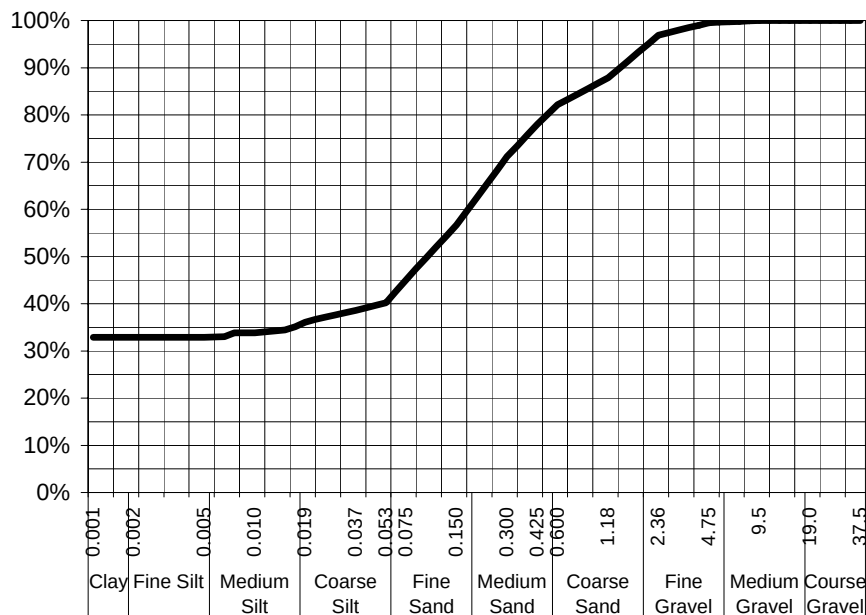
**CLIENT:** Timothy Rohde **DATE REPORTED:** 26-Oct-2011  
**COMPANY:** Sinclair Knight Merz **DATE RECEIVED:** 17-Oct-2011  
**ADDRESS:** P O Box 312 Flinders Lane **REPORT NO:** EB1121537-020 / PSD  
Melbourne, Vic Australia 8009  
**PROJECT:** QEO9811 400 Wards Well - **SAMPLE ID:** WW23 300-400  
Land Resources

## Particle Size Distribution

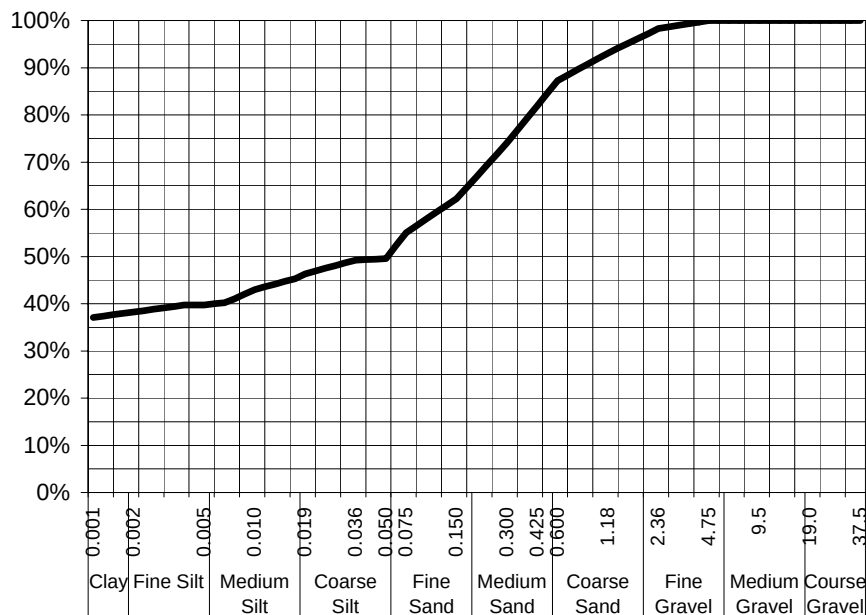
**CLIENT:** Timothy Rohde **DATE REPORTED:** 26-Oct-2011  
**COMPANY:** Sinclair Knight Merz **DATE RECEIVED:** 17-Oct-2011  
**ADDRESS:** P O Box 312 Flinders Lane **REPORT NO:** EB1121537-022 / PSD  
Melbourne, Vic Australia 8009  
**PROJECT:** QEO9811 400 Wards Well - **SAMPLE ID:** WW28 0-100  
Land Resources

## Particle Size Distribution

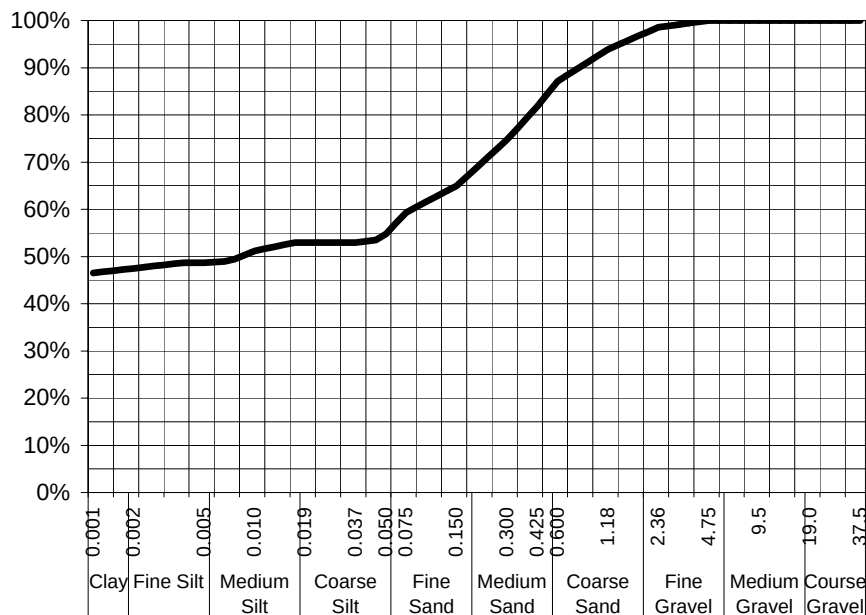
**CLIENT:** Timothy Rohde **DATE REPORTED:** 26-Oct-2011  
**COMPANY:** Sinclair Knight Merz **DATE RECEIVED:** 17-Oct-2011  
**ADDRESS:** P O Box 312 Flinders Lane **REPORT NO:** EB1121537-024 / PSD  
Melbourne, Vic Australia 8009  
**PROJECT:** QEO9811 400 Wards Well - **SAMPLE ID:** WW28 700-800  
Land Resources

## Particle Size Distribution

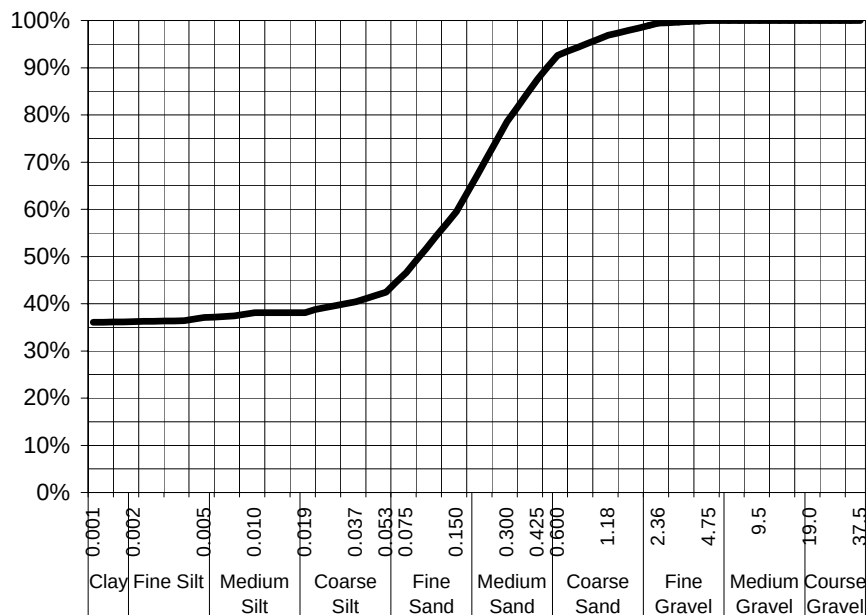
**CLIENT:** Timothy Rohde **DATE REPORTED:** 26-Oct-2011  
**COMPANY:** Sinclair Knight Merz **DATE RECEIVED:** 17-Oct-2011  
**ADDRESS:** P O Box 312 Flinders Lane **REPORT NO:** EB1121537-025 / PSD  
Melbourne, Vic Australia 8009  
**PROJECT:** QEO9811 400 Wards Well - **SAMPLE ID:** WW36 0-100  
Land Resources

## Particle Size Distribution

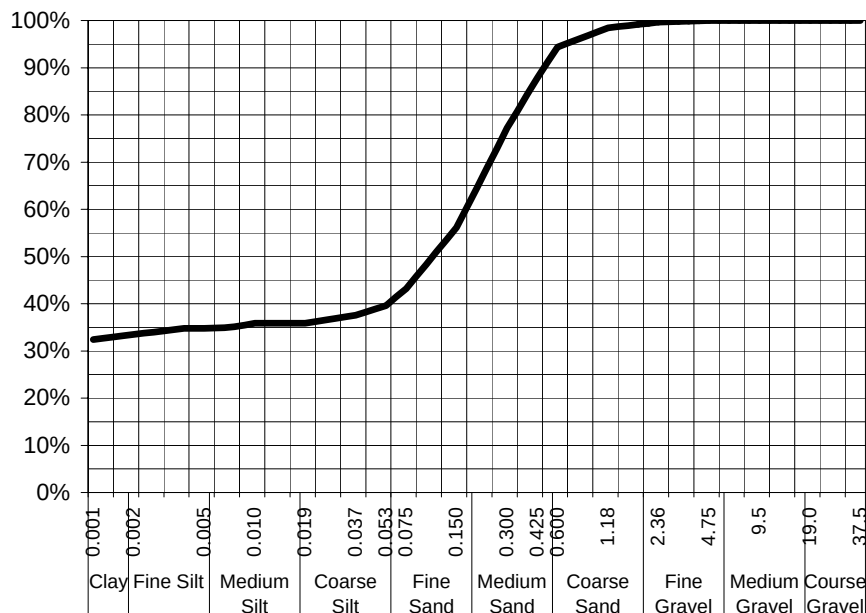
**CLIENT:** Timothy Rohde **DATE REPORTED:** 26-Oct-2011  
**COMPANY:** Sinclair Knight Merz **DATE RECEIVED:** 17-Oct-2011  
**ADDRESS:** P O Box 312 Flinders Lane **REPORT NO:** EB1121537-027 / PSD  
Melbourne, Vic Australia 8009  
**PROJECT:** QEO9811 400 Wards Well - **SAMPLE ID:** WW36 700-800  
Land Resources

## Particle Size Distribution

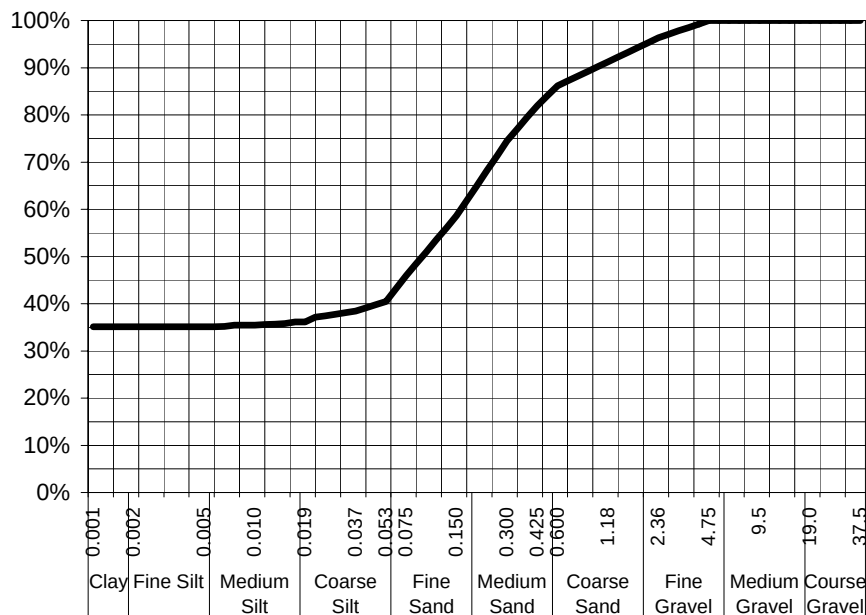
**CLIENT:** Timothy Rohde **DATE REPORTED:** 26-Oct-2011  
**COMPANY:** Sinclair Knight Merz **DATE RECEIVED:** 17-Oct-2011  
**ADDRESS:** P O Box 312 Flinders Lane **REPORT NO:** EB1121537-029 / PSD  
Melbourne, Vic Australia 8009  
**PROJECT:** QEO9811 400 Wards Well - **SAMPLE ID:** WW38 500-600  
Land Resources

## Particle Size Distribution

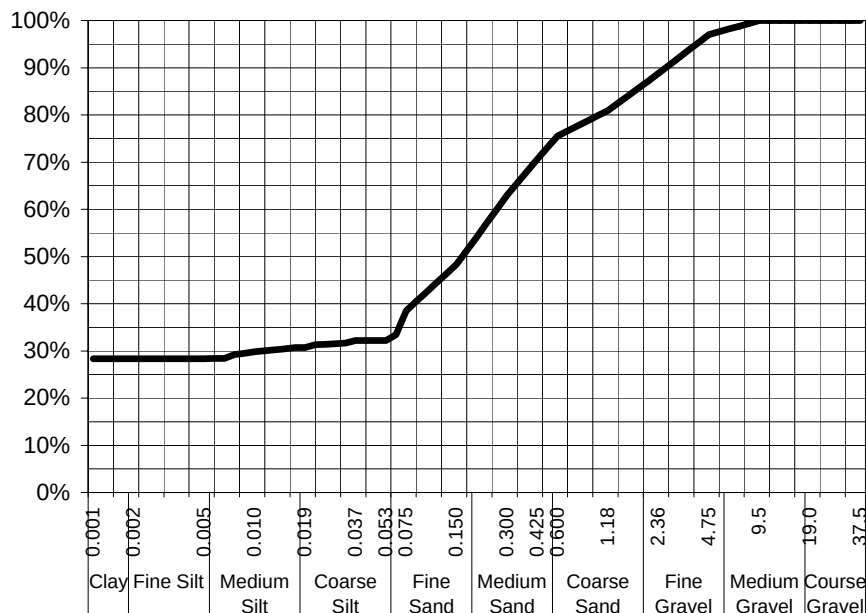
**CLIENT:** Timothy Rohde **DATE REPORTED:** 26-Oct-2011  
**COMPANY:** Sinclair Knight Merz **DATE RECEIVED:** 17-Oct-2011  
**ADDRESS:** P O Box 312 Flinders Lane **REPORT NO:** EB1121537-030 / PSD  
Melbourne, Vic Australia 8009  
**PROJECT:** QEO9811 400 Wards Well - **SAMPLE ID:** WW44 0-100  
Land Resources

## Particle Size Distribution

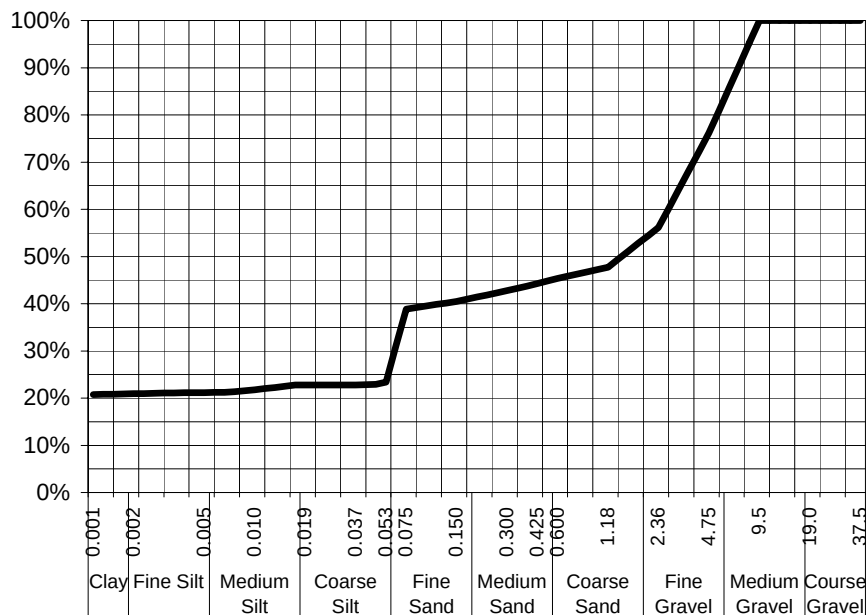
**CLIENT:** Timothy Rohde **DATE REPORTED:** 26-Oct-2011  
**COMPANY:** Sinclair Knight Merz **DATE RECEIVED:** 17-Oct-2011  
**ADDRESS:** P O Box 312 Flinders Lane **REPORT NO:** EB1121537-032 / PSD  
Melbourne, Vic Australia 8009  
**PROJECT:** QEO9811 400 Wards Well - **SAMPLE ID:** WW44 500-600  
Land Resources

## Particle Size Distribution

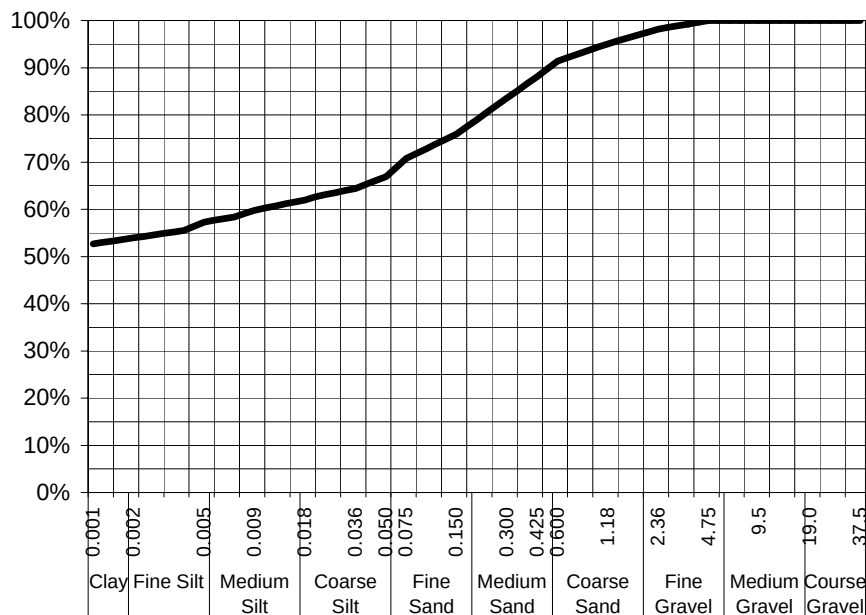
**CLIENT:** Timothy Rohde **DATE REPORTED:** 26-Oct-2011  
**COMPANY:** Sinclair Knight Merz **DATE RECEIVED:** 17-Oct-2011  
**ADDRESS:** P O Box 312 Flinders Lane **REPORT NO:** EB1121537-033 / PSD  
Melbourne, Vic Australia 8009  
**PROJECT:** QEO9811 400 Wards Well - **SAMPLE ID:** WW47 0-100  
Land Resources

## Particle Size Distribution

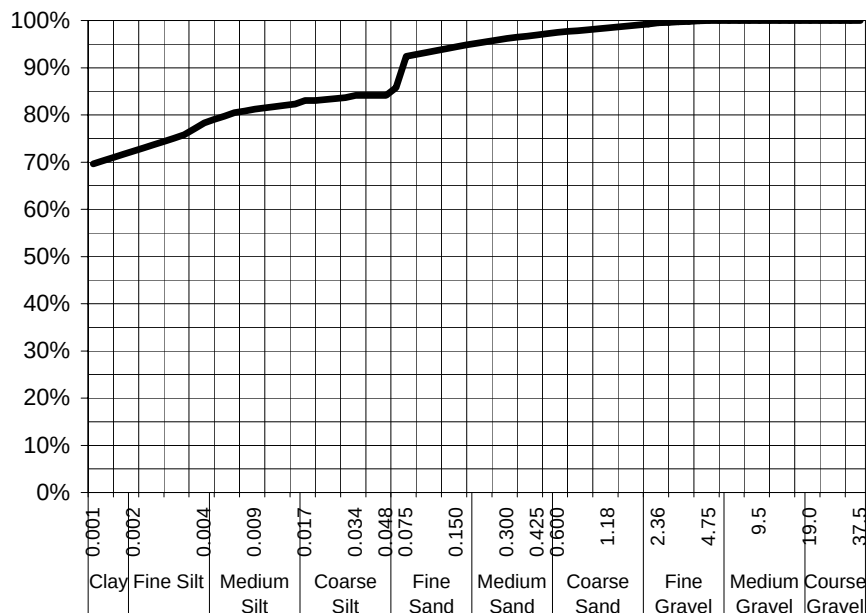
**CLIENT:** Timothy Rohde **DATE REPORTED:** 26-Oct-2011  
**COMPANY:** Sinclair Knight Merz **DATE RECEIVED:** 17-Oct-2011  
**ADDRESS:** P O Box 312 Flinders Lane **REPORT NO:** EB1121537-035 / PSD  
Melbourne, Vic Australia 8009  
**PROJECT:** QEO9811 400 Wards Well - **SAMPLE ID:** WW60 0-20  
Land Resources

## Particle Size Distribution

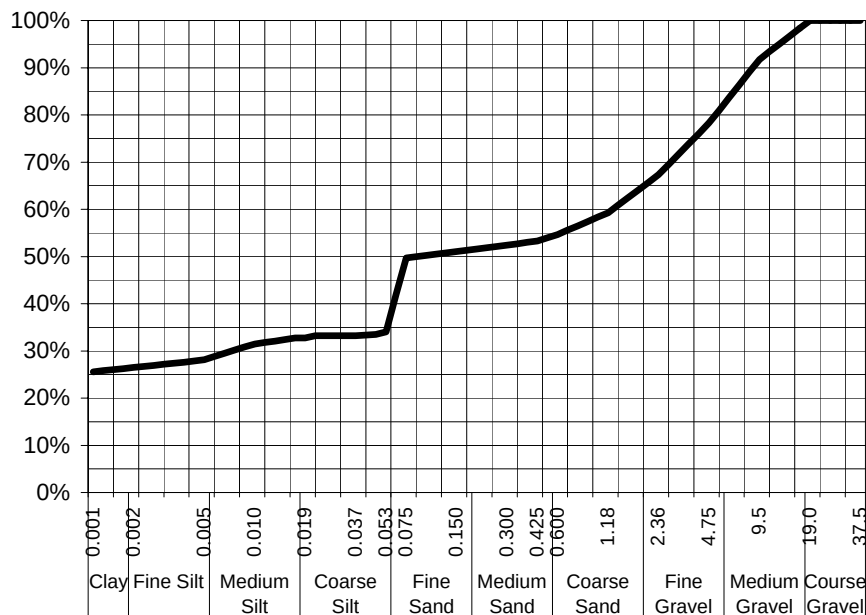
**CLIENT:** Timothy Rohde **DATE REPORTED:** 26-Oct-2011  
**COMPANY:** Sinclair Knight Merz **DATE RECEIVED:** 17-Oct-2011  
**ADDRESS:** P O Box 312 Flinders Lane **REPORT NO:** EB1121537-037 / PSD  
Melbourne, Vic Australia 8009  
**PROJECT:** QEO9811 400 Wards Well - **SAMPLE ID:** WW60 700-800  
Land Resources

## Particle Size Distribution

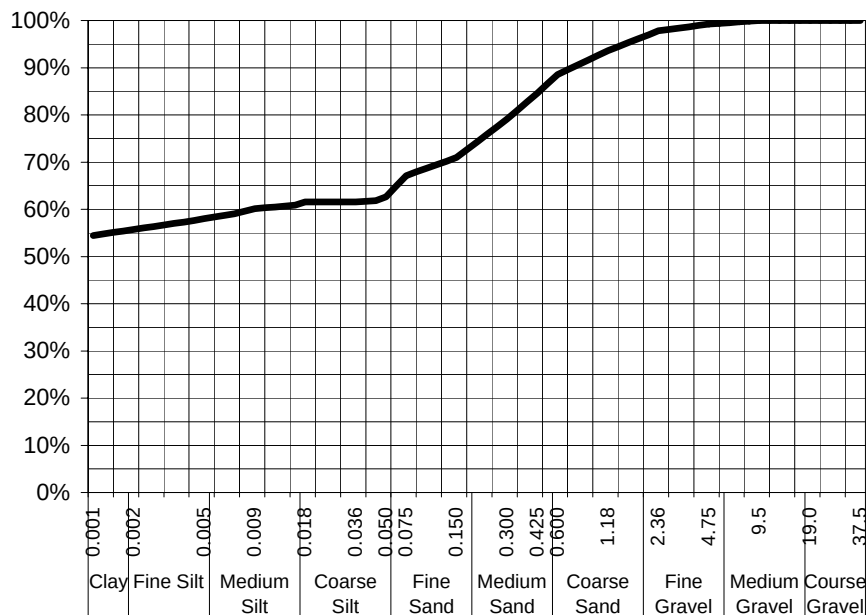
**CLIENT:** Timothy Rohde **DATE REPORTED:** 26-Oct-2011  
**COMPANY:** Sinclair Knight Merz **DATE RECEIVED:** 17-Oct-2011  
**ADDRESS:** P O Box 312 Flinders Lane **REPORT NO:** EB1121537-039 / PSD  
Melbourne, Vic Australia 8009  
**PROJECT:** QEO9811 400 Wards Well - **SAMPLE ID:** WW69 200-300  
Land Resources

## Particle Size Distribution

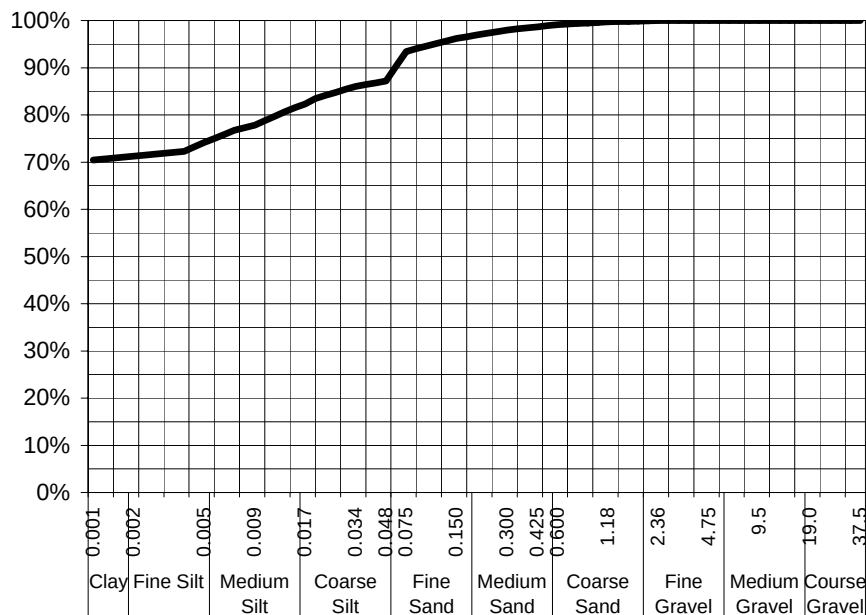
**CLIENT:** Timothy Rohde **DATE REPORTED:** 26-Oct-2011  
**COMPANY:** Sinclair Knight Merz **DATE RECEIVED:** 17-Oct-2011  
**ADDRESS:** P O Box 312 Flinders Lane **REPORT NO:** EB1121537-041 / PSD  
Melbourne, Vic Australia 8009  
**PROJECT:** QEO9811 400 Wards Well - **SAMPLE ID:** WW75 0-50  
Land Resources

## Particle Size Distribution

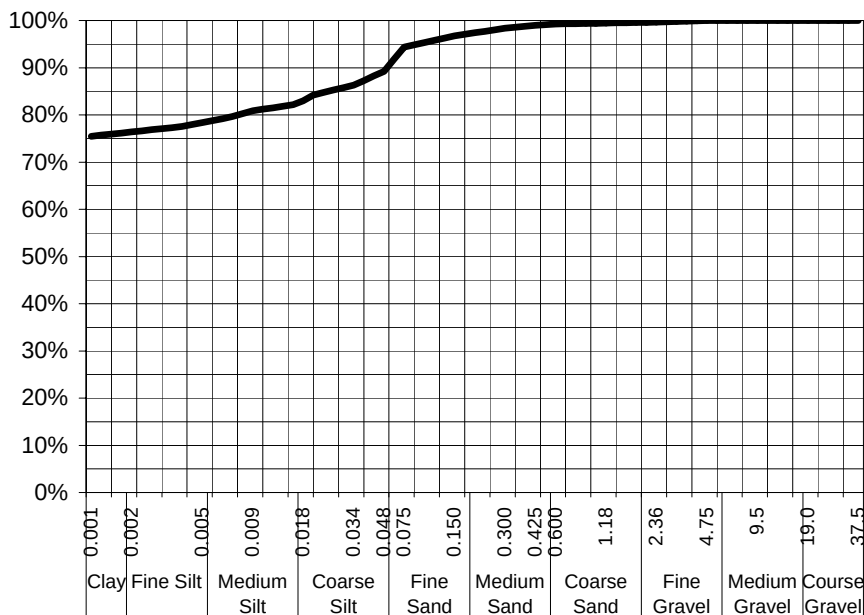
**CLIENT:** Timothy Rohde **DATE REPORTED:** 26-Oct-2011  
**COMPANY:** Sinclair Knight Merz **DATE RECEIVED:** 17-Oct-2011  
**ADDRESS:** P O Box 312 Flinders Lane **REPORT NO:** EB1121537-042 / PSD  
Melbourne, Vic Australia 8009  
**PROJECT:** QEO9811 400 Wards Well - **SAMPLE ID:** WW75 400-500  
Land Resources

## Particle Size Distribution

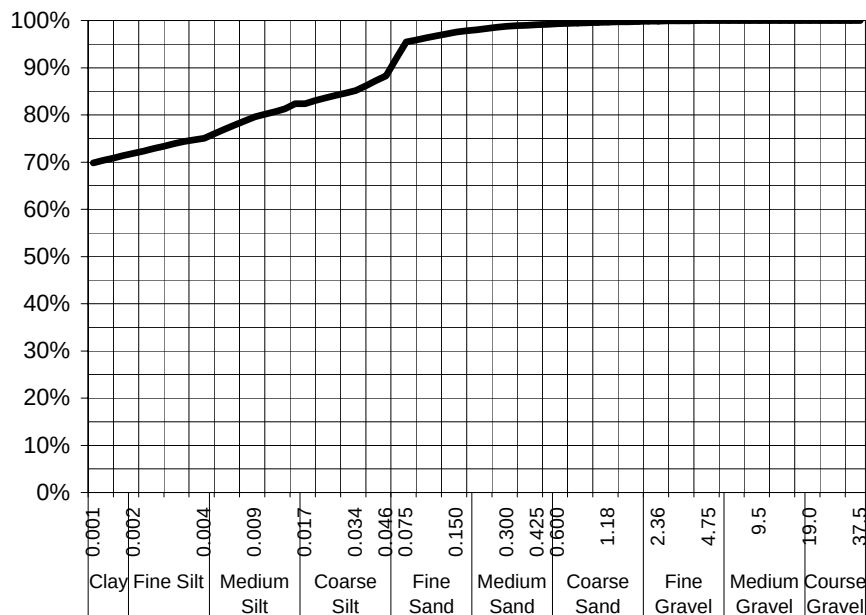
**CLIENT:** Timothy Rohde **DATE REPORTED:** 26-Oct-2011  
**COMPANY:** Sinclair Knight Merz **DATE RECEIVED:** 17-Oct-2011  
**ADDRESS:** P O Box 312 Flinders Lane **REPORT NO:** EB1121537-044 / PSD  
Melbourne, Vic Australia 8009  
**PROJECT:** QEO9811 400 Wards Well - **SAMPLE ID:** WW94 0-50  
Land Resources

## Particle Size Distribution

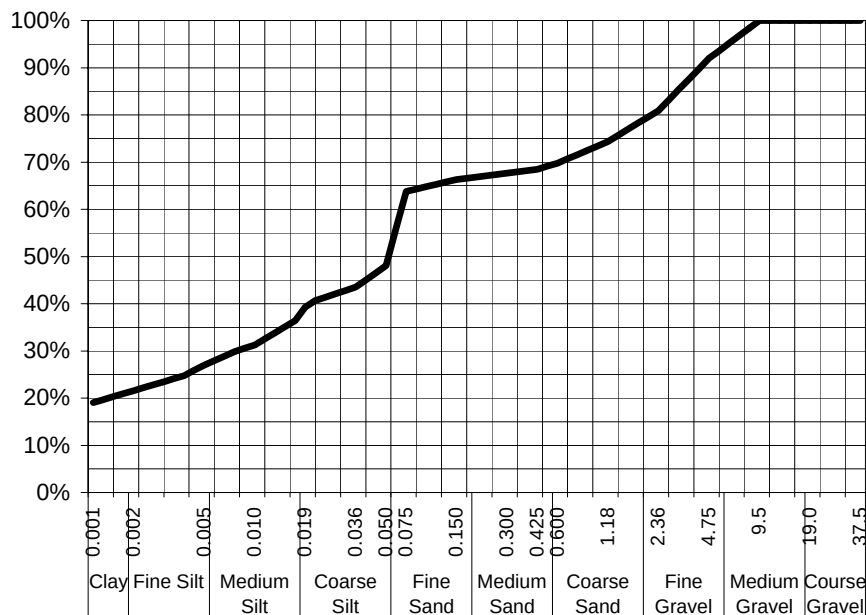
**CLIENT:** Timothy Rohde **DATE REPORTED:** 26-Oct-2011  
**COMPANY:** Sinclair Knight Merz **DATE RECEIVED:** 17-Oct-2011  
**ADDRESS:** P O Box 312 Flinders Lane **REPORT NO:** EB1121537-046 / PSD  
Melbourne, Vic Australia 8009  
**PROJECT:** QEO9811 400 Wards Well - **SAMPLE ID:** WW94 600-700  
Land Resources

## Particle Size Distribution

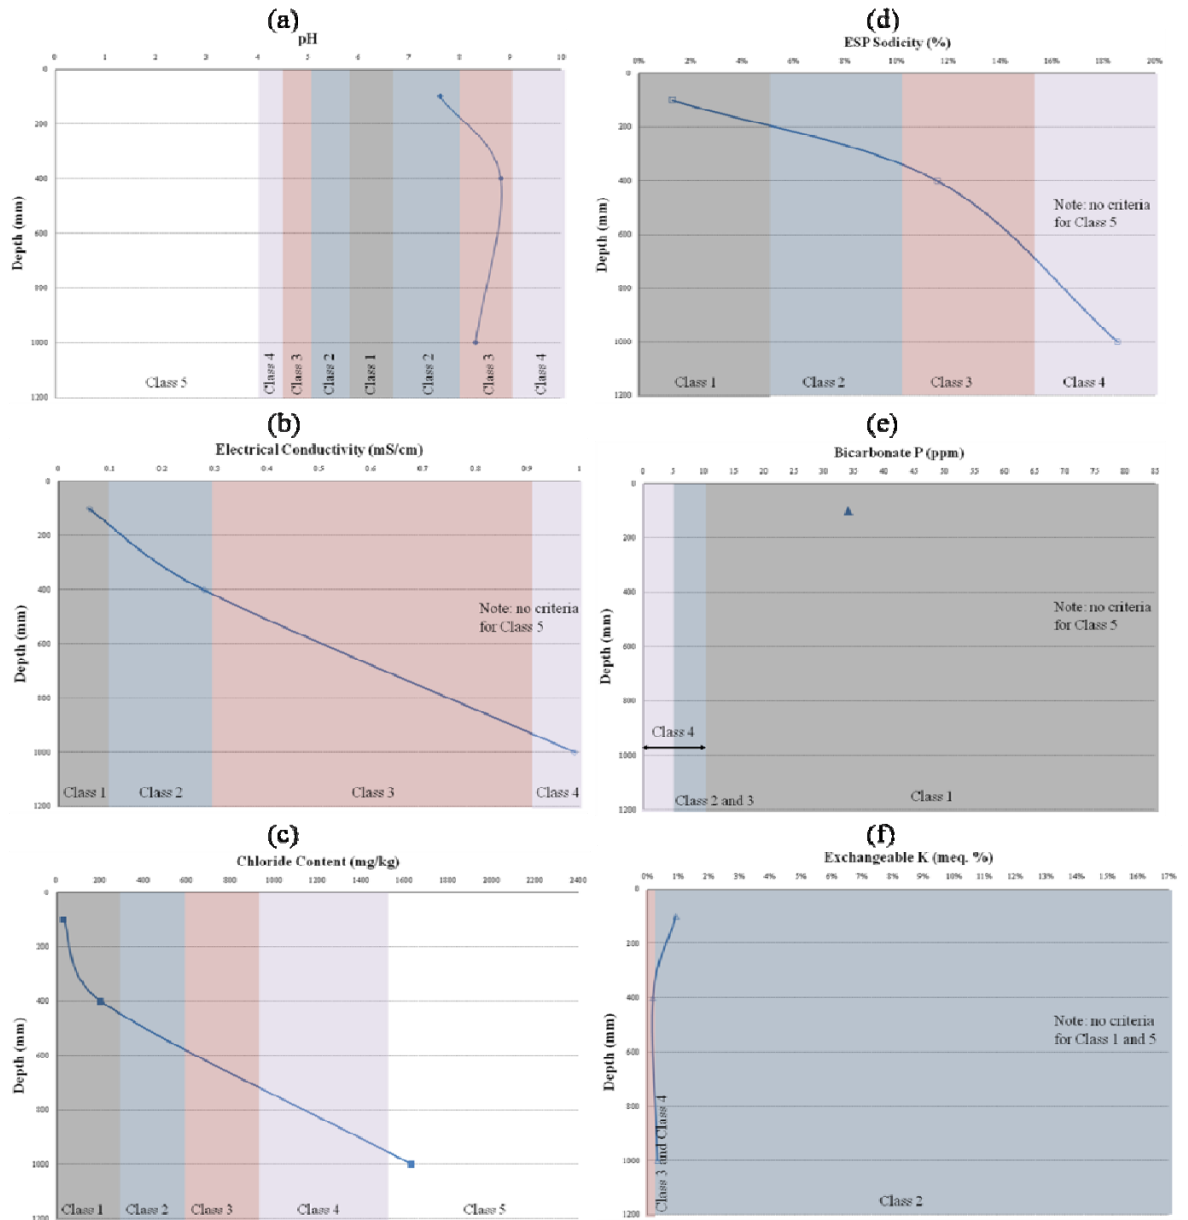
■ Figure A 1 Vertosol: Site 15 (a) pH, (b) Electrical conductivity, (c) Chloride content, (d) ESP. (e) Bicarbonate P, and (f) Exchangeable K

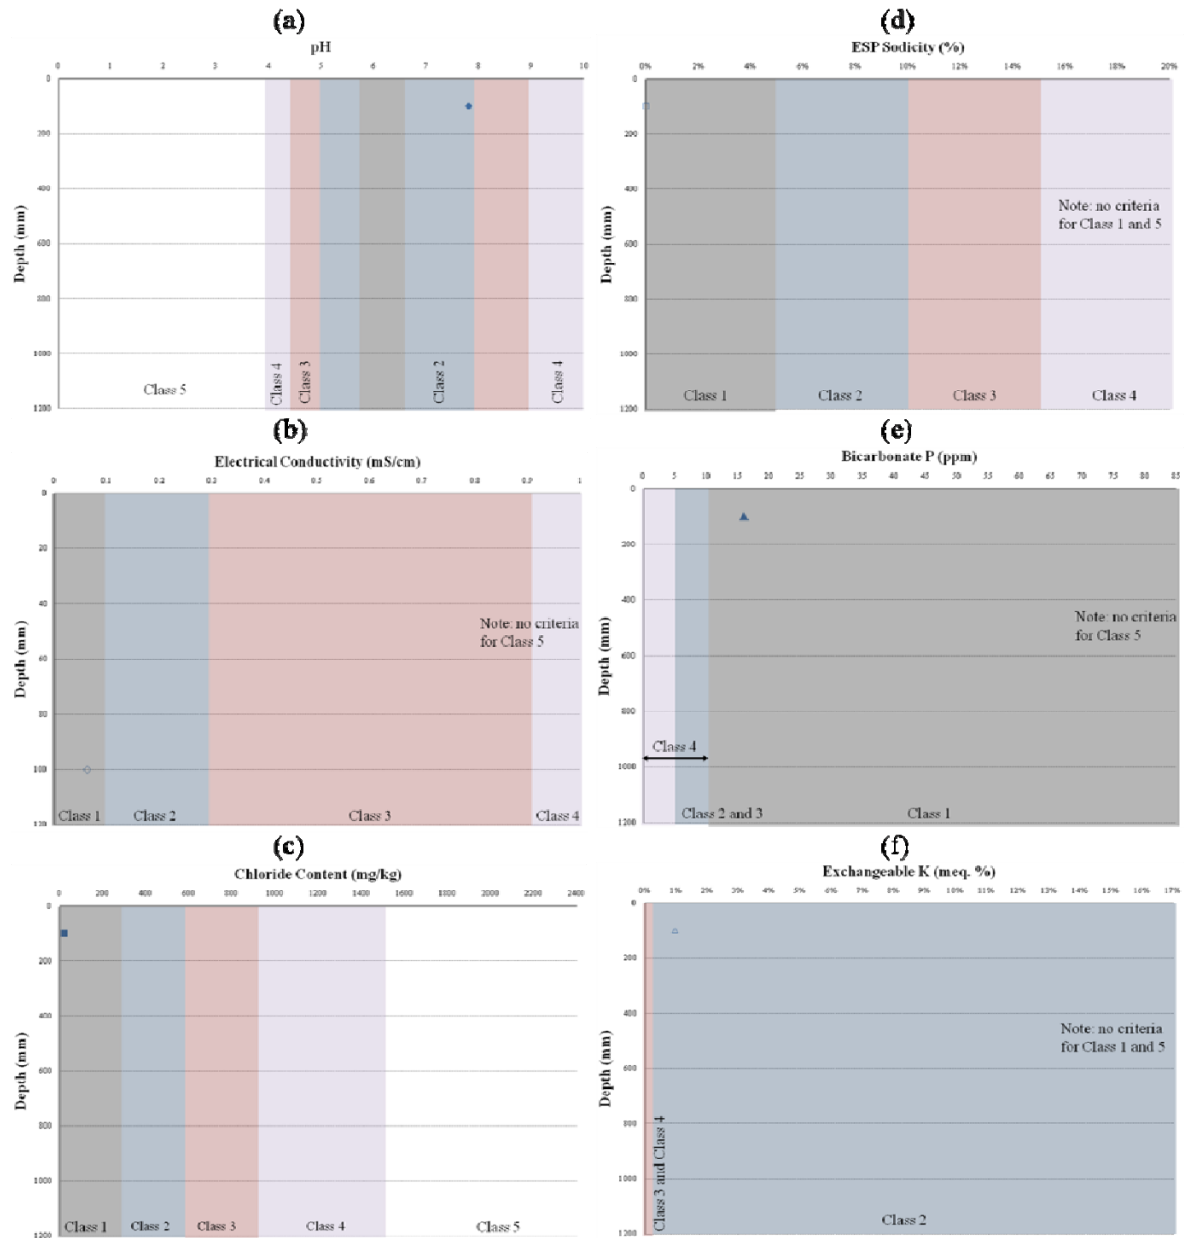
■ Figure A 2 Vertosol: Site 22 (a) pH, (b) Electrical conductivity, (c) Chloride content, (d) ESP, (e) Bicarbonate P, and (f) Exchangeable K

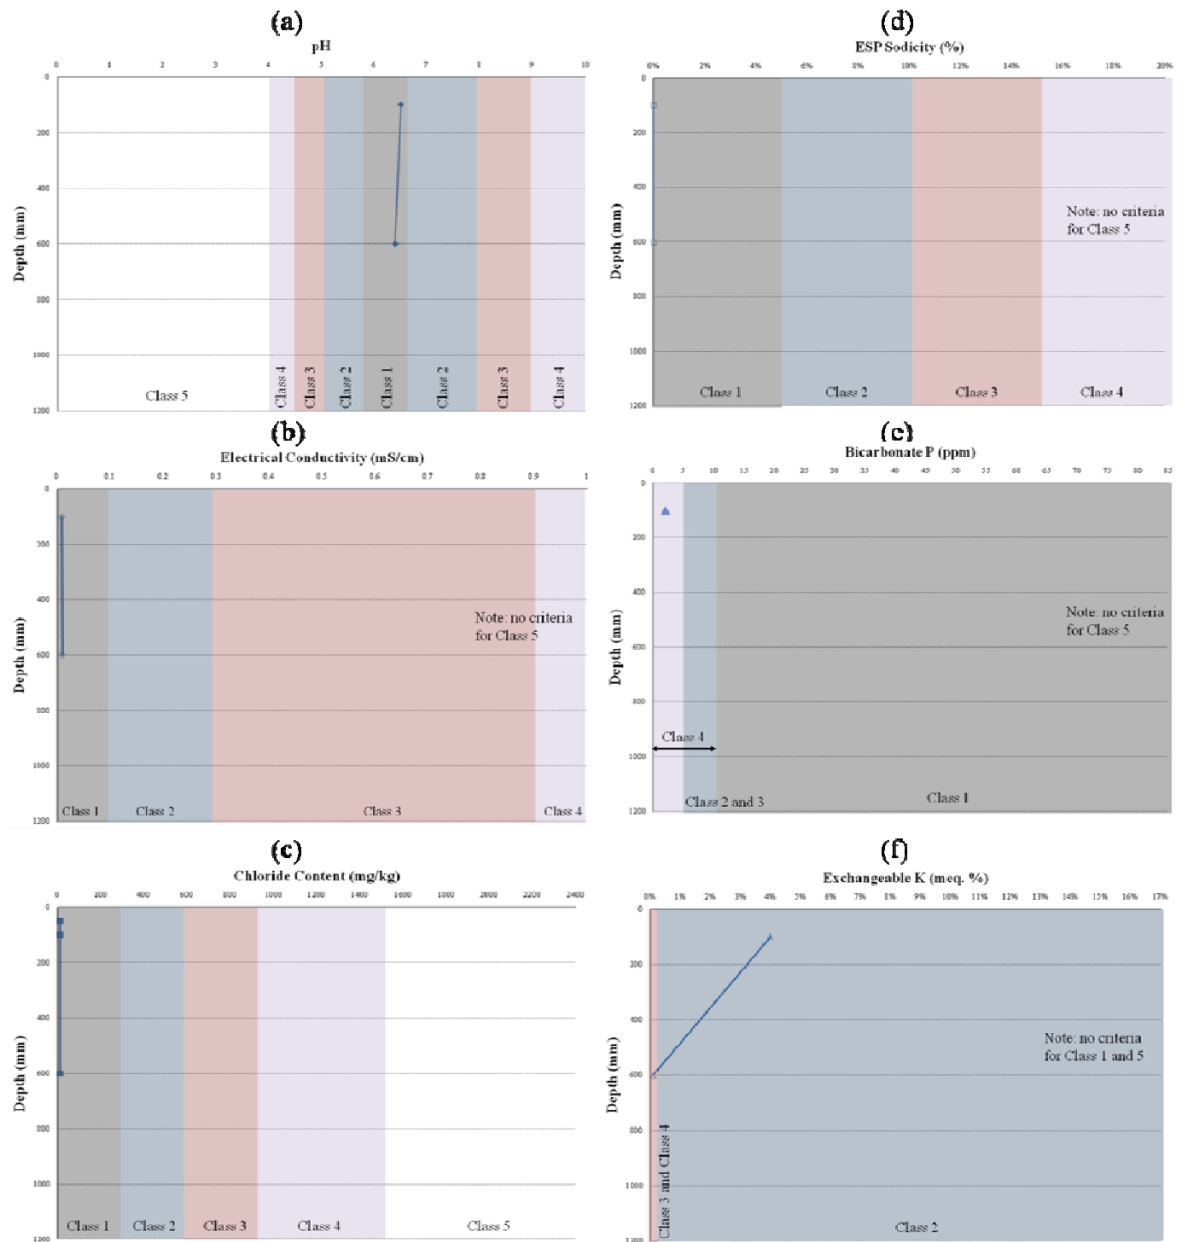
■ Figure A 3 Vertosol: Site 9 (a) pH, (b) Electrical conductivity, (c) Chloride content, (d) ESP, (e) Bicarbonate P, and (f) Exchangeable K

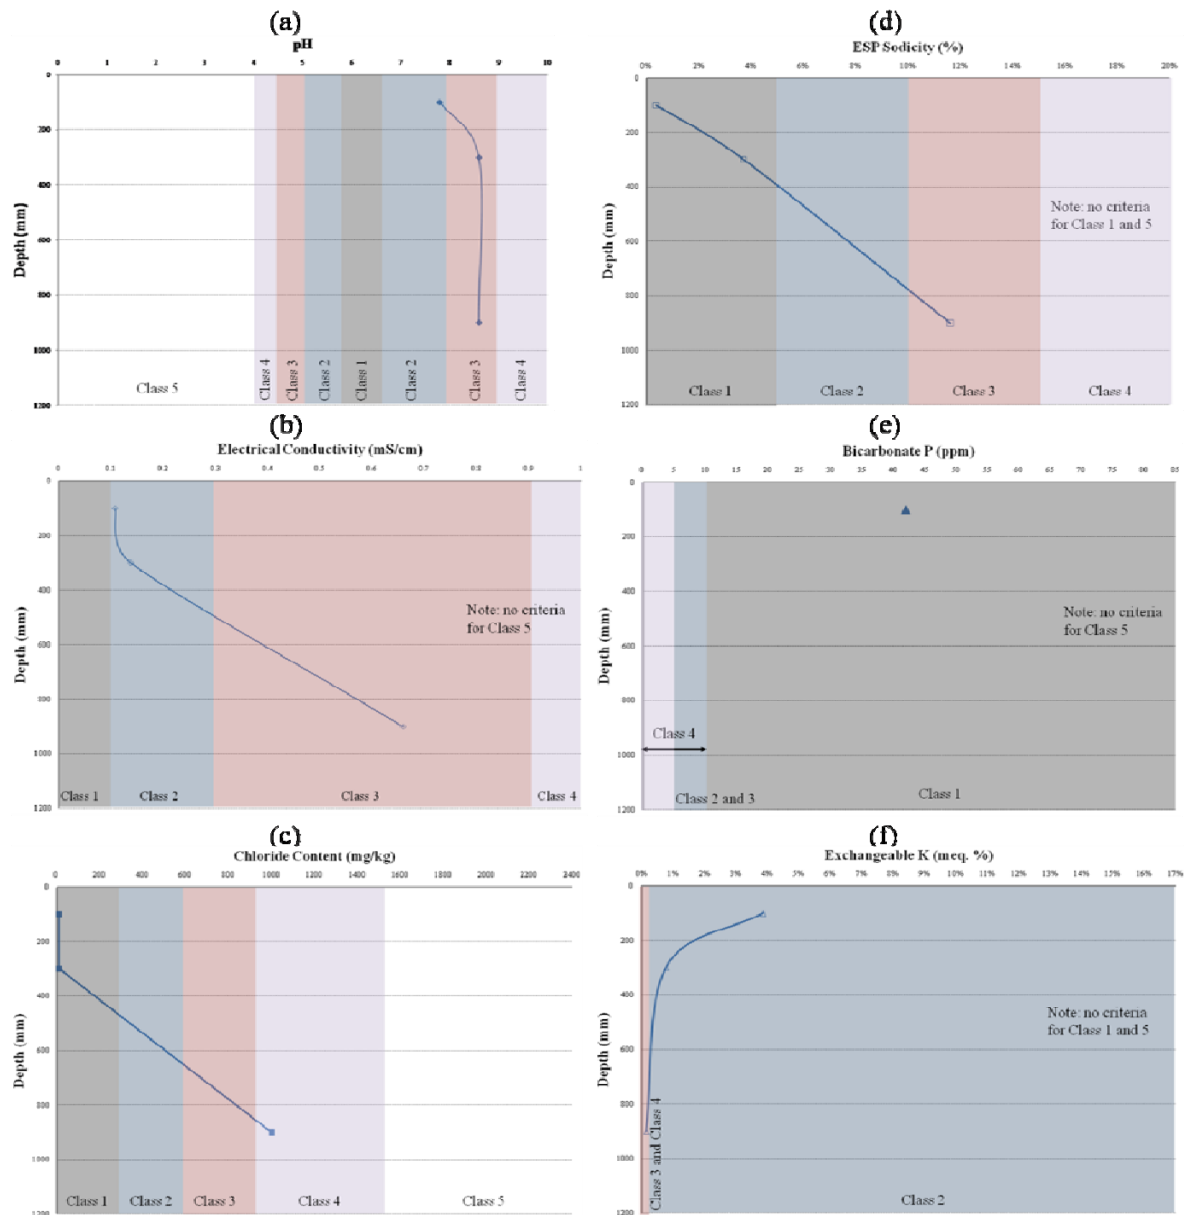
■ Figure A 4 Vertosol Site 6 (a) pH, (b) Electrical conductivity, (c) Chloride content, (d) ESP, (e) Bicarbonate P, and (f) Exchangeable K

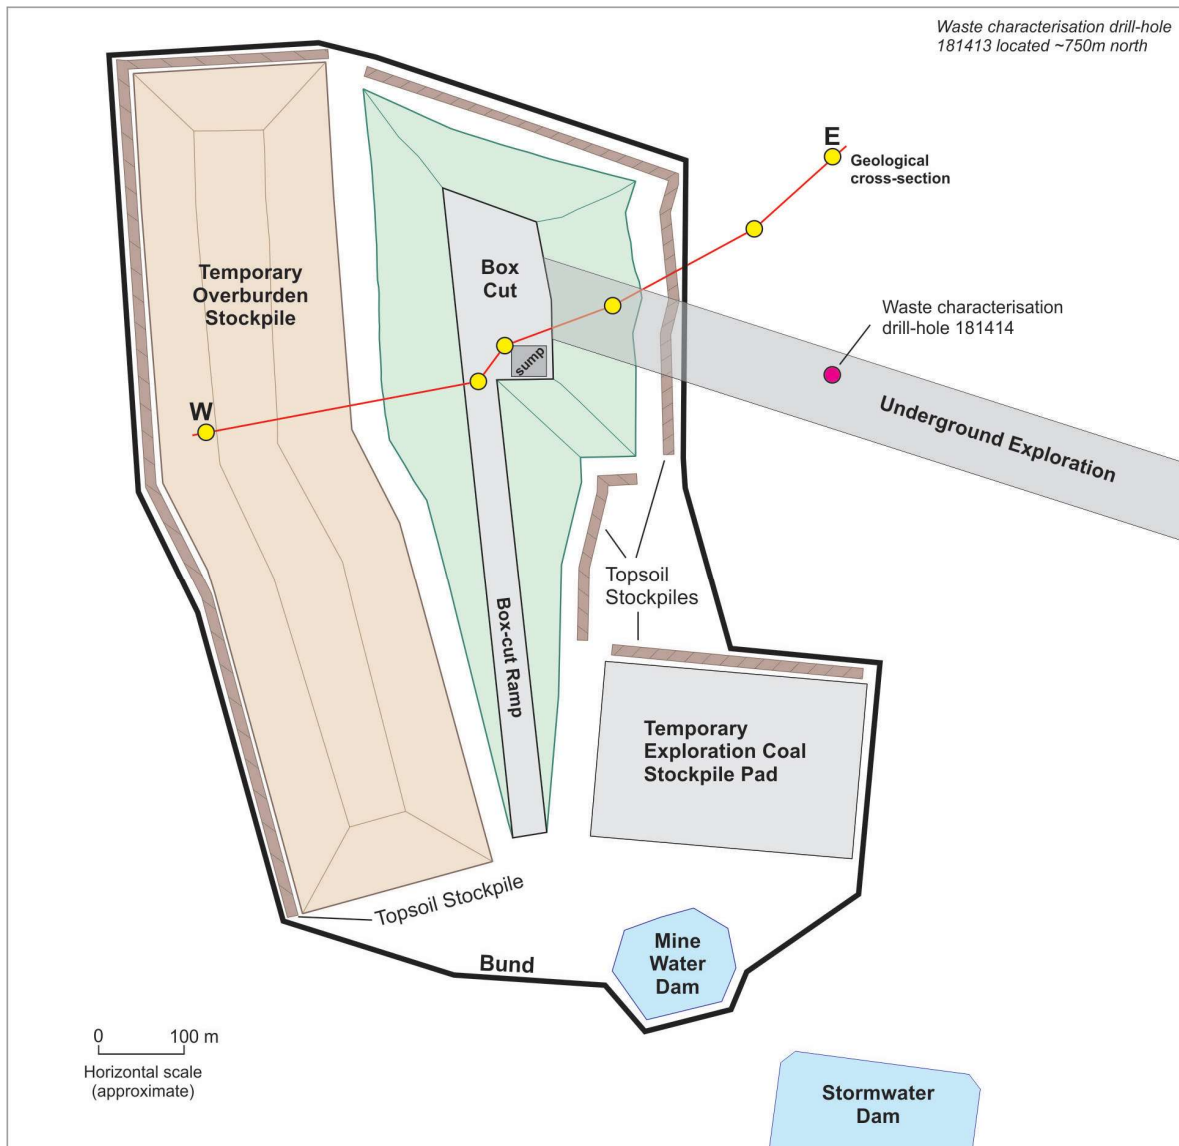
Wards Well is proposed as a future underground mining operation, however operations are currently limited to exploration activities (Environmental Authority EPPR00668513). Current approvals allow surface exploration drilling and underground exploration. The underground exploration activity will consist of up to 1,800 m of in-seam sampling in an easterly direction from a box-cut entry (Figure 1).

**Figure 1: Box-cut and exploration activity area (Refer to Figure 2 for the geological cross-section marked)**

The disturbance activities are contained within a bunded area and surface water within the bunded area flows from northwest towards the south and is captured by a Mine Water Dam (Figures 1 and 3). Surface water and sediment run-off outside of the bunded area flow from north-northwest around the outside of the bund into a Stormwater Dam located immediately south of the bunded area (Figures 1 and 3). Water from the Stormwater Dam can be used on site for exploration activities (e.g. dust suppression) or directed back into overland flow southeast towards the tributary of Eaglefield Creek.

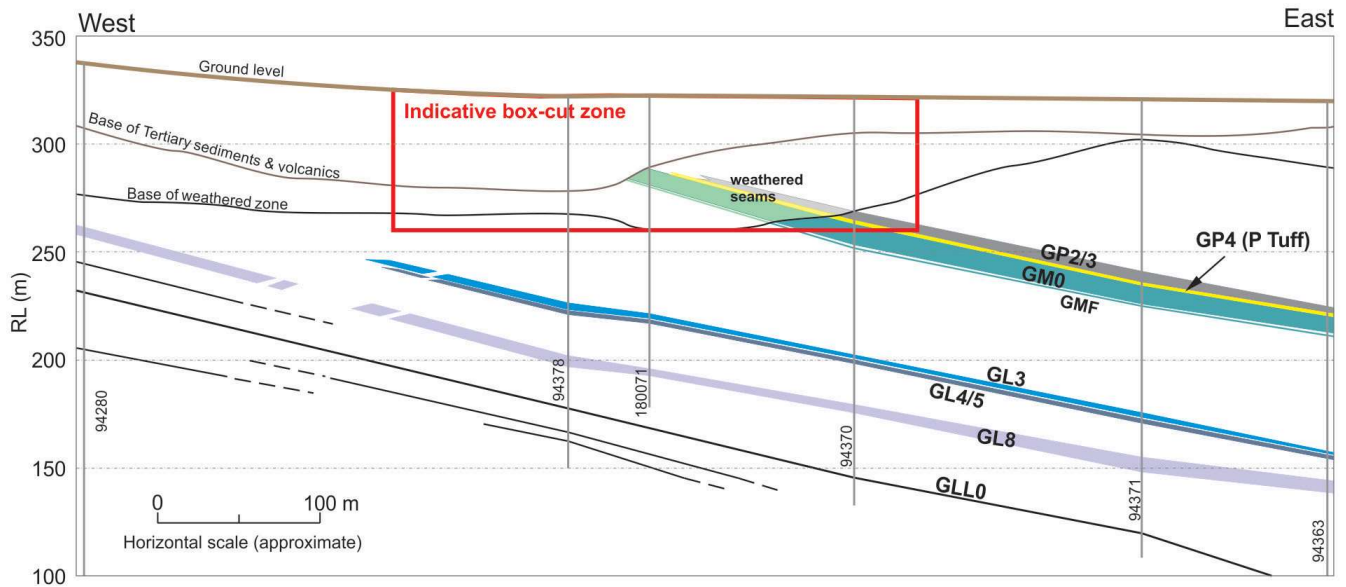
The geological units in the box-cut area are diagrammatically shown in a geological cross-section from west (left) to east (right) through the box-cut (Figure 2). The coal measures are overlain by weathered Tertiary sediments and basalt. As evident in Table 1 and Figure 2, weathered materials comprise approximately 93% of the total volume of mine (mineral) waste from the box-cut, including a proportion of weathered GP and GM seams (Figure 2)

**Figure 2: Geological cross-section through the activity area (Cross-section location shown on Figure 1)**
