# Progressive Rehabilitation and Closure Plan

## Wards Well Mine

| <b>Document title</b> | Progressive Rehabilitation and Closure Plan |
| <b>Version number</b> | V3.0 |

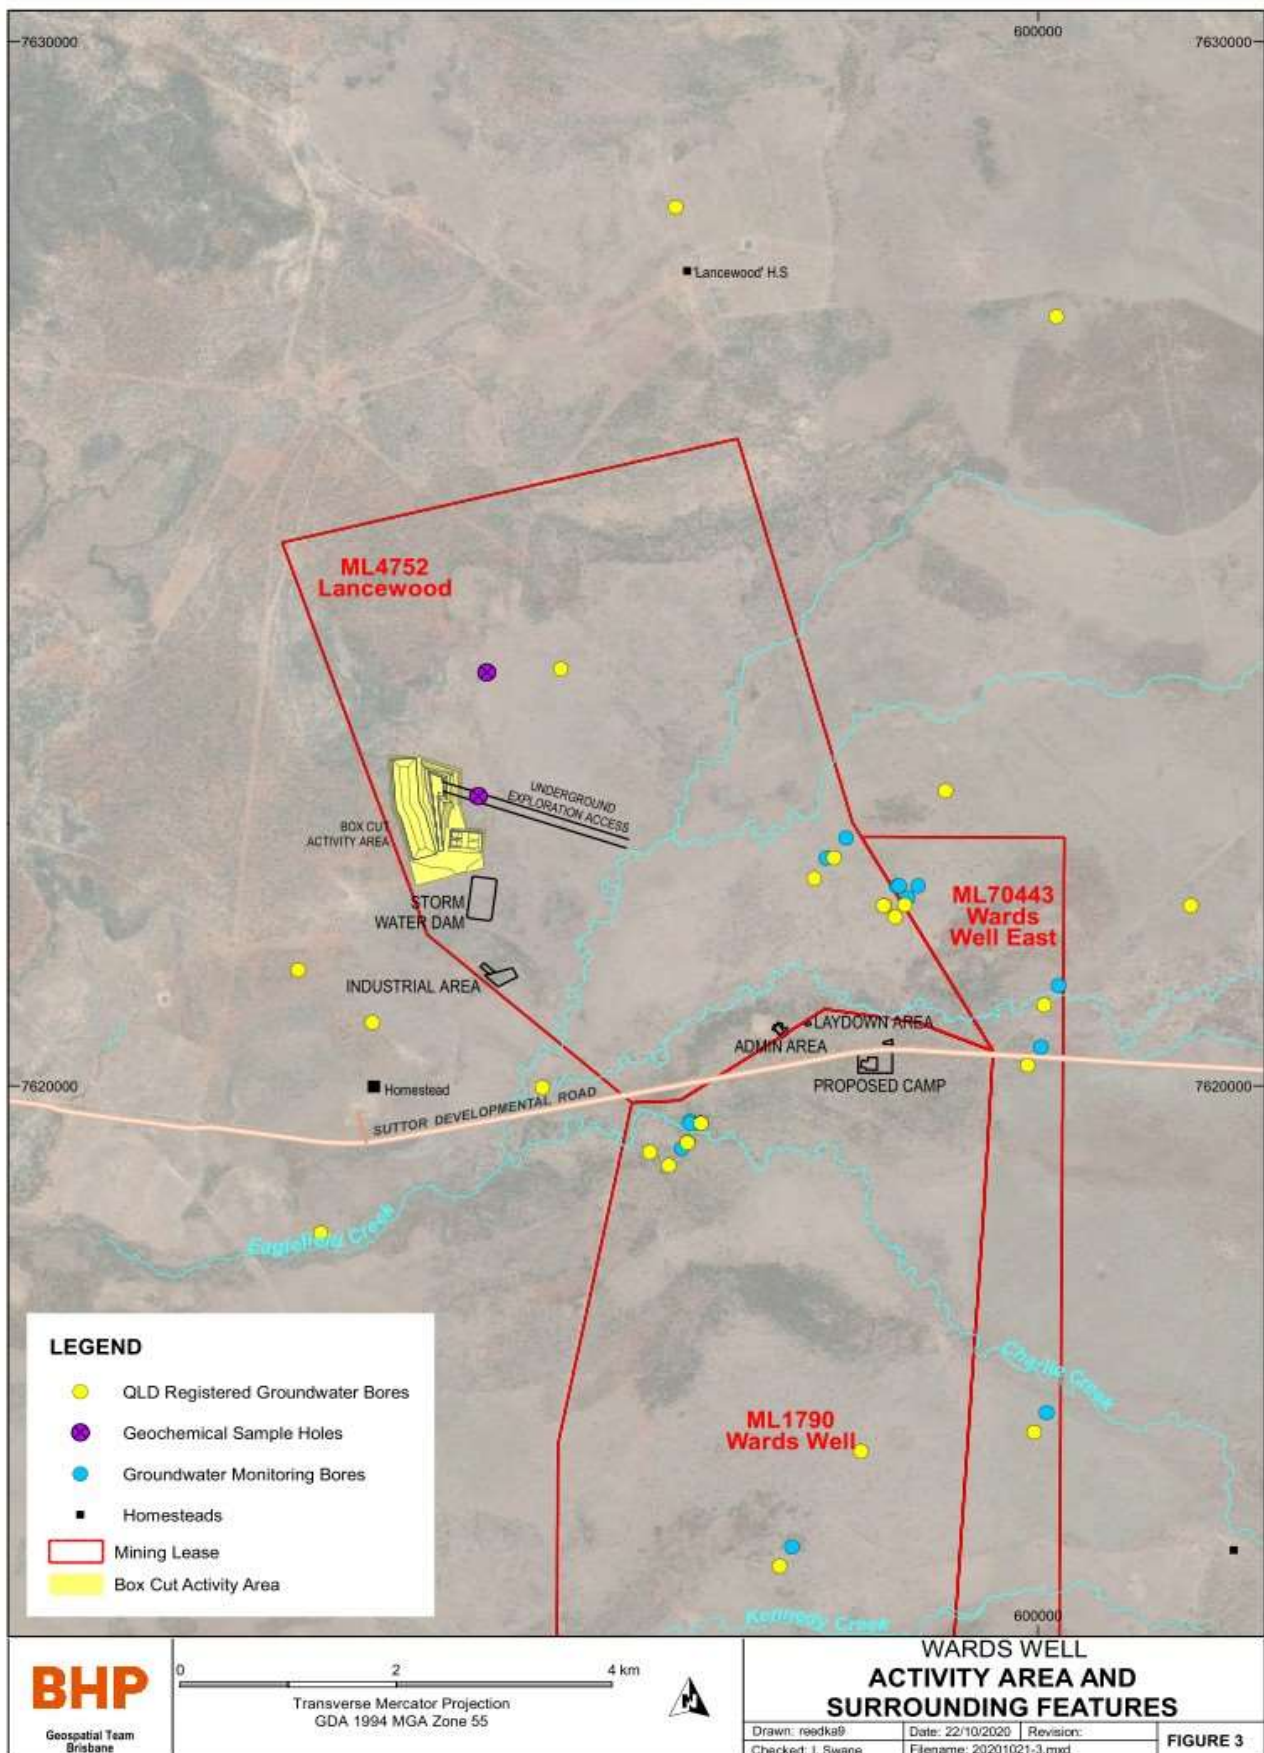
Figure 3: Locations of groundwater bores/wells in the vicinity of the activity area

The broader Wards Well area is drained by Eaglefield Creek (northern area), Charlie Creek (middle area) and Kennedy Creek (southern area) and their minor tributaries. The creek systems discharge to the northwest flowing towards the Suttor River, which is part of the Burdekin system. In each case the water courses are ephemeral. The seasonal variability in flows is evident with many months recording zero stream flow. Of direct relevance to the activity area – the focus of this report – the nearest drainage is an ephemeral northern tributary of Eaglefield Creek and is located approximately 1.2 km southeast of the activity area (Figure 3). There are no surface water features within 1 km of the activity area.

The disturbance activities are contained within a bunded area and surface water within the bunded area flows from northwest towards the south and is captured by a Mine Water Dam (Figures 1 and 3). Surface water and sediment run-off outside of the bunded area flow from north-northwest around the outside of the bund into a Stormwater Dam located immediately south of the bunded area (Figures 1 and 3). Water from the Stormwater Dam can be used on site for exploration activities (e.g. dust suppression) or directed back into overland flow southeast towards the tributary of Eaglefield Creek.

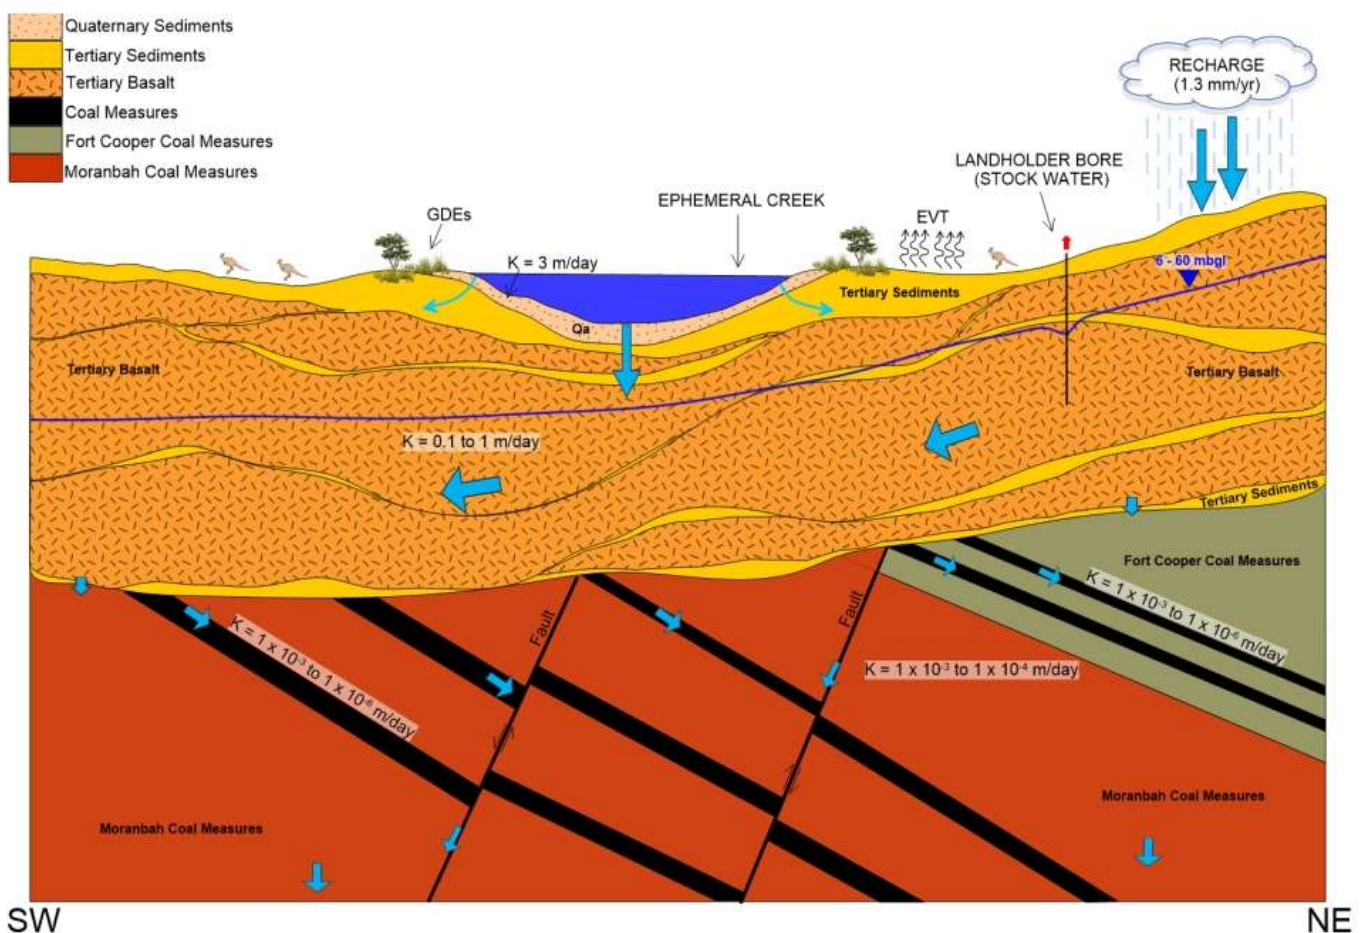
Figure 4: Hydrogeological conceptual model of the Wards Well district (Golder, 2020)

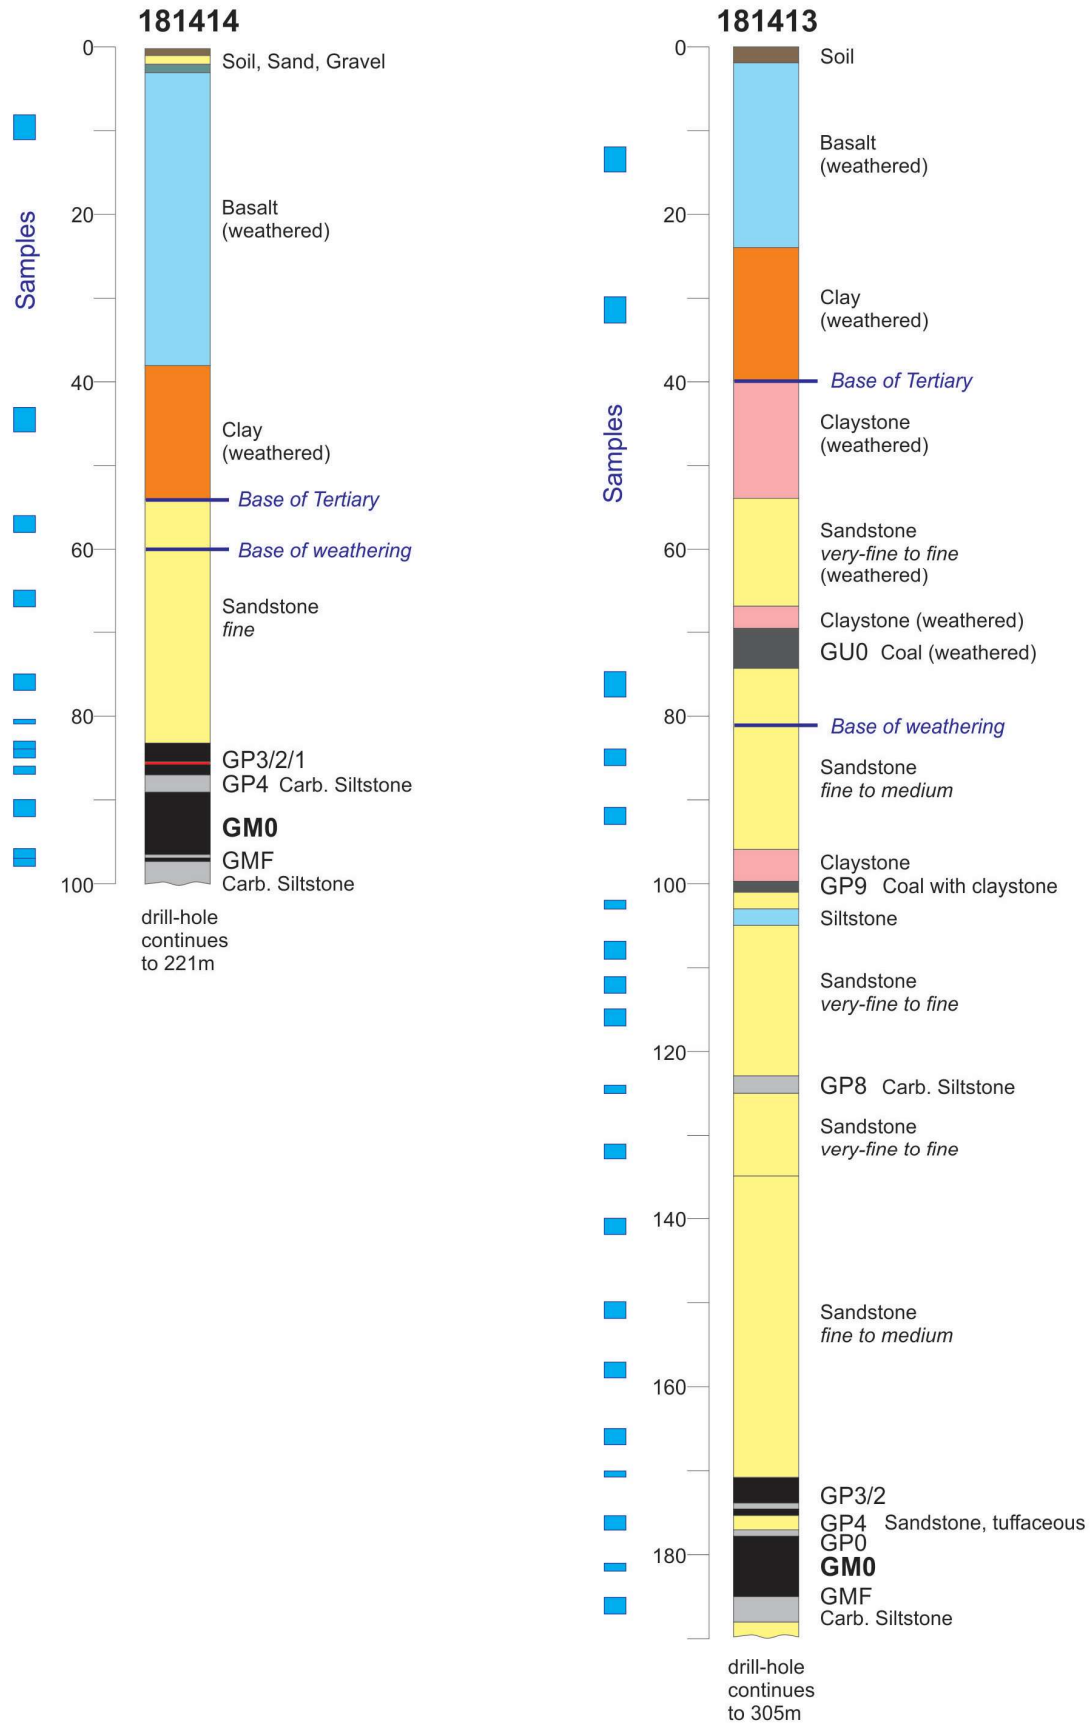
Figure 5: Stratigraphic column and sampling intervals to GMF seam from drill-holes 181413 and 181414

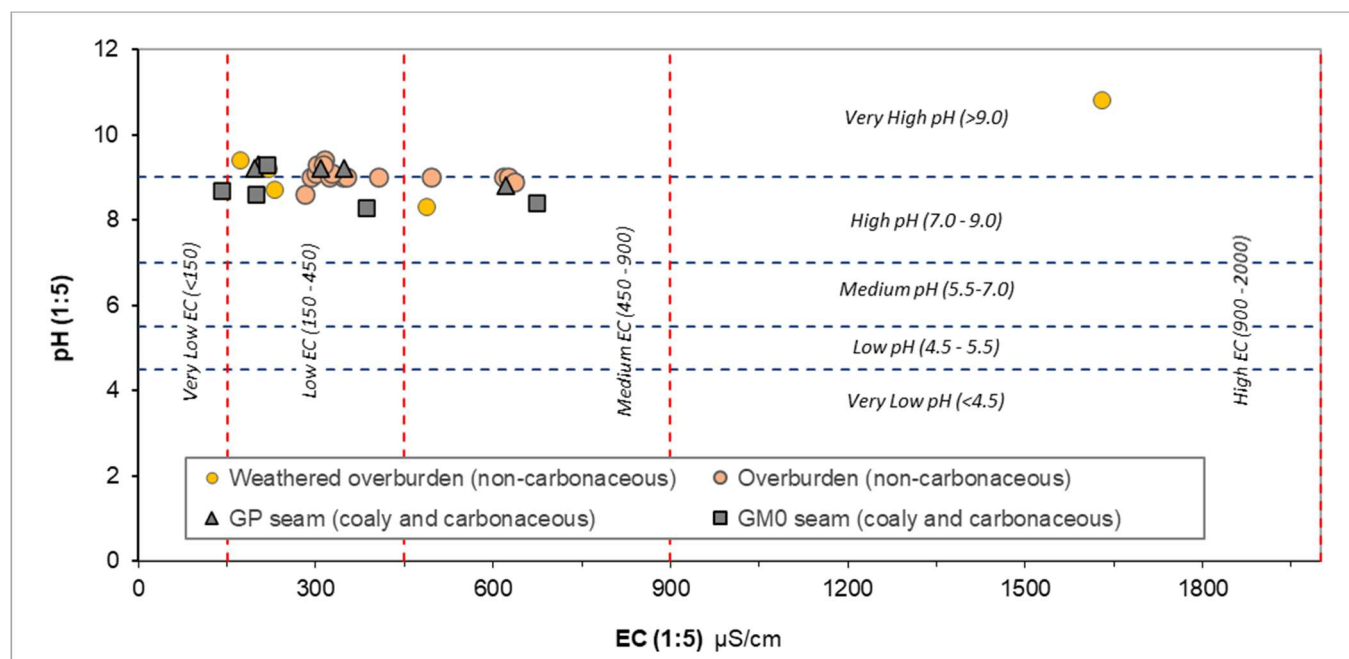
The samples had pH-neutral to alkaline soil pH<sub>1:5</sub> values ranging from pH 8.3 to 10.8 – classifying them as ‘High’ to ‘Very High’ soil pH, and generally ‘Low’ to ‘Medium’ soil electrical conductivity (EC<sub>1:5</sub>) values ranging from 140 to 1630 µS/cm [with median, 75<sup>th</sup> and 90<sup>th</sup> percentile values of 322, 447 and 625 µS/cm, respectively]. As evident in Figure 6 and Table 4, there is little distinction between samples of different lithology or between weathered versus fresh, or between seam samples versus overburden samples.

Figure 6: Electrical conductivity (EC) and pH

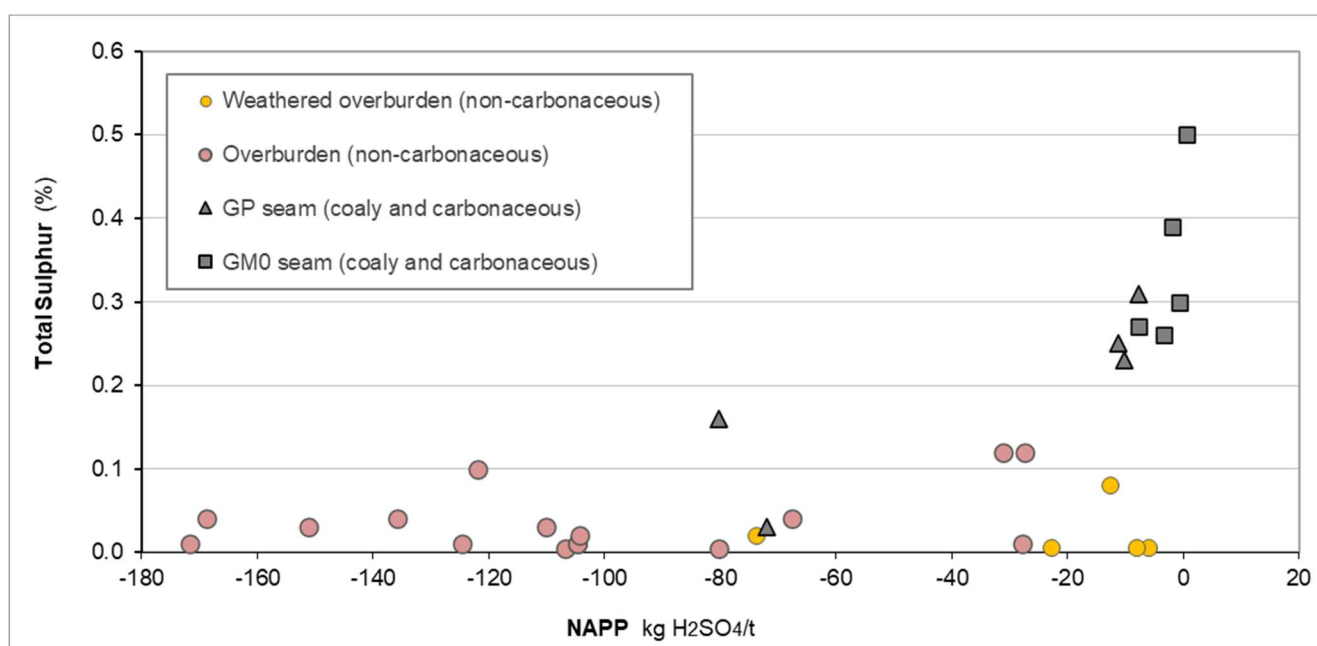
The calculated NAPP values for these samples (NAPP calculated from Scr, where available) are shown in Table 4. Based on the low MPA and generally significantly higher ANC values, the calculated NAPP values were negative for all except one sample (a GM0 seam/floor sample), indicating a greater proportion of neutralising capacity (ANC) compared to potential acidity (MPA). The NAPP values ranged from -172 to +0.5 kg H<sub>2</sub>SO<sub>4</sub>/t, with median and 75<sup>th</sup> percentile NAPP values of -68 and -9 kg H<sub>2</sub>SO<sub>4</sub>/t. As expected, the NAPP values for coaly and carbonaceous samples were generally higher (less negative) compared to non-coaly or non-carbonaceous samples. The relationship between NAPP and Total S is shown in Figure 7, which illustrates a clear increase in Total S in the coaly and carbonaceous samples compared to non-carbonaceous materials, in agreement with similar trends observed for coal deposits within the Moranbah Coal Measures.

Figure 7: Total sulphur versus NAPP

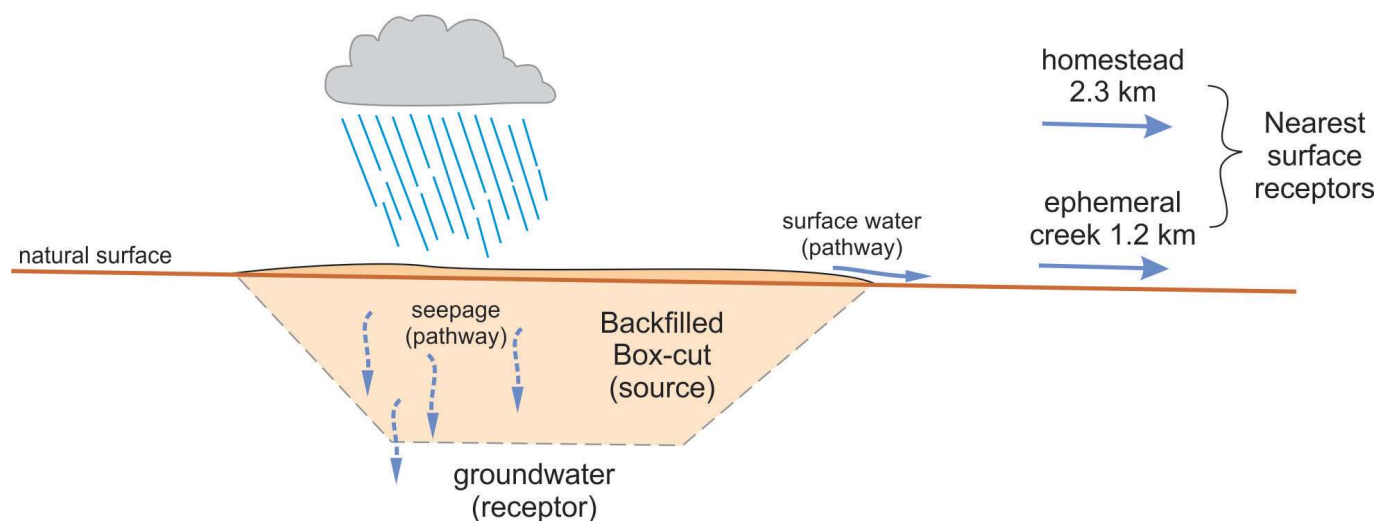
Figure 8: Source-Pathway-Receptor (SPR) conceptual site model at closure

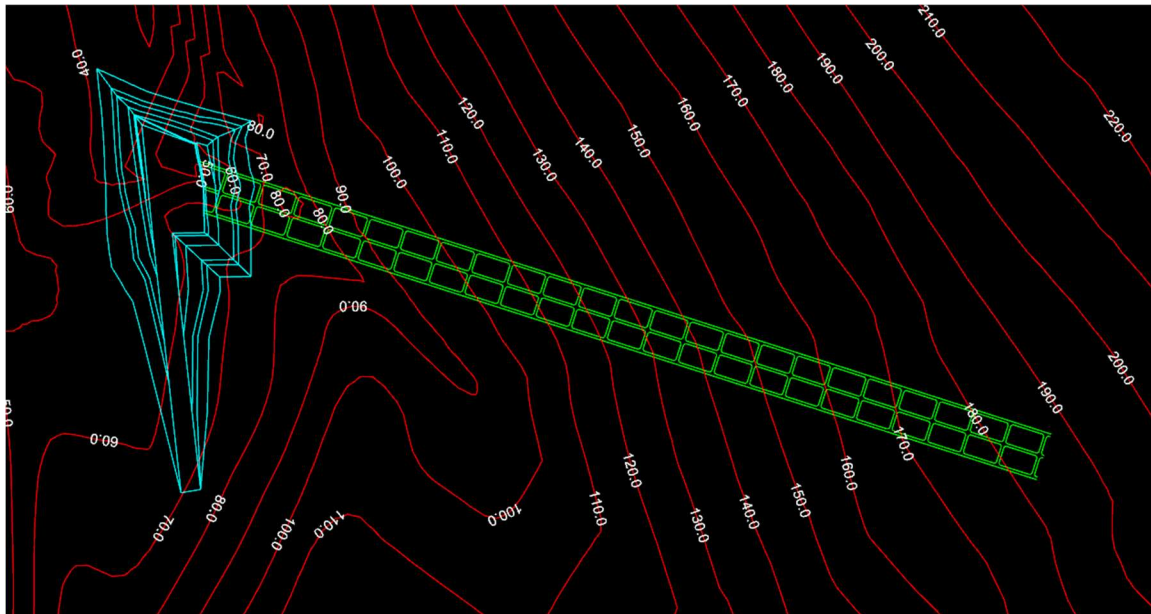
Figure 2 - Wards Well Exploration Adit Layout and Depth of Cover.

The Wards Well Exploration Adit is located on the Lancewood Mining Lease (Figure 1). As a part of mine closure provisions an assessment is required to determine if subsidence of the surface is likely to occur as a result of trial underground mining activities. The proposed underground mine comprises a 3 heading adit developed from a box cut highwall. The development will range in depth from 50m to 190m (Figure 2). The mining will take place in the Goonyella Middle seam within the Moranbah Coal Measures. The area is located in an area of reduced Tertiary sediment and basalt thickness.

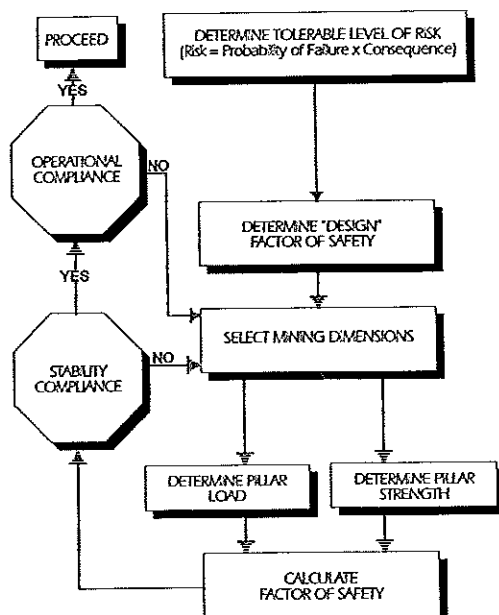
PILLAR DESIGN DECISION PROCESS

The design methodology has evolved from a probabilistic analysis of field performance of pillar systems in New South Wales and Queensland. Two forms of pillar strength relationships have been quantified by this analysis; a power law formula, and a linear formula. A marginally higher confidence level is associated with the power law formula.

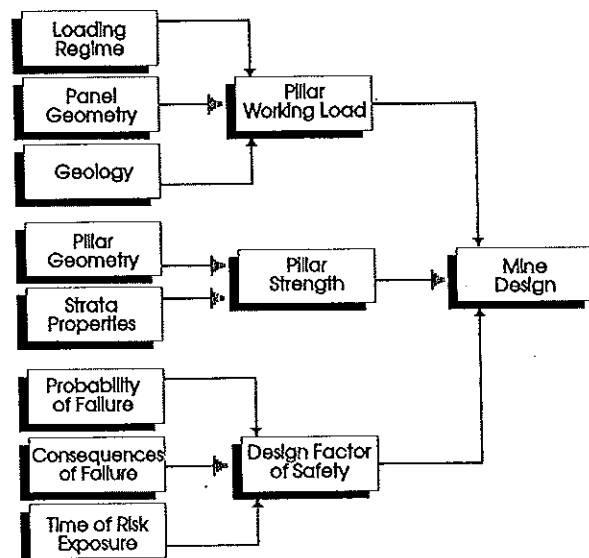
Principal Influences on Pillar Load, Strength and Factor of Safety

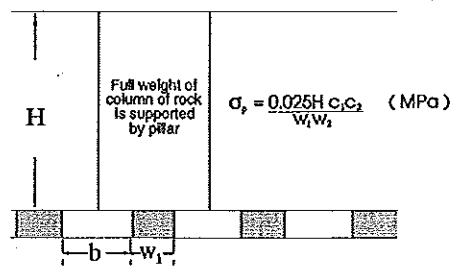
In an extensive layout comprising pillars of irregular size, the pillars with the greater width to height

ratios are subjected to more load because they are stiffer and, therefore, provide greater resistance to

Figure 1. Tributary Area Load

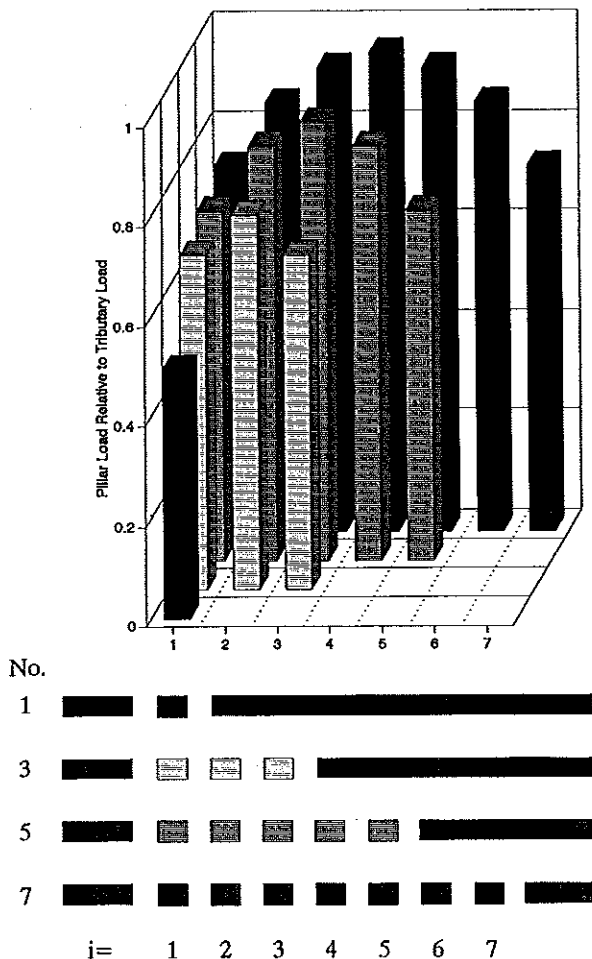
Figure 2. Panel Pillar Loading

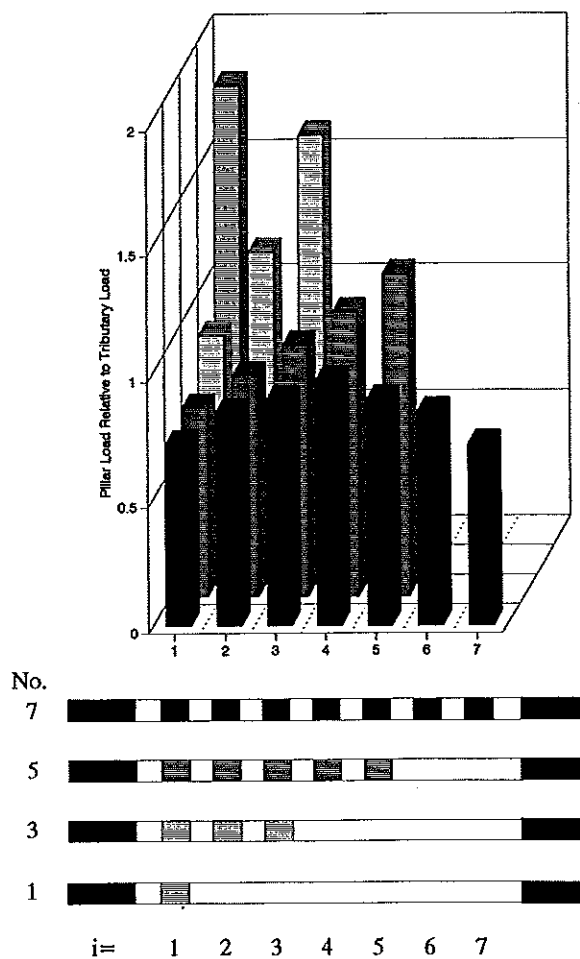
Figure 3. Abutment Loading on Standing Pillars

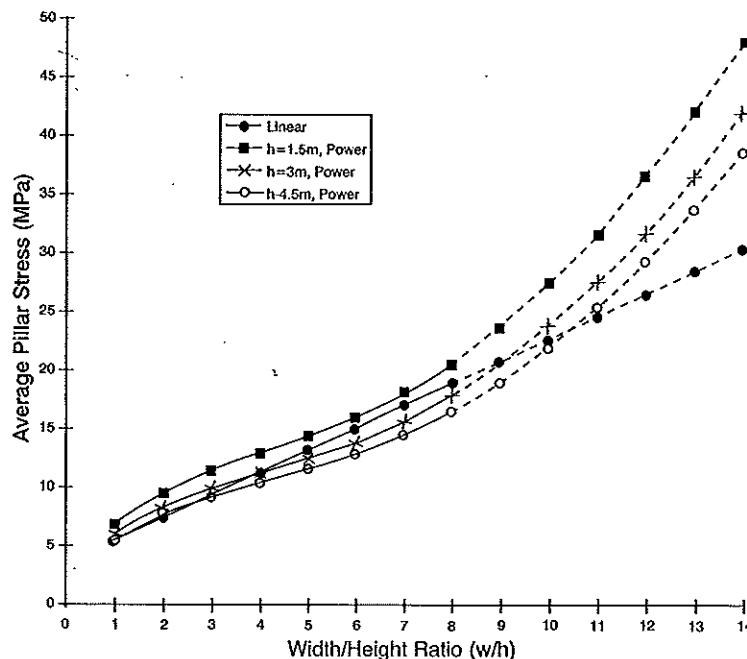
Close correlations were obtained in both cases, with the strength parameters for the linear and the power law formulae differing by only 5% and 3%, respectively. In all cases, a lower standard deviation was associated with the power law formulae (0.0689 to 0.0735) than the linear law formulae (0.0776 to 0.0863).

Figure 4. Strength v. Width/Height Ratio

cases, although collapsed cases carry a much higher weighting. Neither the Australian nor the South African databases contain a collapsed case above a  $w/h$  ratio of 8.2, hence there are no checks on the upper limits to which the formulae find application.

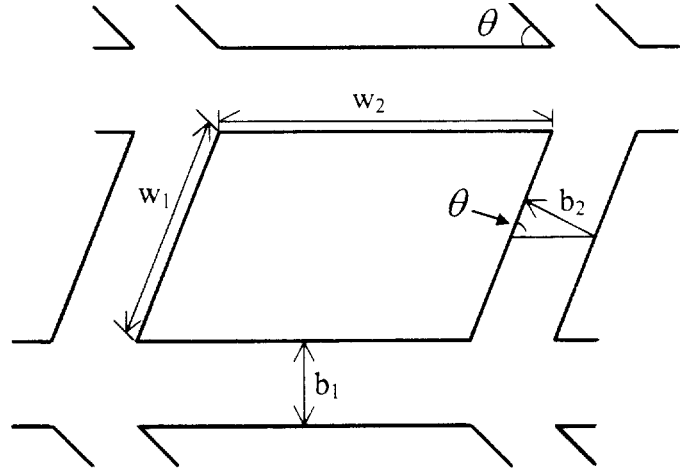
Figure 1.—Definition of mining variables associated with a parallelepiped pillar.

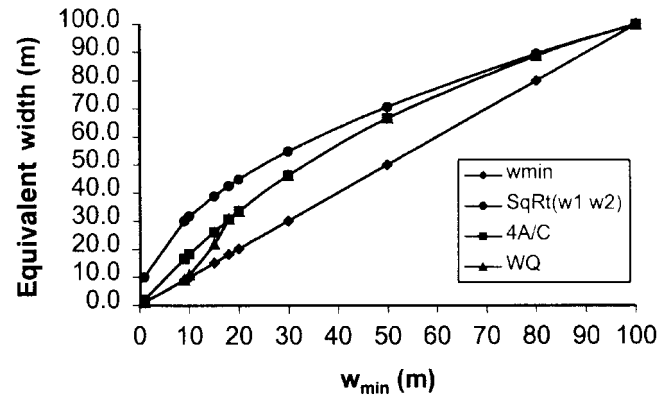
Table 1 and figure 2 show the effects of the various approaches when applied to calculating the effective width of a 100-m-long, 3-m-high rectangular pillar.

Figure 2.—Comparison of the various proposals for calculating the effective width of a 100-m-long, 3-m-high rectangular pillar.

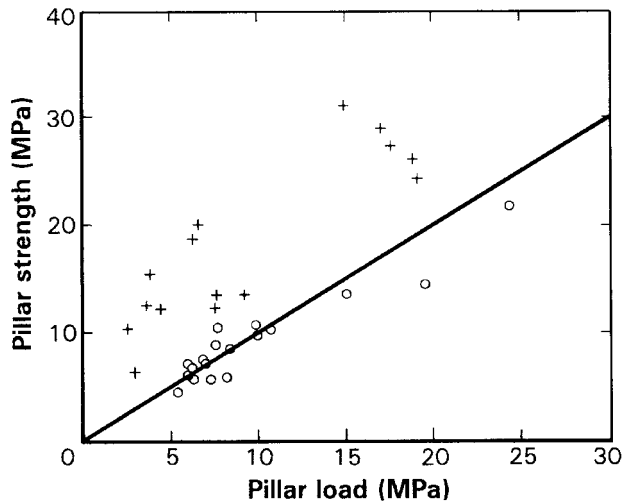
Figure 3.—Pillar strength and pillar load relationship for both the failed (o) and unfailed (+) Australian cases.

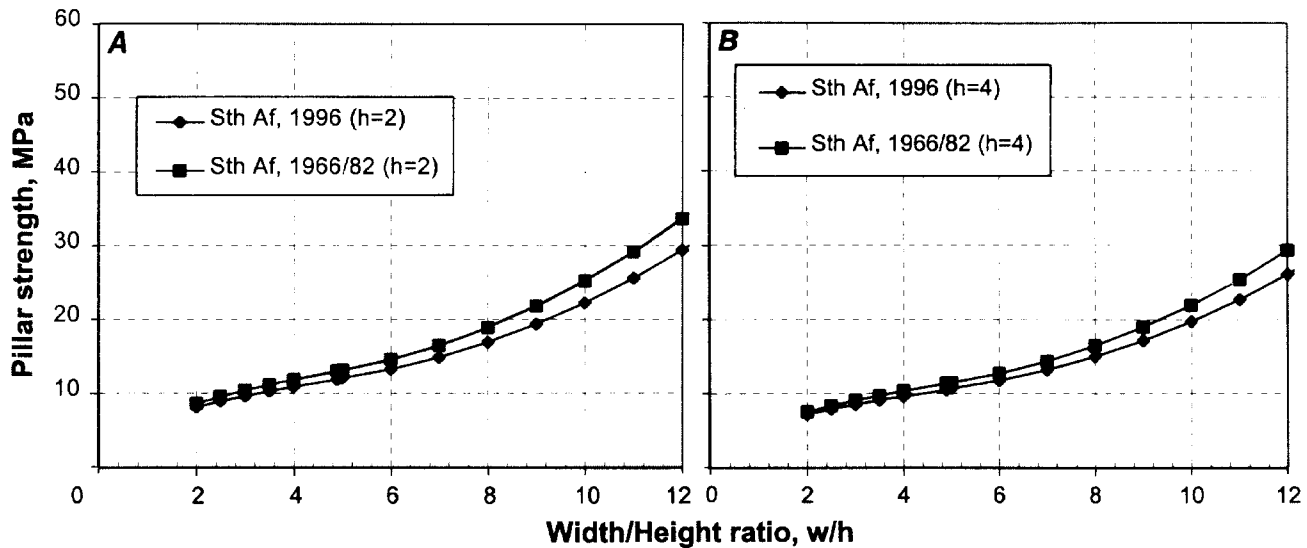
Figure 4.—Comparison between South African power formulas, 1966/82 and 1996. A,  $h = 2$  m; B,  $h = 4$  m.

Figure 4 shows the comparison between the pillar strength produced by equations 22a and 22b and that predicted by the original Salamon and Munro formula and its modified squat pillar form. In the case of a mining height of 2 m, the figure shows that for a given pillar strength, pillars designed with the

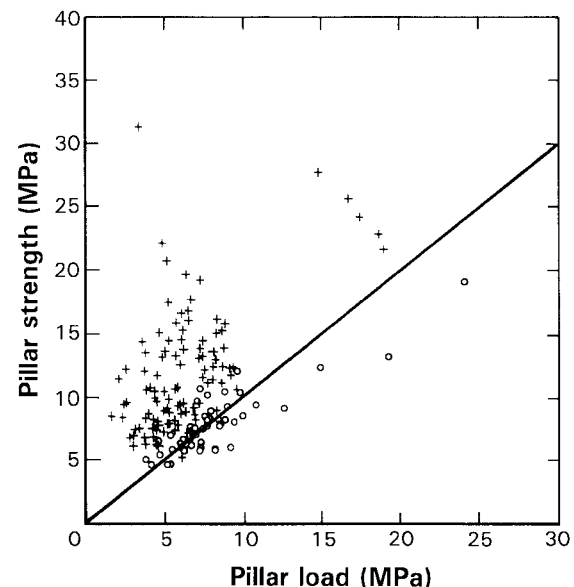
Figure 5.—The failed (o) and unfailed (+) cases in a pillar strength versus pillar load plot using the combined Australian-South African database.

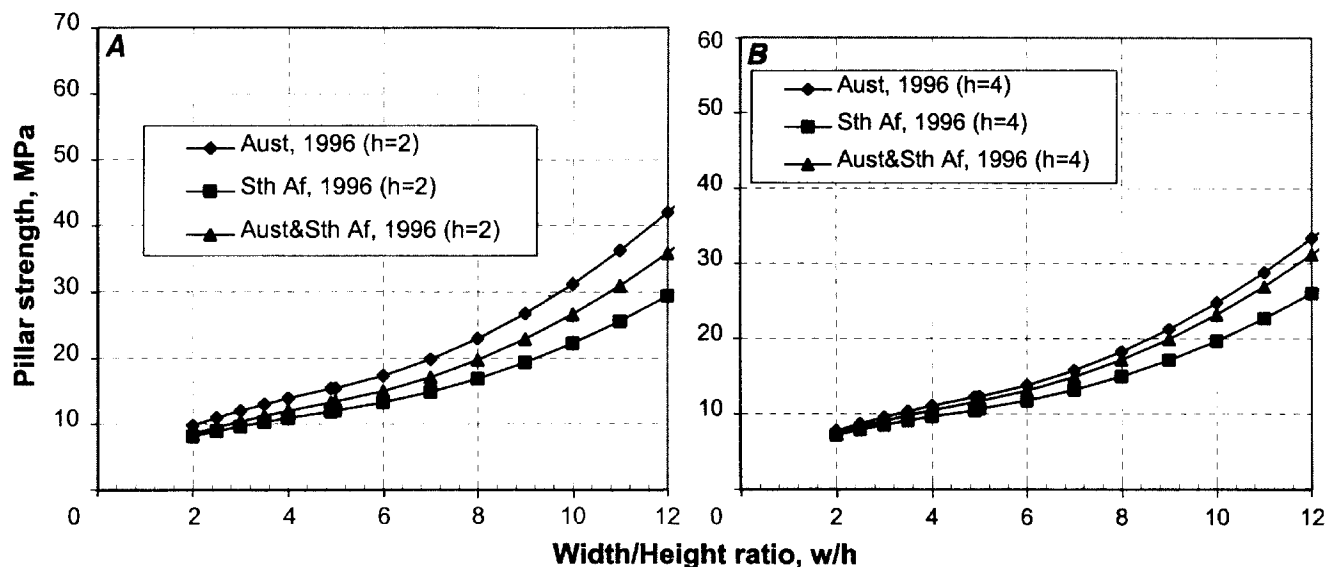
Figure 6.—Comparison between power law strength formulas derived for the Australian, South African, and combined databases. A,  $h = 2$  m; B,  $h = 4$  m.

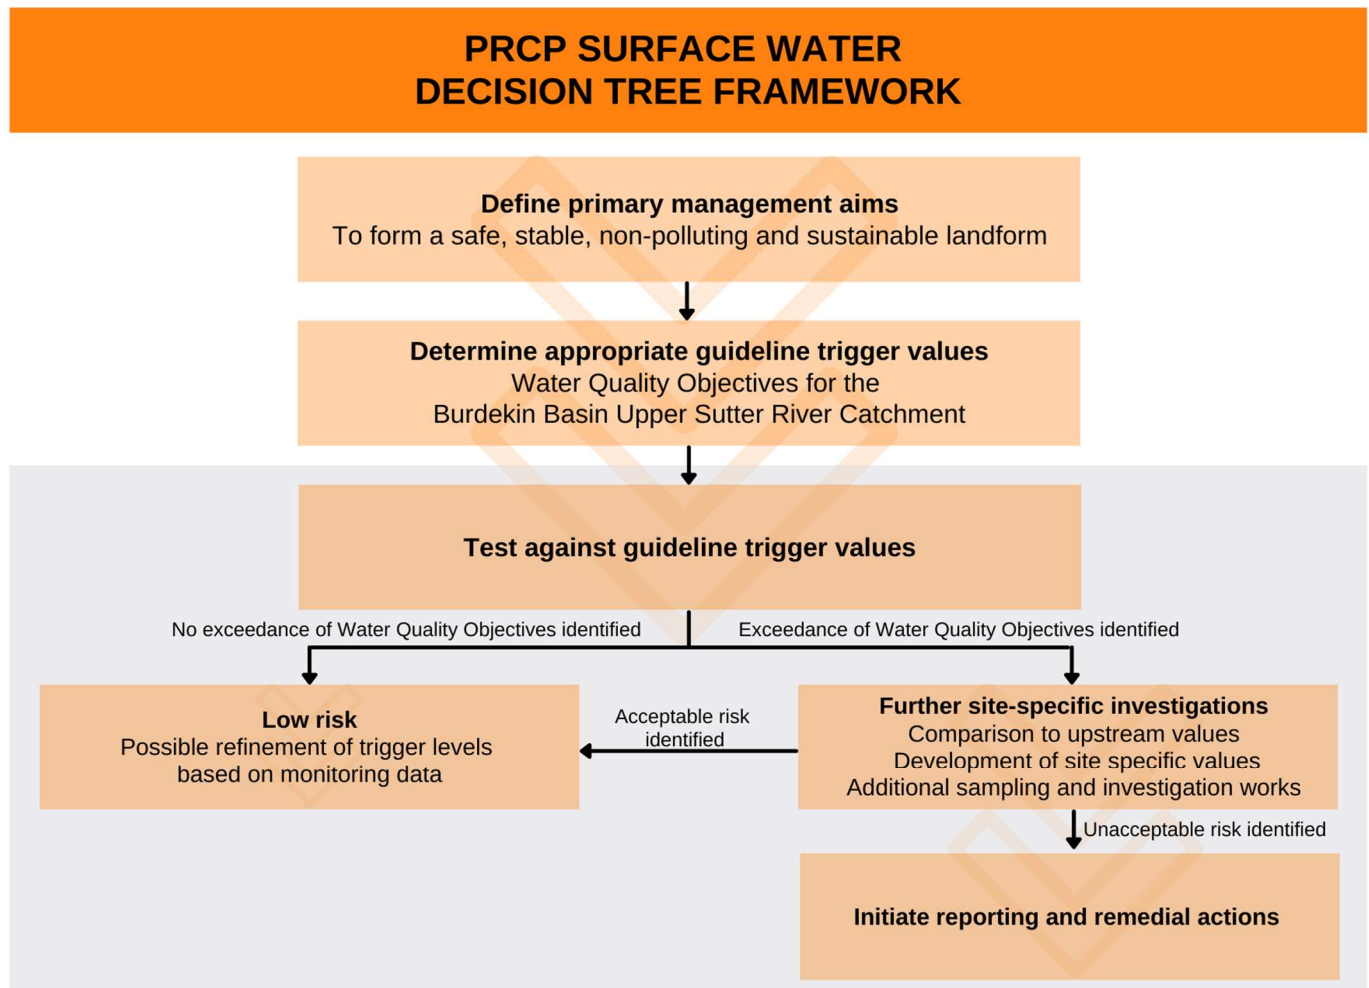
For the purpose of the PRCP schedule, the application of the nominated water milestone criteria will follow the decision tree framework approach outlined in Section 3.3 of the ANZECC/ARMCANZ 2000 Water Quality Guidelines<sup>40</sup>, as shown below in Figure 36.

**Figure 36: Water decision tree framework (Adapted from ANZECC/ARMCANZ, 2000)**

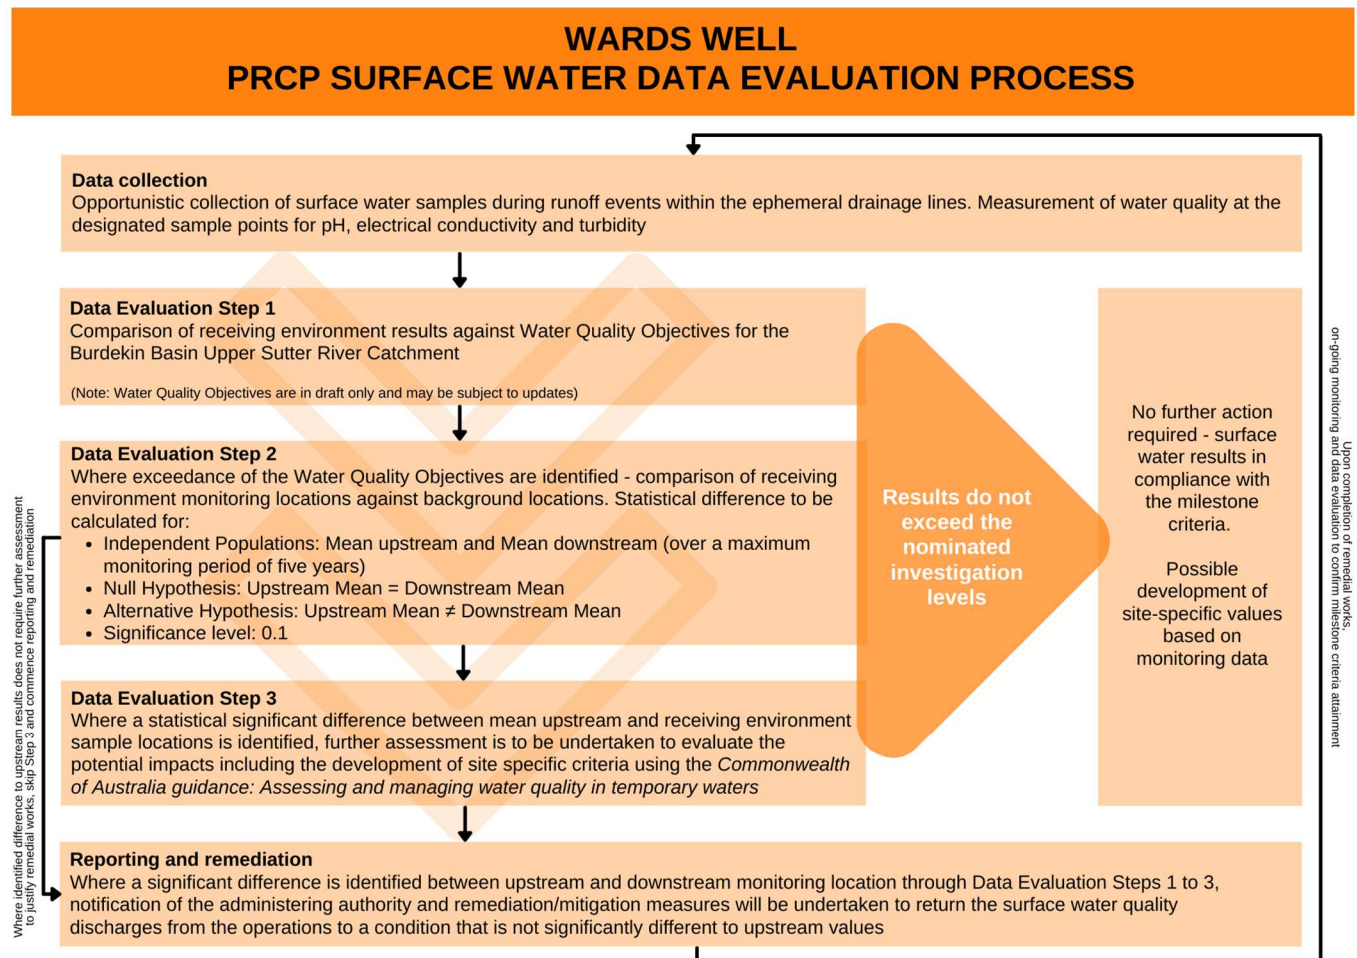
**Figure 37: Wards Well surface water data evaluation flow diagram**

In accordance with the ANZECC/ARMCANZ surface water decision tree framework and the preferential approach to the derivation of site-specific toxicant guideline values, Step 3 includes additional investigation and development of site-specific criteria where a statistical significant difference between upstream mean and receiving environment sample locations is identified. The development of site-specific criteria will be undertaken using the Commonwealth of Australia guidance: Assessing and managing water quality in temporary waters<sup>42</sup>. The aim of Step 3 is to take into consideration the specific environment in which the site is located including a more thorough investigation of the receptors and potential risks associated with any identified exceedance. This step will require suitable data sets and to be undertaken by suitably experienced persons.

Figure 37 provides a flow diagram of the approach to surface water data evaluation.

| | <ul style="list-style-type: none"> <li>• Rainfall runoff from the area is not significantly different to upstream values for the following: pH, EC and turbidity as per Appendix 13, Figure 37</li> <li>• Deep drainage from the area is not significantly different as per Appendix 13, Figure 37, to EC levels of: <ul style="list-style-type: none"> <li>– the EPP (Water) schedule documents water quality objectives for relevant groundwater chemistry zones; or</li> <li>– local water quality objectives developed in accordance with the Queensland Water Quality Guidelines</li> </ul> </li> <li>• Land suitability class <math>\leq 3</math>, or not different from pre-mining class if <math>\geq 4</math>. The assessment is to be conducted by an appropriately qualified person and completed in accordance with LSA Framework for Open-Cut Coal Mine Rehabilitation 2018 (A rule-set for land suitability assessment of sustainable beef cattle grazing on land rehabilitated after open-cut coal mining in the Bowen Basin Queensland) unless otherwise agreed in writing between the administering authority and the environmental authority holder.<br/><br/>If the land suitability class is assessed as not different from pre-mining class if <math>\geq 4</math> for all or a portion of a rehabilitation area, an assessment of reference sites must be carried out to determine if the limitation/s resulting in the class of <math>\geq 4</math> is consistent with that of reference sites.</li> <li>• Certification by an appropriately qualified person that pasture meets a pasture condition rating <math>\leq 3</math>, based on the Pasture Condition Assessment Table as per Stocktake: Balancing Supply and Demand (<a href="https://futurebeef.com.au/workshops/sustainable-grazing/stocktake-balancing-supply-demand/">https://futurebeef.com.au/workshops/sustainable-grazing/stocktake-balancing-supply-demand/</a>), as provided in Table 33.</li> </ul> |

| RM7 | <ul style="list-style-type: none"> <li>• Rainfall runoff from the area is not significantly different to upstream values for the following: pH, EC and turbidity as per Appendix 13, Figure 37</li> <li>• Deep drainage from the area is not significantly different, as per Appendix 13, Figure 37, to EC levels of: <ul style="list-style-type: none"> <li>– the Environmental Protection (Water and Wetland Biodiversity) Policy 2019 schedule documents water quality objectives for relevant groundwater chemistry zones; or</li> <li>– local water quality objectives developed in accordance with the latest version of the Queensland Water Quality Guidelines</li> </ul> </li> </ul> |
